MANDATORY SERVICE BULLETIN

NO. MSB-42-032/1

Type: DA 42

- Installation of a ventilation hole in Filler Cap Fitting, Auxiliary Fuel Tank
- Inspection of the Auxiliary Fuel Tank
- Inspection of the Fuel Tank Ventilation line
- Incorporation of the AMM-TR-OÄM-42-056f into the DA42 AMM

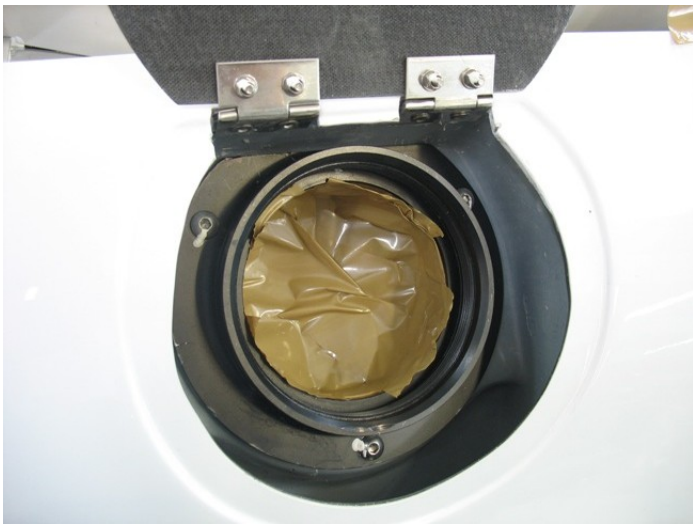
<p>NOTE:</p> <p>If WI-MSB-42-032, rev. 0 has been carried out, start with item 7 of this Work Instruction.</p>
1	<p>Remove fuel filler cap and check filler cap fitting, if ventilation hole is drilled. (Refer to drawing D60-2814-00-30 "f", Section C-C.)</p> <p>Note: Filler cap fittings with revision level "f" or higher have the ventilation hole already installed.</p>
2	<p>If ventilation hole is not installed (prior revision level "f" of fuel filler fitting) :</p> <p>Seal fuel filler inlet for instance with tape. (Debris must not fall into the auxiliary tank)</p>

3	Drill hole, diameter 1.5 mm (0.06 in) in filler cap fitting according to drawing D60-2814-00-30 "f", Section C-C
4	Remove tape from fuel filler inlet.
5	Clean working area and check for foreign objects.
6	Perform Items 1 to 5 for RH side.

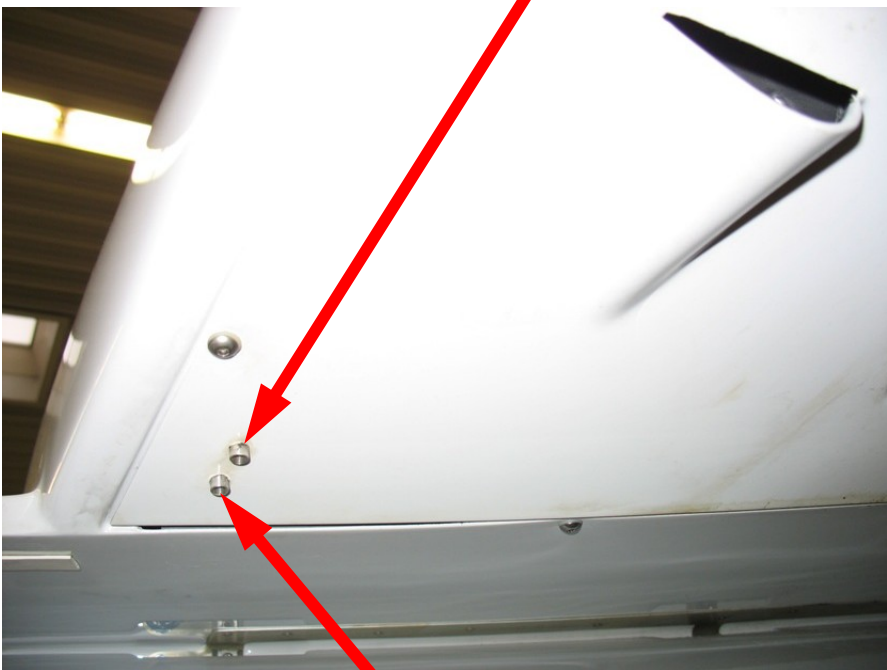
7	<p>Check outlet positions LH of fuel filler drain and tank ventilation line of Auxiliary Tank:</p> <p>NOTE: Use compressed air to check position of the lines.</p> <p>CAUTION: Fuel filler cap must be removed!</p> <p>Check, that the fuel filler drain is connected to the rear outlet.</p>

<p>Check, that tank ventilation line of auxiliary tank is connected to the front outlet.</p> <p>Check also the air flow through the fuel bleed line. (Air must opt out of the Auxiliary tank, line must not be blocked.)</p>
8	<p>If position of fuel filler drain line and tank ventilation line is not installed according to positions given in item 7 of this work instruction, remove access cover and interchange positions.</p>
9	<p>Measure volume of the Tank:</p> <p>Drain Auxiliary Tank completely and refuel Tank.</p> <p>To ensure, that no damage occurred to the tank, prior this modification, the capacity must be at least 52 liters (13,7 US gal)</p>
