# RECOMMENDED SERVICE BULLETIN

## RSB 42-036/2

Installation of a water separator in the Manifold Air Pressure (MAP) lines of the ECU.  
ATA-Code: 76

### „INSTALLATION OF WATER SEPARATOR, ECU “

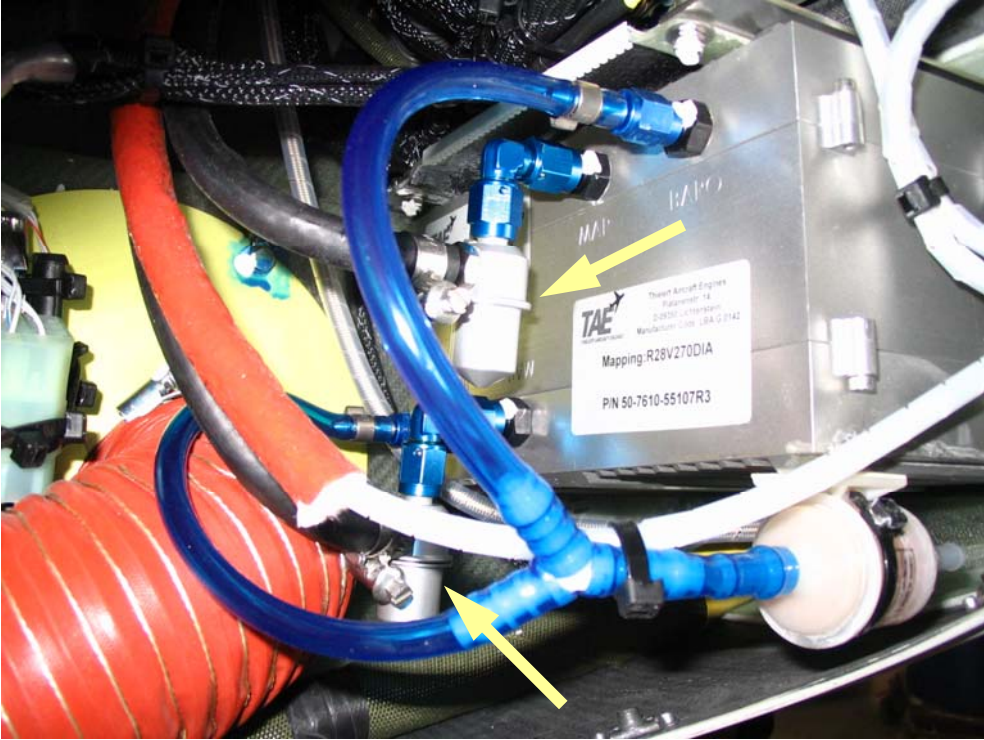
<p style="text-align: center;">Picture1: Installed Water separators and connector fittings.</p>

1	Remove LH ECU-compartment access cover.
2	Open hose clamps on both MAP lines and remove MAP-lines.
3	<p>If no water separators have been installed before:</p> <ul style="list-style-type: none"> <li>• Remove both connector fittings from the fittings of ECU A and B on the ECU housing.</li> <li>• Install new 90° connector fittings E934103 onto the fittings of ECU A and B on the ECU housing.</li> <li>• Adjust the 90° connector fittings downwards.</li> </ul>
4	<p>If water separators are already installed:</p> <ul style="list-style-type: none"> <li>• Disconnect water separators from the 90° connector fittings.</li> <li>• Make sure that 90° connector fittings are oriented downwards.</li> </ul>
5	Install water separators D60-9076-14-01 onto the 90°connector fittings, refer to picture 1.
6	<p>Connect both MAP lines to the water separators tighten hose clamps, refer to picture 1.</p>
