# MANDATORY SERVICE BULLETIN

## NO. MSB-42-039

Installation of a redesigned breather line and a new oil separator

### „REDESIGN OF BREATHER LINE AND OIL SEPARATOR “

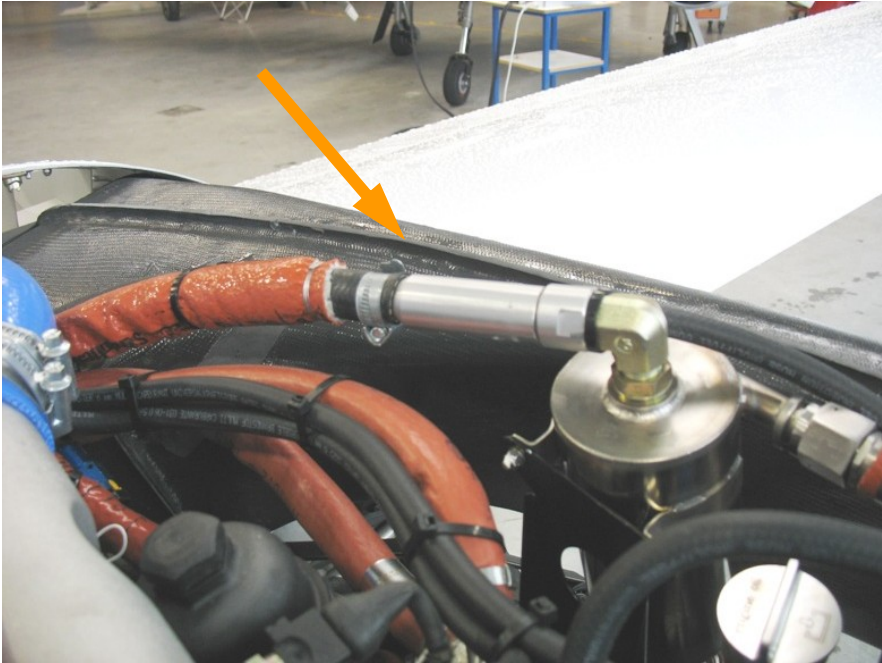
A design change in the turbo charging system from Thielert Aircraft Engines requires also the replacement of the oil separator and the breather line.

3	<p>Install new oil separator and new breather line according the following picture of this WI. Shorten breather line and fire sleeve as required and install breather line bypass (D60-7906-40-30 / D60-7906-40-31) acc. to picture.</p>
