RECOMMENDED SERVICE BULLETIN NO. RSB-42-041/1

Welding reinforcement of the cabin heat exchanger (RH-engine) and defrost heat exchanger (LH-engine), P/N D60-2140-10-00.

WORK INSTRUCTION WI-RSB-42-041

"WELDING REINFORCMENT OF THE CABIN HEAT EXCHANGER TUBE"

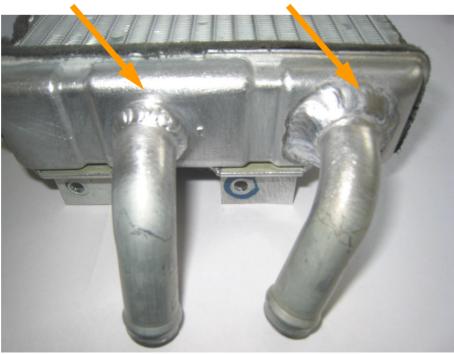
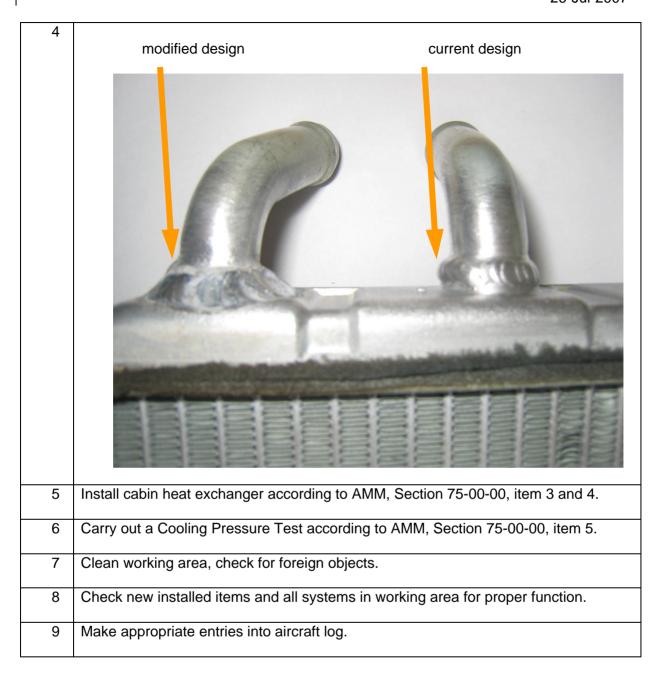
Minor leakage may occur on the pipe in- and outlet of the cabin- and defrost heat exchanger. Therefore a welding reinforcement of the pipes on the heat exchanger is recommended with this service bulletin.

The pictures are showing one pipe with the current design, and one pipe with a welding reinforcement. The reinforcement has to be carried out on both pipes.

- 2 | Clean welding area around pipes thoroughly.
- 3 Make a welding reinforcement on **both** pipes according to the following pictures.

Welding Method: WIG (141), TIG Welding Filler Metal: see item II.3

Welding specification complying with DIN 65 118, Section 1.
