# MANDATORY SERVICE BULLETIN

## NO. MSB-42-043/1

Type: DA 42, DA 42 M

Replacement of aileron bellcrank located in the wing, with a bellcrank that allows for additional angular movement of the push rod, and replacement of a bent rod end.

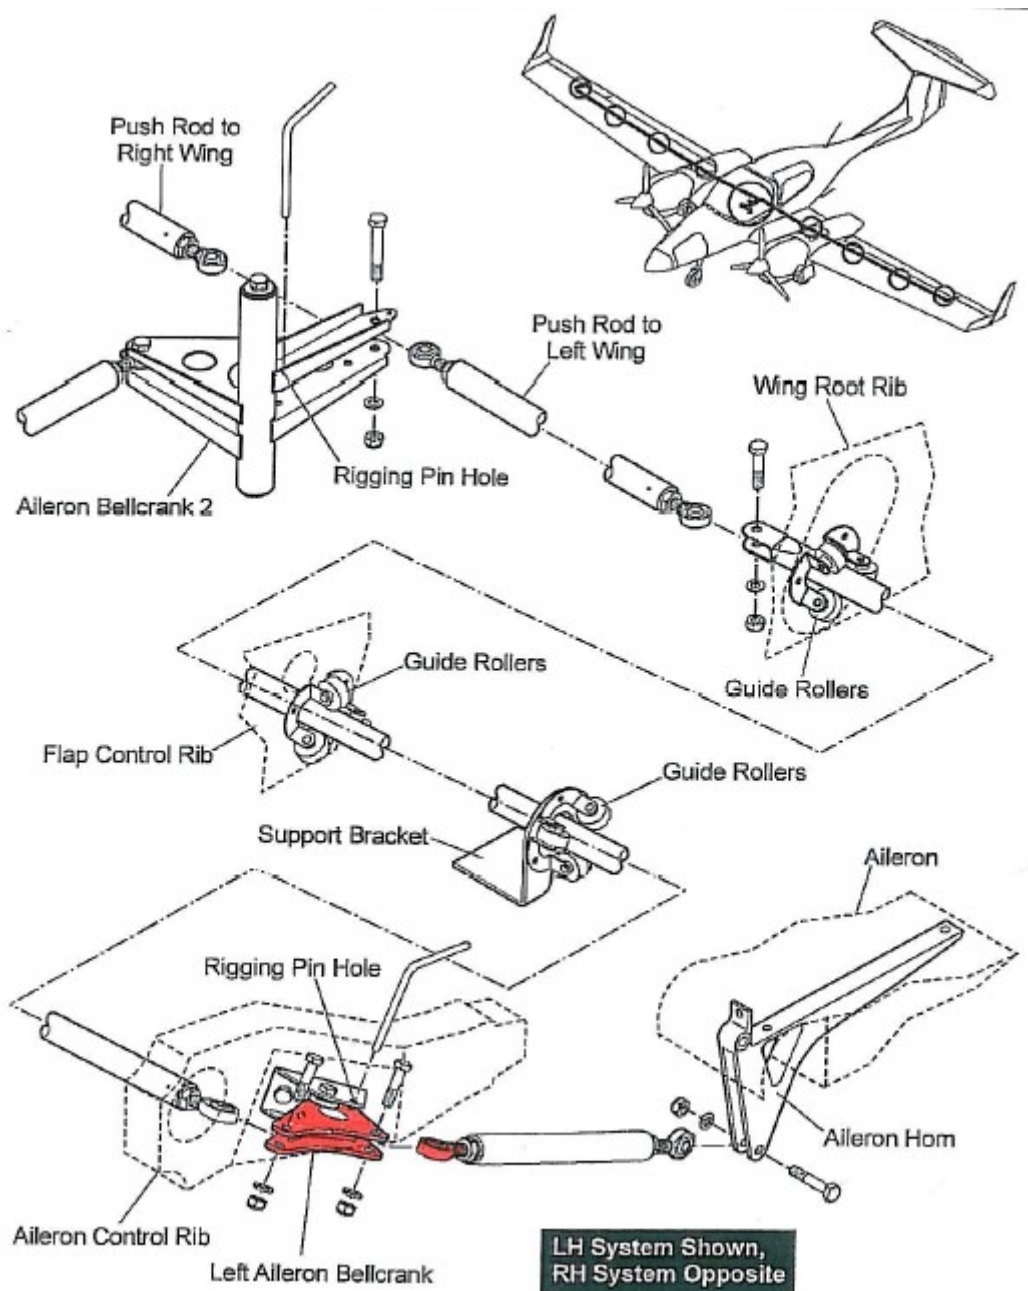
Rod ends in the aileron control system were slightly bent to achieve clearance. This non-preferable practice became obsolete, since a new design of the aileron bellcrank is available. This service bulletin calls for replacement of the bent rod end and the installation of the new design aileron bellcrank.

**Figure 1:** Aileron Controls in the Wing (colored items are affected by this SB)

3.	Replace aileron bellcrank, refer to AMM section 27-00-00. <b>NOTE:</b> Keep bolt and washers, replace self-locking nut.
4.	Replace bent rod end (eye-end fitting with spherical bearing) and adjust to correct length, refer to AMM section 27-00-00. <b>CAUTION:</b> The thread of the rod end must be in safety.

5.	Install Bonding Sheet and reconnect/reinstall the push rods to the bellcrank using the LN 9037-M6x32 bolts and a new self-locking nuts. Refer to drawing D60-2717-00-00 and AMM section 27-10-00.
