MANDATORY SERVICE BULLETIN

NO. MSB-42-055

“Water Circulation Installation in Thielert TAE 125-01 Engines”

WI-MSB-42-055

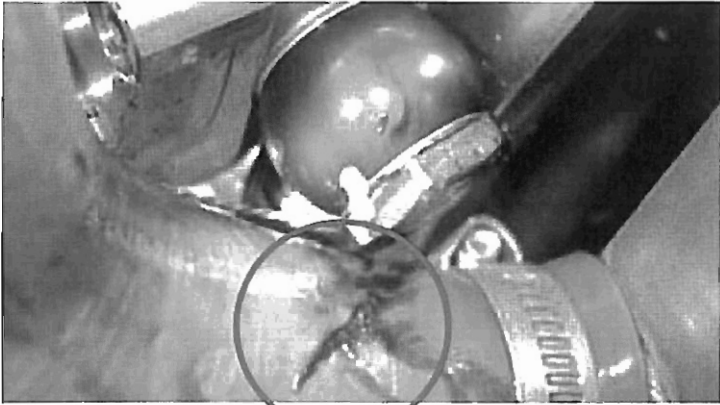
1	Remove cowlings in accordance with AMM section 71-10.
2	<p>Inspect the coolant hoses at the banjo-screw for wear. If wear is noticed, replace the damaged hose in accordance with AMM section 75-00. Pay attention for sufficient clearance between the gear box and the coolant hose.</p>

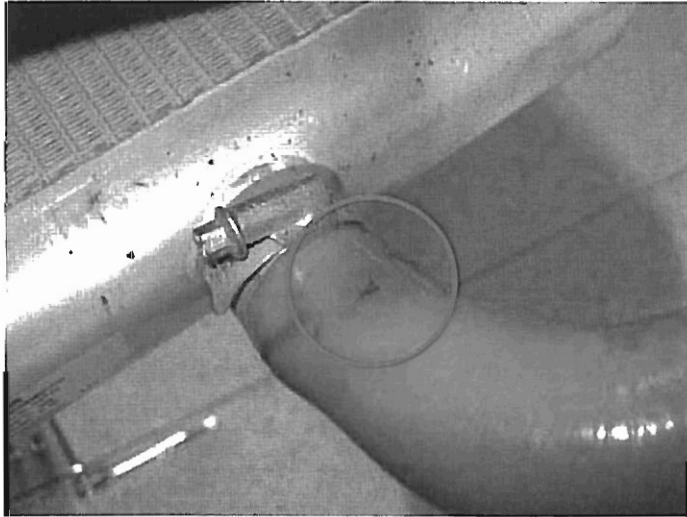
3

Inspect the inlet hose of the water cooler for wear (front side). If wear is noticed, replace the damaged hose in accordance with AMM section 75-00.

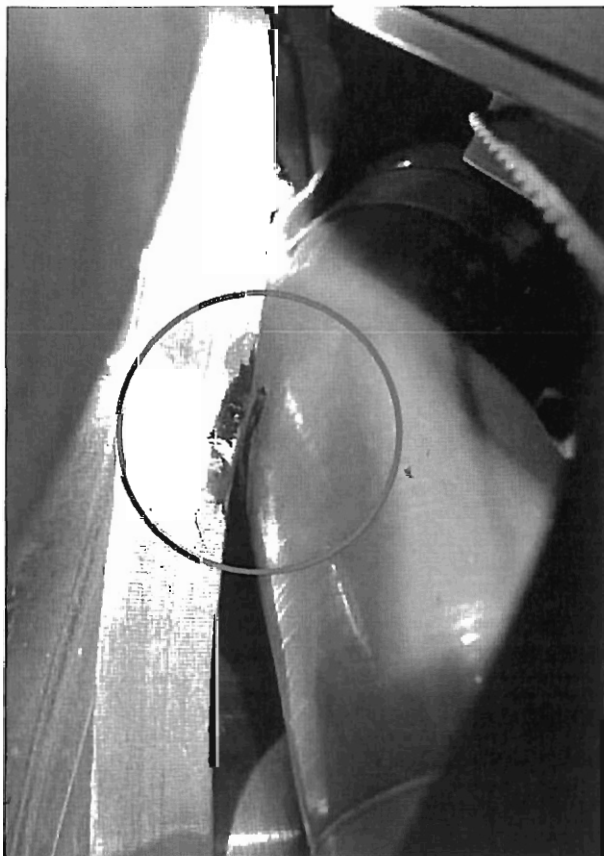
4

Check the upper coolant hose near the gear box for wear. If wear is noticed, replace the damaged hose in accordance with AMM section 75-00. Pay attention for sufficient clearance between the gear box and the hose.

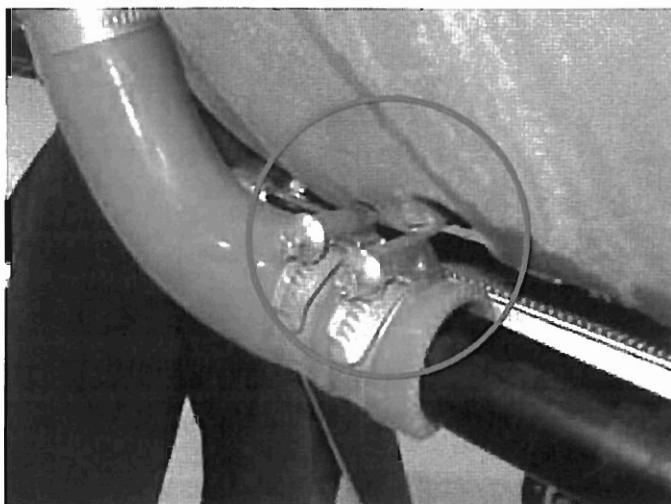
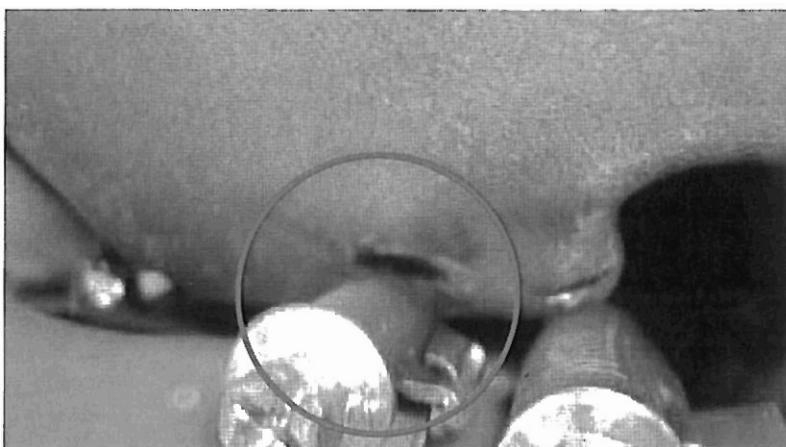
5

Check the clamps of the coolant hose of the water cooler outlet line for adequate clearance to the oil pan. If the clamps touching the pan and damages to the oil pan are detected contact Thielert Aircraft Engines for further maintenance/repair actions.

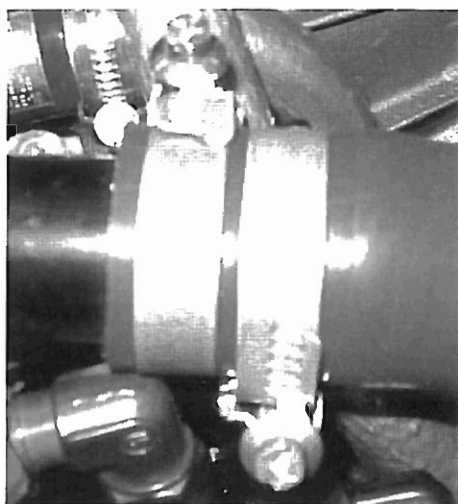
Check all hose clamps for proper installation.
For all connections which require two clamps the clamps must be installed in accordance with the following pictures. The minimum angle between the two screws must be 90° (cf. left picture below).

Sufficient Installation.

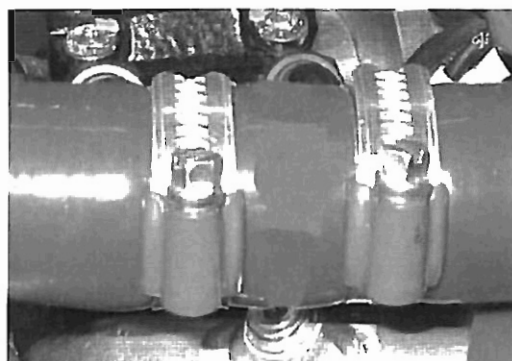
Wrong Installation.

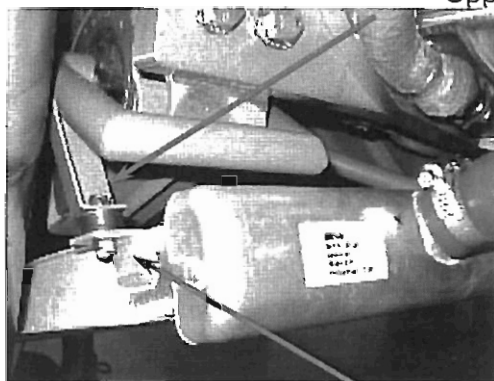
Forward RH.

Check the four coolant radiator shock mounts for supporting washers, compare with Table III-I. Check the clearance between the hose and the gear box assembly.
If supporting washers are installed and the clearance is more than 8 mm (0,315 in) proceed with step 11.

Ensure that the shock mounts are not distorted torsionally.
