MANDATORY SERVICE BULLETIN

NO. MSB-42-058

I.5 Subject

“Wire secured bolts for engine support”

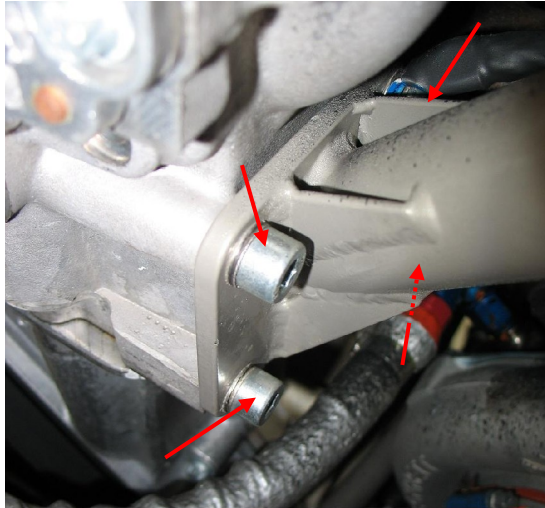
Check the installed attachment of the right rear engine support bracket for the type of used washers. The picture shows only the two rear bolts.

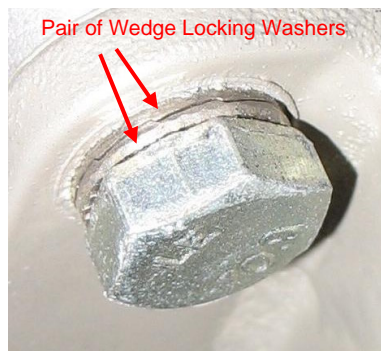
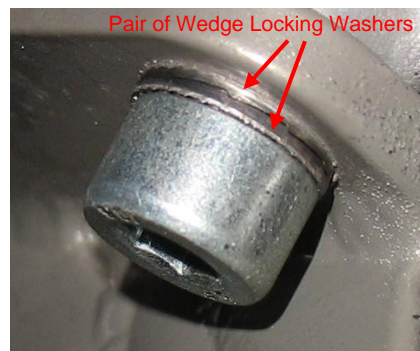
If for the attachment of the right rear engine support bracket Wedge Locking Washers are used as it is shown in the pictures there is no further action required, proceed with item 10 of this section.

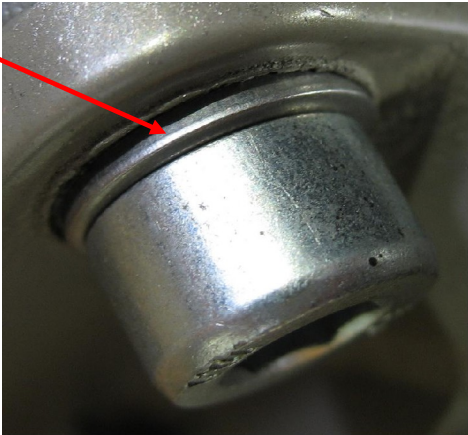
5	<p>If for the attachment of the right rear engine support bracket flat washers are used as shown in the picture, proceed with item 6 of this section.</p> <p>flat washer</p>

6	<p>Retighten the 4 bolts that fix the right rear engine support bracket to the engine with 20 Nm. In case that a bolt already has started to come loose and started to unscrew by itself, remove the bolt, apply LOCTITE 243 screw locking fluid and tighten the bolt with 20 Nm. Apply TORQUE-SEAL Anti Sabotage Inspector's Laquer (or equivalent) to the screw heads.</p> <p>Caution: Do not remove more than one bolt at once.</p>
7	Clean working area and check for foreign objects.
8	Perform functional check of all new altered or repaired parts.
9	Test all systems in working area for function.
10	Install cowlings according to AMM, section 71-10.
11	If the second engine is affected carry out items 1 -10 of this section on the second engine.

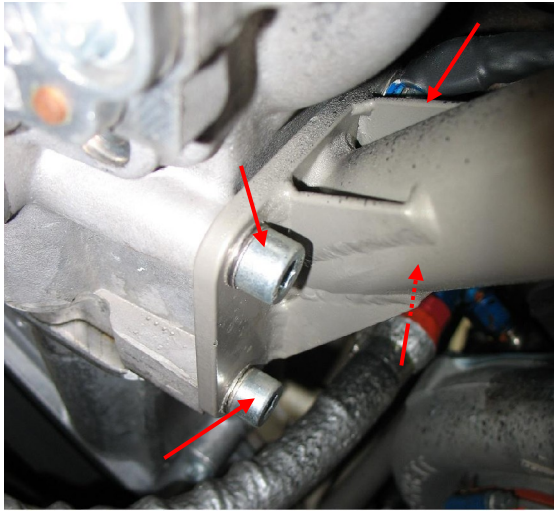
1	<p>Make sure that the engine is secured: Set ELECT MASTER switch to OFF Set the ENGINE MASTER switch to OFF Set the power lever to 0%</p>
2	<p>Remove cowlings according to AMM, section 71-10.</p>
3	<p>Check the installed attachment of the right rear engine support bracket for the type of used washers. The picture shows only the two rear bolts.</p>

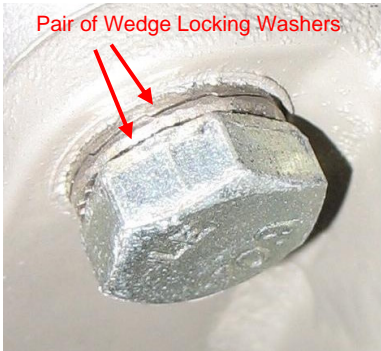
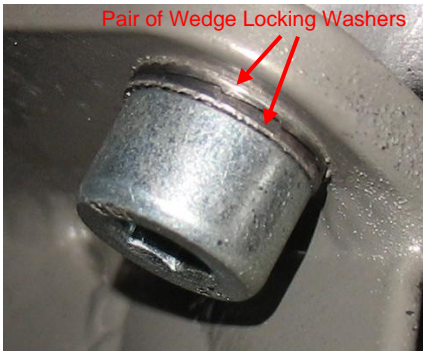
4	<p>If for the attachment of the right rear engine support bracket Wedge Locking Washers are used as it is shown in the pictures there is no further action required, proceed with item 17 of this section.</p> <div style="display: flex; justify-content: space-around;">

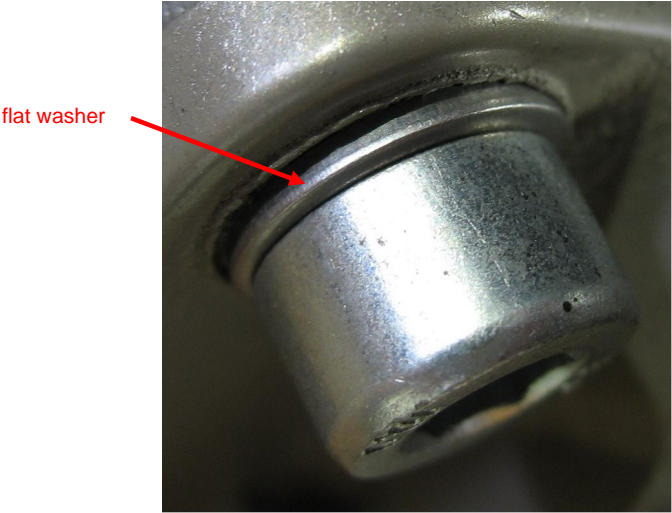
5	<p>If for the attachment of the right rear engine support bracket flat washers are used as shown in the picture, proceed with item 6 of this section.</p>

6	<p>Before removing the engine support bracket discharge or lift the engine according to AMM, chapter 71.</p>
7	<p>To gain access unplug the connection of the solenoid of the unfeathering accumulator (see picture) and remove tie-wraps. Remove the bolt of the right rear engine shock mount.</p>
