MANDATORY SERVICE BULLETIN

NO. MSB 42-063/1

Inspection and Modifications of the NLG centering unit mount.

“Modification of NLG centering unit mount”

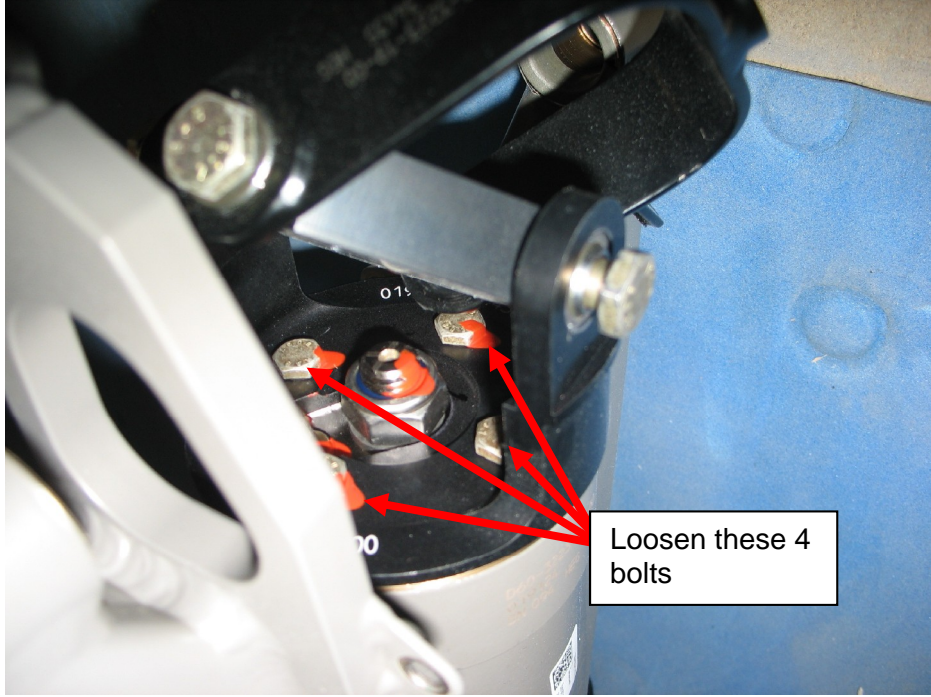
4.	<p>Remove preload of centering unit spring:</p> <p>WARNING: The centering unit is spring loaded. The spring force can cause serious injury to personnel.</p> <p>Loosen and turn each of the 4 bolts of the damper unit on top of the NLG-leg three revolutions to give at least 3 mm (0.12 in) travel of NLG-damper unit.</p>

<p>Loosen these 4 bolts</p>
5.	<p>Remove centering unit:</p> <p>Remove the 4 bolts which fix the centering unit onto the NLG leg. Use a heat gun to loosen the thread locker, but do not exceed 150 °C/ 302 °F on screw head.</p> <p>Caution: Do not damage NLG leg powder coat.</p> <p>Make sure there is no tension on the centering unit mechanism. Move the centering unit clear of the NLG.</p>

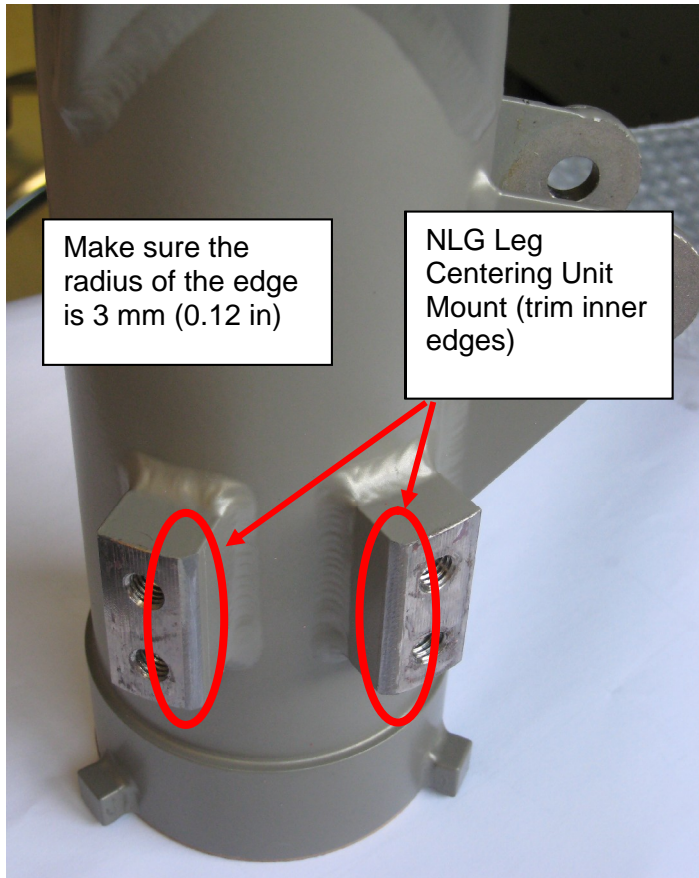
Due to sharp edges on the casing mounting main part of the NLG leg the centering unit mounting block can be damaged and cracks can occur in the block. By removing the sharp edges future damage can be avoided.

Modification of the centering unit mount:
Mark 3 mm (0.12 in) left and right from the inner edges of the mount.
File the edges to a radius of 3 mm (0.12 in).

CAUTION: Make sure not to damage the NLG surface while filing the edges.

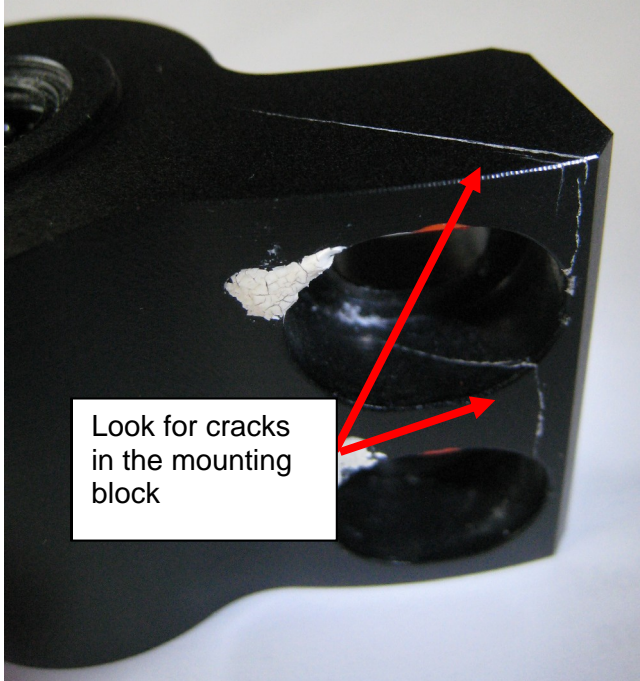
<p>8.</p>	<p>Inspect the mounting block P/N: D60-3223-64-51 for cracks.</p> <p>Criterion 1 If there are cracks one both sides, replace the damaged mounting block with a new one (D60-3223-64-51_1) immediately.</p> <p>Criterion 2 If there are cracks similar to the ones in the picture below on one side only, replace the damaged mounting block with a new one (D60-3223-64-51_1) within the next 100 flight hours from the inspection. If this criterion is met proceed with step 10.</p>

<p>9.</p>	<p>Remove the ring P/N D60-3223-64-31 from the cracked mounting block and push the bearing P/N LBBR 12-2LS clean of Mounting Block with a 16mm (0.63in) pin. Install the bearing in the new mounting block, use Aeroshell 5 or equivalent and tighten the ring.</p>
<p>10.</p>	<p>Make sure the tire is aligned straight. Align the centring unit. Install the centering unit back onto the NLG leg by securing it with the four bolts (20Nm /15 ft lb). Apply Loctite 243 or equivalent onto the threads.</p>
