RECOMMENDED SERVICE BULLETIN

NO. RSB 42-072/2

Application of an improved sealant on the fire sensors or replacement by a sealed fire sensor

WI-RSB 42-072

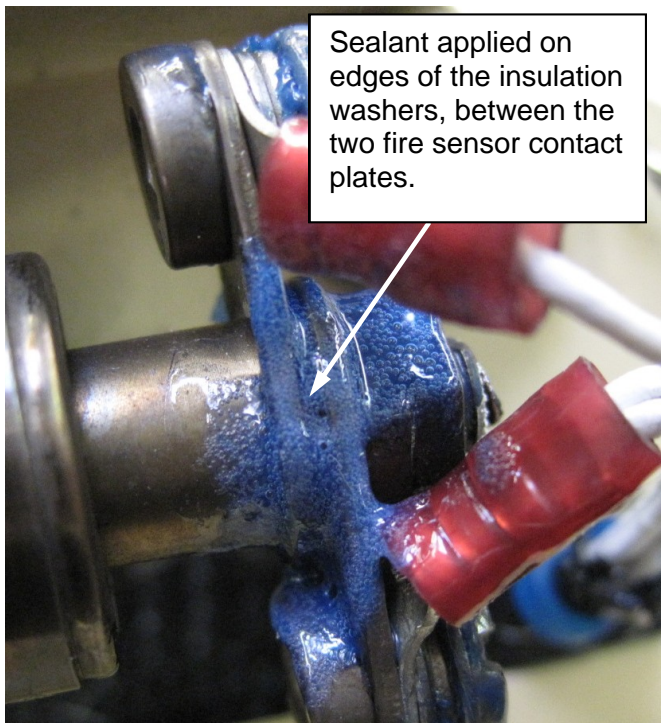
<p>Sealant applied on edges of the insulation washers, between the two fire sensor contact plates.</p> </div> <p>CAUTION: When handling chemicals always obey the Health and Safety Instructions given by the manufacturer.</p>

1	Remove the upper and lower cowling on LH and RH engine.
2	<p>Clean the rear of the fire sensors with an Isopropyl alcohol based cleaner (in particular the area of the insulation washers of the sensors).</p> <p>CAUTION: When handling chemicals always obey the Health and Safety instructions given by the manufacturer.</p>
3	Let the cleaned area dry for about 30 minutes.
4	<p>Apply the sealant onto the edges of the insulation washers of the fire sensors. Ensure that the washers are covered with the sealant completely. This will make the fire sensor water resistant and therefore avoiding inadvertent fire sensor triggering. See picture below.</p> <div data-bbox="507 1267 1171 1989" data-label="Image">

5	Let the sealant dry for at least 24 hours before engine operation.
6	Perform functional check of the fire sensor as described in the preflight inspection of the AFM (latest revision).
7	Make necessary entries into aircraft logs.
