# MANDATORY SERVICE BULLETIN

## NO. MSB 42-076

ATA-Code: 54-00

### „Sealing of Holes in Firewall“

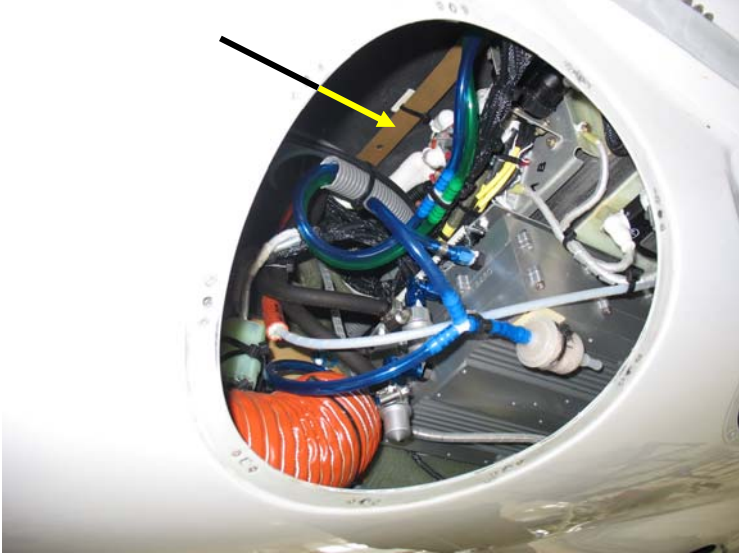
1	Remove the ECU access panel from the LH nacelle.
2	<p>The arrow in this picture indicates the bonding stripe in the ECU compartment of the LH engine. Along the area rear of and above the bonding stripe holes possibly might have been drilled through the composite structure during production process.</p>

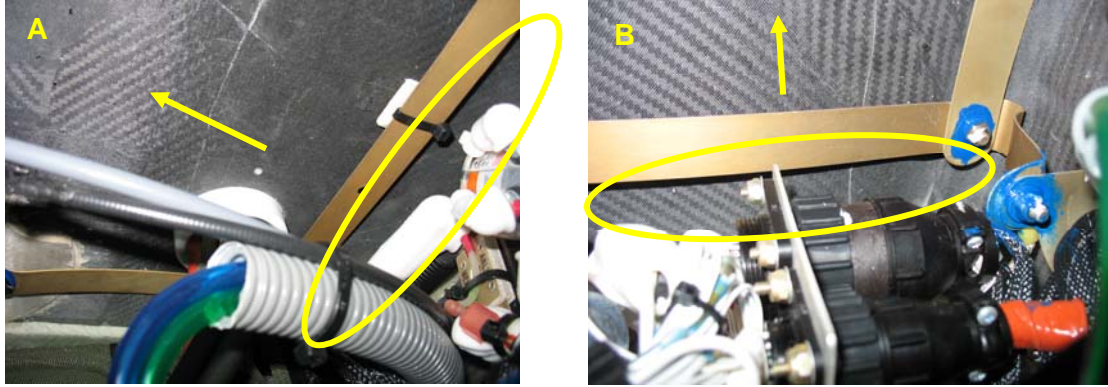
3	<p>Inspect the area along the rear edge of the bonding stripe for holes with a diameter of approximately 4 mm that were possibly drilled into the composite structure. The arrows indicate the flight direction.</p>

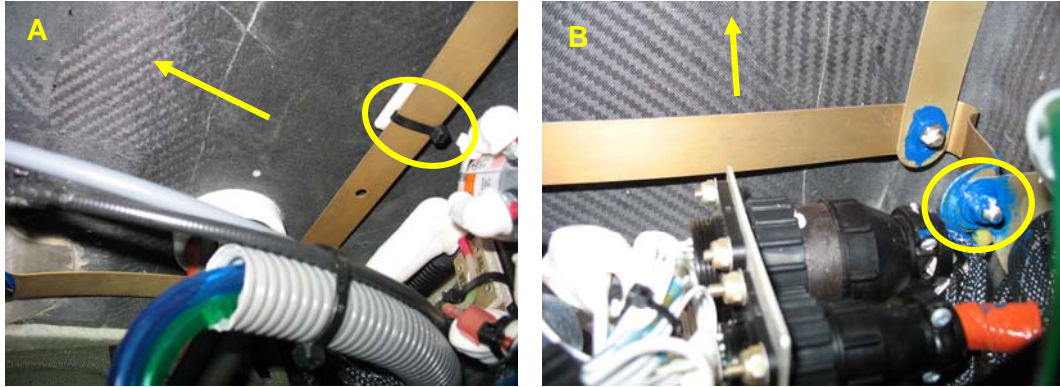
4	<p>If no holes are found continue with item 14.          If holes are found, typically four holes positioned in a line along the rear edge of the bonding stripe with a distance between 150 mm and 190mm from each other, continue with item 5.</p>
5	<p>Disconnect the airplane main battery for maintenance. Refer to AMM, section 24-31.</p>
6	<p>Remove the tie wrap (Picture A) and the screw that connects the bonding stripes and the bonding cable (Picture B). The arrows indicate the flight direction.</p>

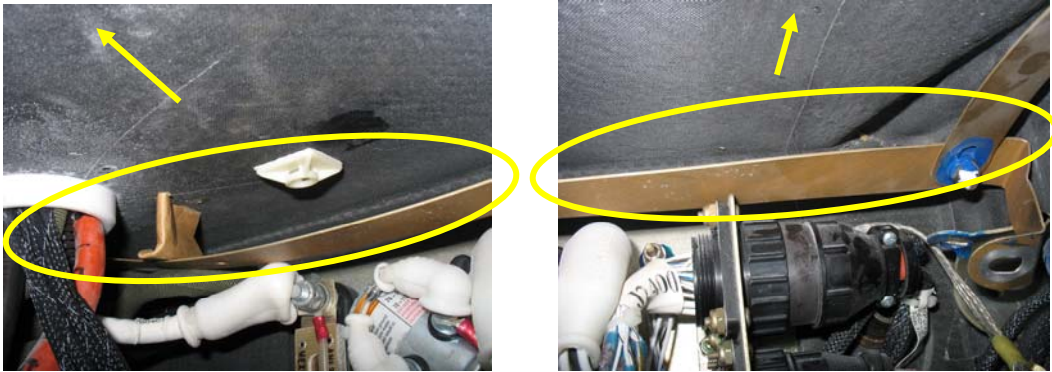
7	<p>Pull down the bonding stripe carefully. Inspect the composite structure above the bonding stripe and in the area rear of the bonding stripe for holes with a diameter of approximately 4 mm. Again the arrows indicate the flight direction.</p>

<p>Note : Use an appropriate spacer to hold down the bonding stripe.</p>
