# MANDATORY SERVICE BULLETIN

NO. MSB 42-088/3

### I.5 Subject

This Service Bulletin prescribes the inspection of the joints that connect the MLG (main landing gear) damper with the MLG trailing arm for cracks.

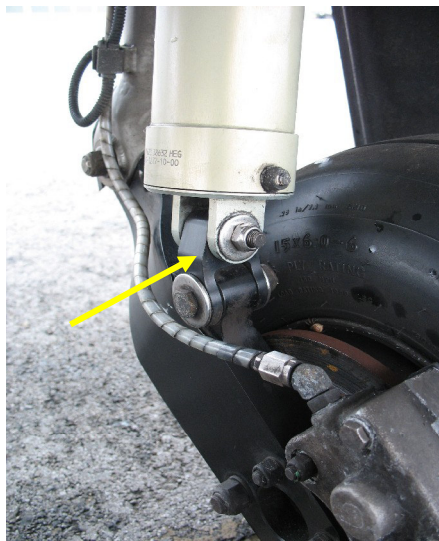
Picture 1

Depending on environmental, operating and runway conditions the MLG joint P/N D60-3217-23-5x (4 different lengths available) made of aluminium is susceptible to cracking. These cracks have been detected during standard maintenance, but if such cracks remain undetected, this may lead to failure of the joint and subsequent damage or malfunction of the MLG. To avoid such undetected cracks, this Service Bulletin prescribes special recurring inspection of the MLG joint.

2 Remove the joint P/N D60-3217-23-5x (4 different lengths available) that connects the LH MLG damper and the LH MLG trailing arm. The joint is indicated in the picture. Refer to AMM, section 32-10.

The MLG joint D60-3217-23-5x has been replaced by an improved design. Replacement of the MLG joint with the new design P/N D64-3217-23-0x (4 different lengths available) made of steel is described in this Service Bulletin. If MLG joint D64-3217-23-0x (4 different lengths available) is installed, no recurring inspection is necessary.

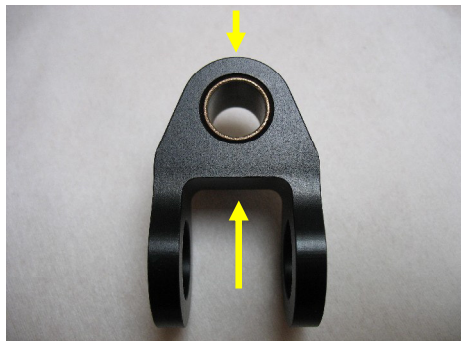
Picture 2

4 Examine the MLG joint for cracks.

**CAUTION:** Look especially in the areas indicated by the arrows.

5 If cracks are found, replace the MLG joint i.a.w. Section III.2. Otherwise reinstall MLG Joint.
