RECOMMENDED SERVICE BULLETIN

RSB 42-094

Installation of a stiffener on the alternator cable.

WI-RSB 42-094

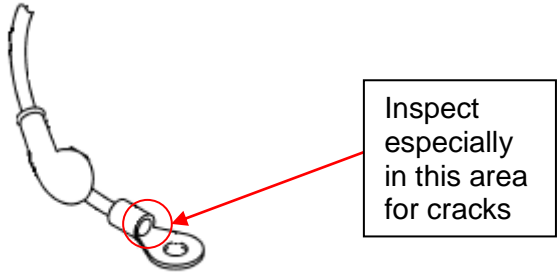
4	<p>Move the insulating boot from the alternator cables back and inspect the ring terminals for cracks.</p> <ul style="list-style-type: none"> If cracks are found, replace the alternator cable with P/N D60-2407-17-00_1 for the LH alternator and P/N D60-2407-18-00_1 for the RH alternator and proceed with item 6 on the affected side. <p>NOTE: At replacement of the alternator cable it is necessary to seal the fire wall hole with the engine harness with fireproof sealant. Make sure that the fire wall is waterproof.</p> <ul style="list-style-type: none"> If there is no crack, install the stiffener acc. this work instruction. <div style="text-align: center;">
