# MANDATORY SERVICE BULLETIN

## MSB 42-099/1

## MSB 42NG-035/1

Inspection / replacement of spherical rod end bearing and safety washer of nose landing gear (NLG) actuator, P/N X11-0006/2 with S/N 0155 and below.

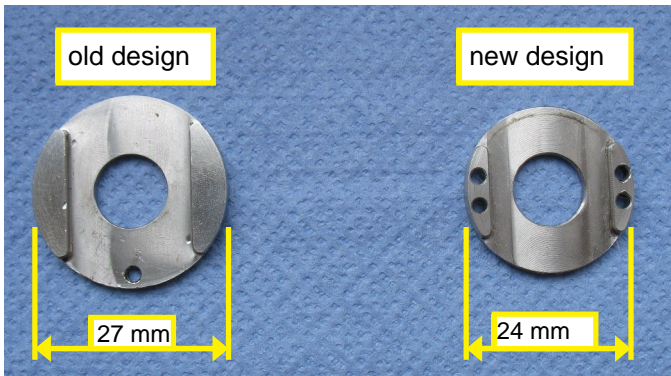
2	If NLG actuator has P/N X11-0006/2 and S/N is 0156 or higher, proceed with item 12.
3	<p>If NLG actuator has P/N X11-0006/2 and S/N is 0155 or lower remove NLG actuator from the aircraft in accordance with AMM, section 32-20.</p> <p>NOTE: It is not necessary to remove the actuator completely from the aircraft. The following work can be done with the actuator remaining connected to the NLG brace assembly and to the hydraulic system.</p>
4	Remove spherical rod end bearing from the NLG actuator piston in accordance with AMM, section 32-30. Discard spherical rod end bearing.
5	<p>Measure diameter of safety washer.</p> <p>Possible diameters are:</p> <ul style="list-style-type: none"> <li>- 27 mm (old design, picture on the left)</li> <li>- 24 mm (P/N X11-0006-00-00.02, Rev B, new design, picture on the right).</li> </ul>

6	If diameter of safety washer is 27 mm replace it with one of the new design with 4 holes for lock wire and with reduced diameter of 24 mm, P/N X11-0006-00-00.02, Rev B.
