# RECOMMENDED SERVICE BULLETIN

## RSB 42-102

#### **I.5 Subject**

Inspection for insufficient clearance between the canopy arms and the resistors of the ice lights in the instrument panel.

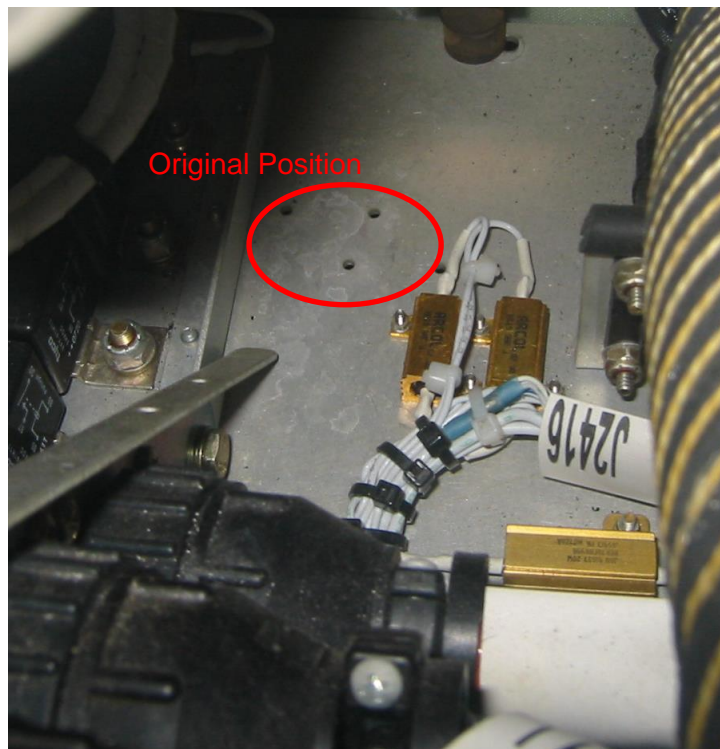
During maintenance it was found that on two airplanes the canopy arms has collided with the resistors of the ice lights in the instrument panel. This Service Bulletin describes the inspection for insufficient clearance and if required the corrective action.

Inspect the resistors of the ice lights (position shown on the photograph) for sign of collision or contact with the canopy arm (such as chafing or dents).

Determine the minimal clearance between the resistors and the canopy arm with the canopy in the closed position.

If there are signs of contact or collision, inspect the canopy arm for chafing and deformation.

If there are signs of contact or collision or if the minimal clearance is less than 2 mm, install the two resistors 30 mm aft and 25 mm to the right from the original position.
