RECOMMENDED SERVICE BULLETIN

RSB 42-108/1

RSB 42NG-046/1

Sealing of Nose cone.

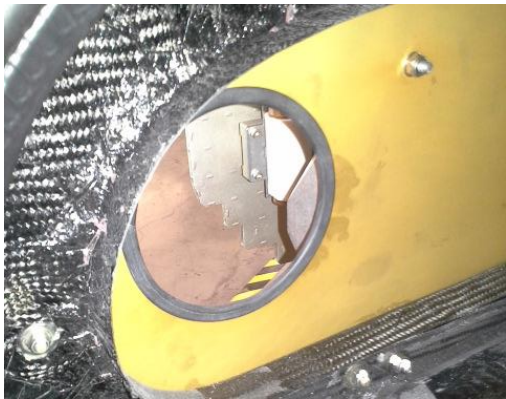
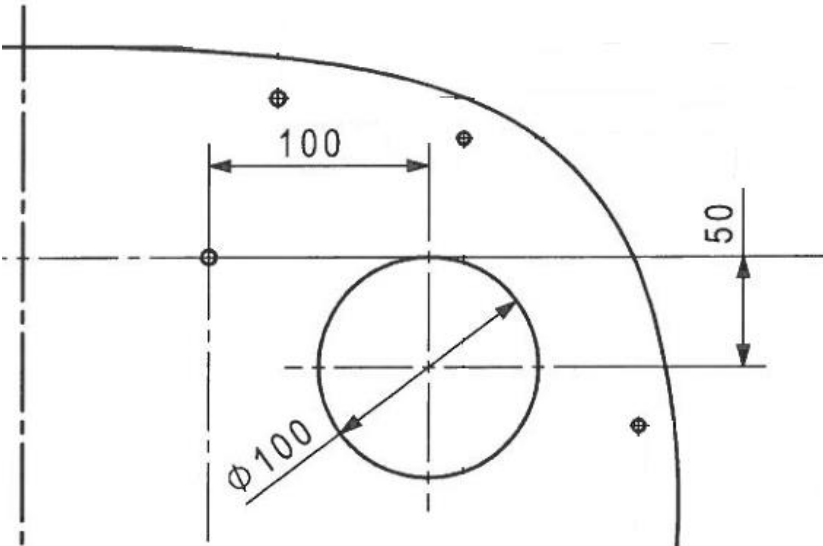
To improve the protective function of the fuselage nose cone, a sealant is applied on the gap to the fuselage. In order to simplify maintenance, additional access holes are added in the nose baggage compartment.

1	Make sure AMM-TR-OÄM-42-119/a has been added to the AMM or an AMM revision with this Temporary Revision incorporated is used.
2	Seal drain hole in nose cone with Terostat MS9380.(see AMM section 5-25)
3	<p>If OÄM 42-119 is installed:</p> <ul style="list-style-type: none"> • Drill holes with 100 mm (4 in.) diameter in the aluminum sheet from nose baggage compartment i.a.w. sketch below. <p>CAUTION Do not damage the weather radar and its supporting structure.</p> <ul style="list-style-type: none"> • Break sharp edges. • Install edge protection on holes. • Remove debris.
