# MANDATORY SERVICE BULLETIN

## MSB 42-109/2

Type: DA 42, DA 42 M with TAE 125-02-99 engines and dual mass flywheel installed

Installation of a start assist relay for ECU start phase monitoring.

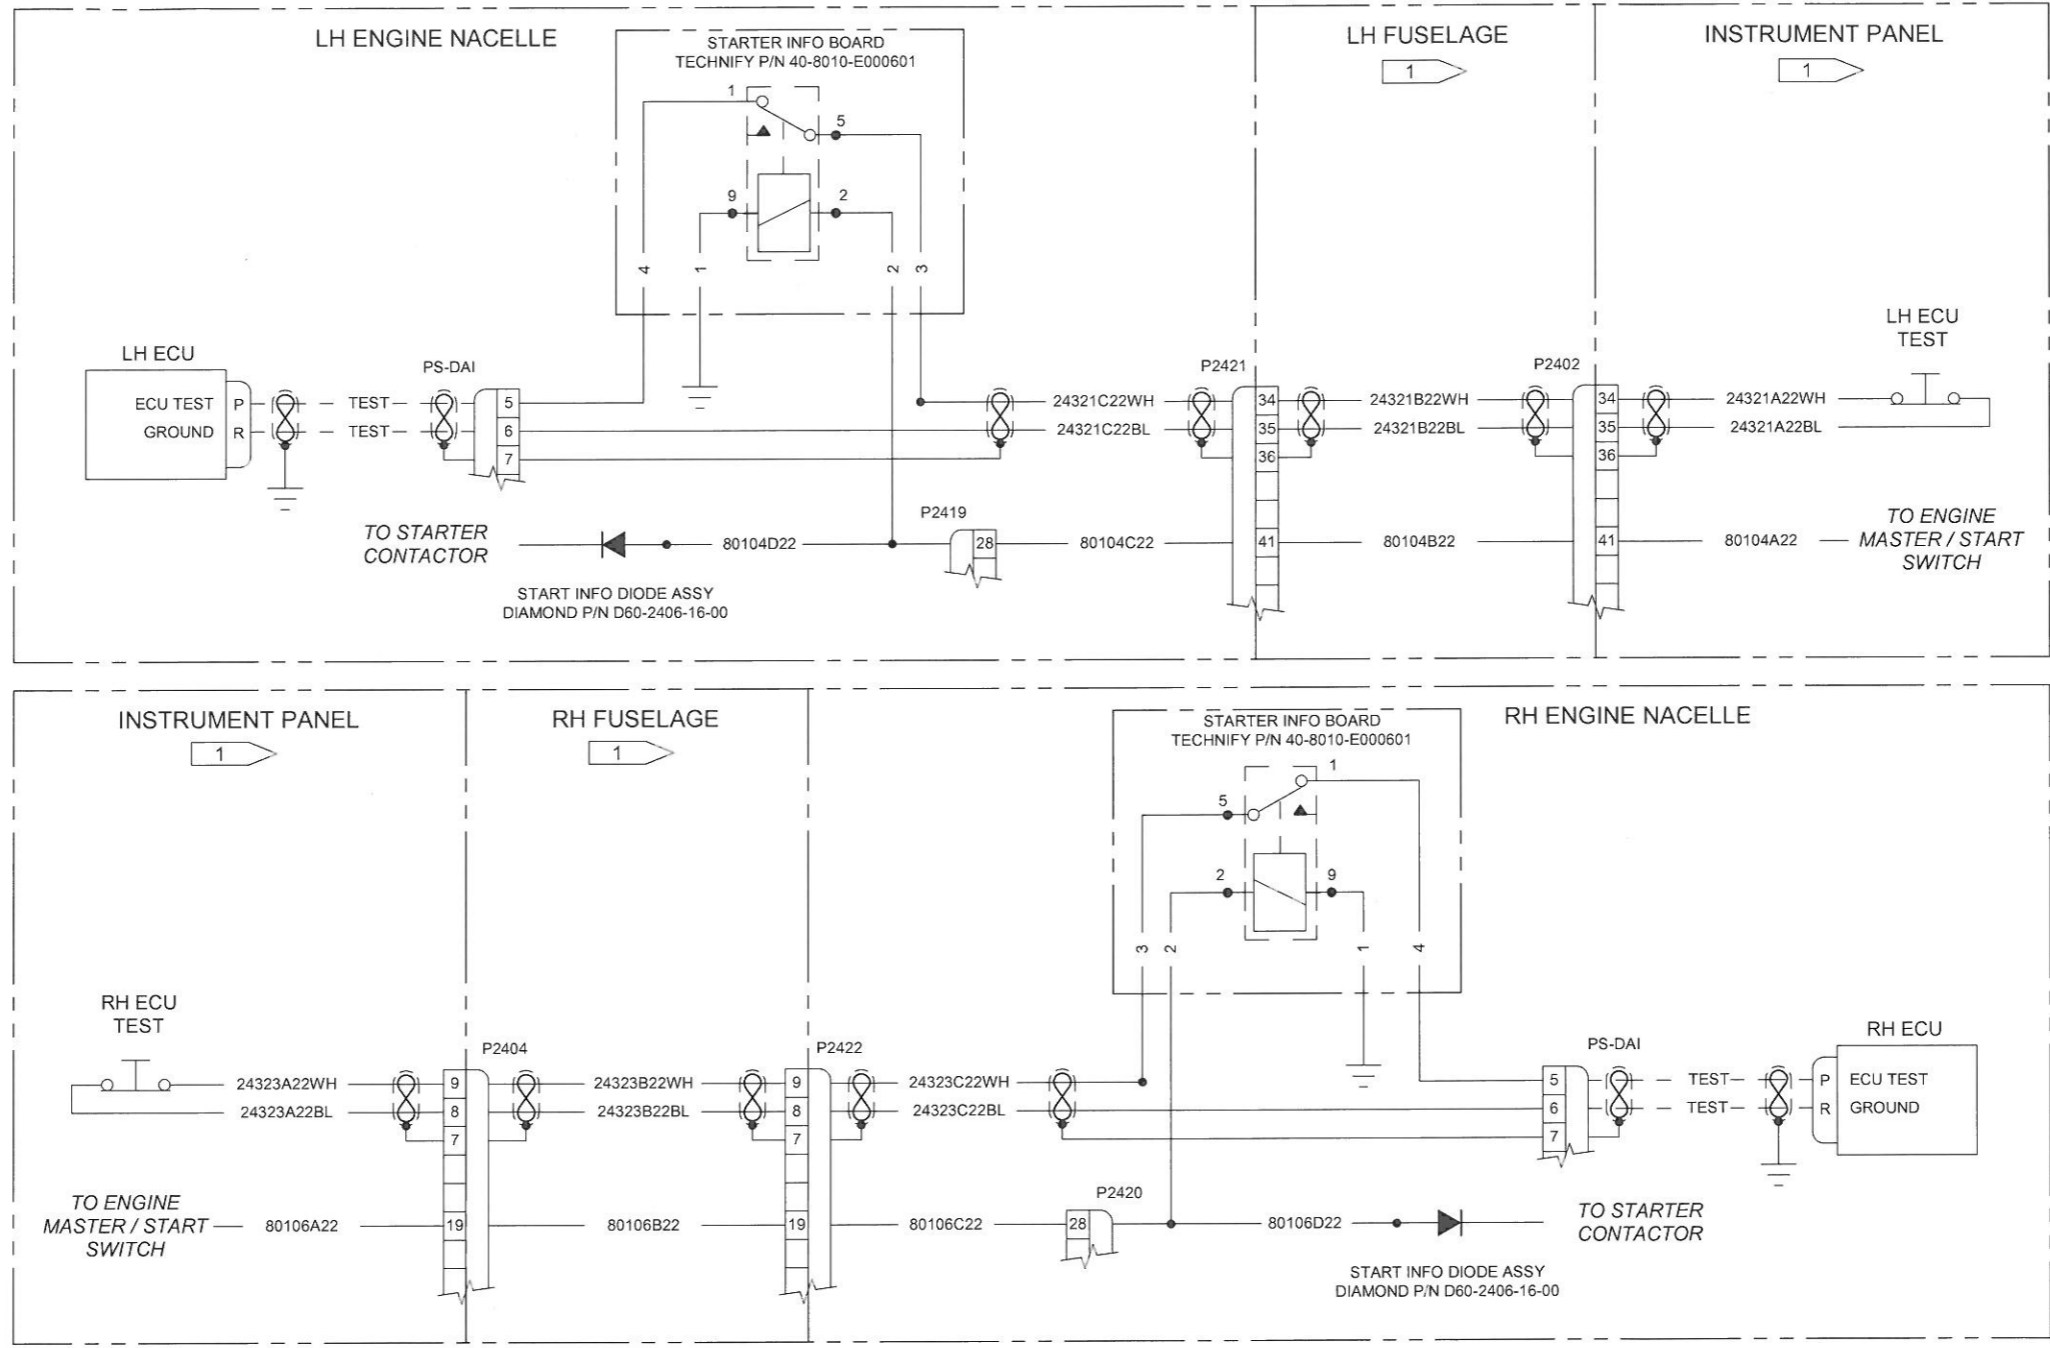
D60-9224-30-05, Schematic, Starter Engaged Input to ECU

A possible overload of the gearbox drive shaft under specific engine start conditions on engines with a dual mass flywheel installed has been identified. To prevent such overload conditions, the engine manufacturer has updated its installation requirements to install an additional start monitoring input to the ECU and a new Firmware and Software Mapping (ref. I.7). This Service Bulletin describes the work necessary to install the required relays in a DA 42 or DA 42 M airplane.

1	Disconnect the main battery for maintenance i.a.w. AMM Section 24-31.
2	Disconnect the ECU backup and alternator excitation batteries i.a.w. AMM Section 24-30.
3	Remove the LH/RH Nacelle Cap ECU access panels i.a.w. AMM Section 52-40.
4	Remove the LH/RH engine top cowlings i.a.w. AMM Section 71-10.
5	Disconnect wire 80104D22 (LH) and 80106D22 (RH) from the engine starter contactors.
6	Cut-off the ring terminals of the wires disconnected above and splice the Start Info, Diode Assemblies P/N D60-2406-16-00 onto the wires.
7	Connect the ring terminal of the Start Info, Diode Assemblies to the engine starter contactor.
8	Secure the Start Info, Diode Assemblies to the engine harness using cable ties.
9	Crimp the sockets P/N 66105-4 onto the wires labelled "4" of both Start Info Boards P/N 40-8010-E000601.
10	Disconnect and disassemble the LH/RH PS-DAI connectors and extract Position 5, wires 24321C22WH (LH) and 24323C22WH (RH).

11	Insert the sockets of the Start Info Boards into Position 5 of connectors PS-DAI.
12	Cut-off the sockets of wires 24321C22WH (LH) and 24323C22WH (RH) and splice the wires labeled "3" of the Start Info Boards onto the wires using Splice, red P/N D-436-36.

13	Re-assemble the LH/RH PS-DAI connectors. Use silicone tape at the strain relief. Re-connect the LH/RH PS-DAI connectors.
14	Disconnect and disassemble the connectors P2419 (LH) and P2420 (RH). Locate the wires 80104D22 (LH) and 80106D22 (RH) at Position 28 of the connectors.
15	If neccessary, cut the wires labelled "2" of the Start Info Board to appropriate length. Splice the wire labelled "2" of the Start Info Boards into the wires mentioned above using Splice, blue P/N D-436-37.
16	Re-assemble the connectors P2419 and P2420. Use silicone tape at the strain relief. Re-connect the connectors.
17	Cut the wire labelled "1" of the Start Info Boards to appropriate length and crimp the ring terminals onto the wires. Connect the ring terminals to the ground studs, where the shields of connectors PS-DAI are connected.
18	Clean working areas, check for foreign objects.
19	Install the LH/RH engine top cowlings i.a.w. AMM Section 71-10.
