MANDATORY SERVICE BULLETIN

MSB 42-112/1

Type: DA 42, DA 42 M
Serial numbers: 42.004 through 42.427
42.AC001 through 42.AC153
42.M001 through 42.M027

Replacement of the aluminum turbo charger clamp with a steel clamp.

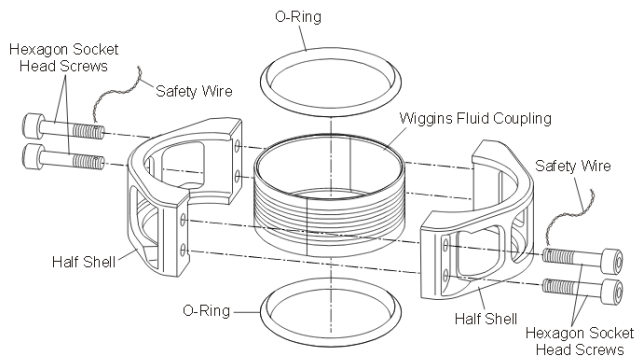
There have been cases of broken aluminum turbo charger clamps which connects the charged air tube to the turbo charger outlet which lead to a power loss situation. To prevent such situations, an improved steel turbo charger clamp was certified as a direct replacement to the aluminum clamp. This Service Bulletin describes the work necessary to install the improved turbo charger clamp.

1. Make sure, that AMM-TR-MÄM-42-879 is inserted into the Airplane Maintenance Manual.
2. Replace the aluminum Clamp with the steel Turbo Charger Clamp D4D-9081-26-05 i.a.w. AMM Section 81-00.
