MANDATORY SERVICE BULLETIN

MSB 42-120/3

Installation of an additional exhaust bracket.

Installation and inspection of an additional exhaust clamp.
Inspection of exhaust pipes.

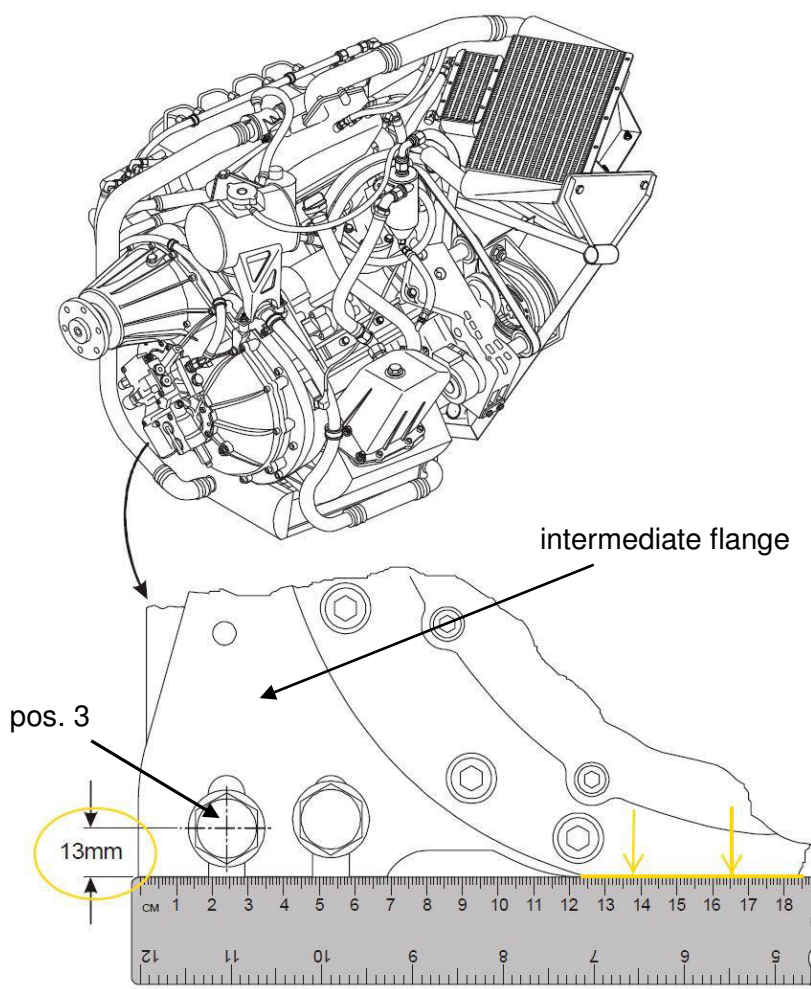
1	Remove engine cowlings in accordance with (i.a.w.) AMM section 71-10.
2	<p>Make sure that the intermediate flange of the engine is installed correctly to the forward engine shock mount. Align a ruler with the straight part of the bottom side of the intermediate flange as shown in the picture below. The distance between screw (pos. 3) and the ruler must be 13mm.</p>
