MANDATORY SERVICE BULLETIN

MSB 42-126/1

MSB 42NG-066/1

Inspection of flap bell crank for cracks, installation of two spacers instead of one long spacer and replacement of early revisions of the affected flap bell crank.

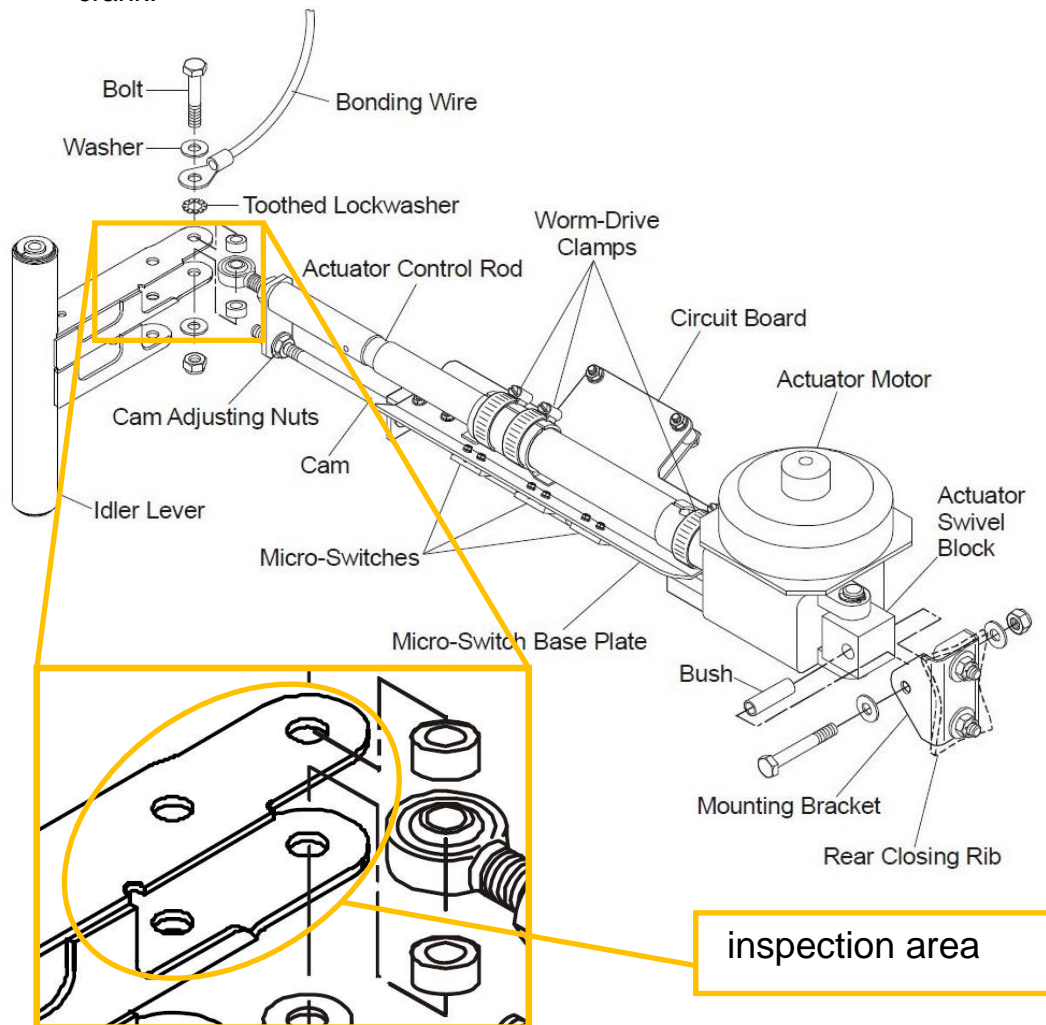
If flap bell crank D60-2757-11-00 revision "e" or "f" is installed:

- Examine the flap bell crank for cracks and deformation in the area where the flap pushrods are attached to the flap bell crank as shown in the figure below.
- If cracks or deformation are found, replace the flap bell crank with the improved flap bell crank D60-2757-11-00_01 in accordance with AMM, Section 27-50.

Note: In case of doubt remove the powder coating and carry out dye penetration method to identify possible cracks.

Note: Apply epoxy based zinc phosphate primer and commercial grade 2K PU lacquer to areas where the powder coating has been removed or has been damaged.

Note: In case the flap bell crank must be replaced, if necessary, remove the aileron push rods from the aileron bell crank and remove the aileron bell crank to gain better access for removing the flap bell crank. Re-install aileron bell crank and aileron push rods after replacement of flap bell crank.
