MANDATORY SERVICE BULLETIN

MSB 42-137/1

MSB 42NG-079/1

Inspection of rudder T-yoke axle nut for looseness.

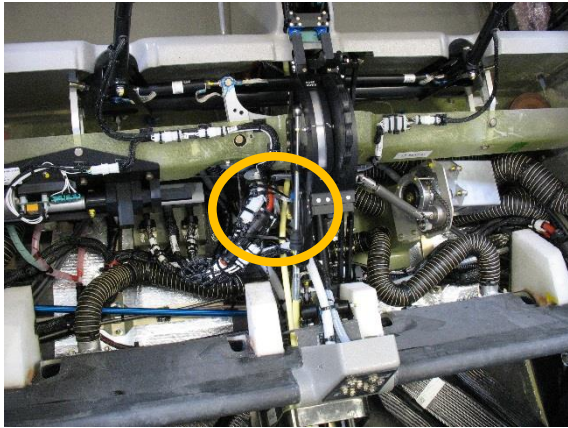
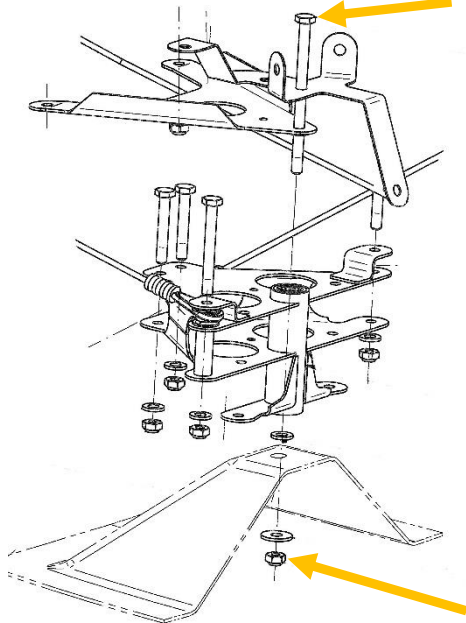
1	Remove the pilot and copilot seat in accordance with AMM Section 25-10.
2	Remove the middle tunnel front cover in accordance with AMM Section 25-10.
3	<p>Check the self-locking nut for correct torque:</p> <ul style="list-style-type: none"> • Block the self-locking nut with a ring-wrench. • Apply a torque of approx. 6 Nm to the head of the T-yoke axle.

4	<p>If the T-yoke axle can be rotated more than one half turn or if the nut is loose:</p> <ul style="list-style-type: none"> • do a condition inspection in accordance with AMM and MSB 42-087 / MSB 42NG-016, • correct any deficiencies, • replace the self-locking nut with a new self-locking nut.
5	Install the middle tunnel front cover in accordance with AMM Section 25-10.
6	Install the pilot and copilot seat in accordance with AMM Section 25-10.
7	Clean working area and check for foreign objects.
8	Perform functional check of altered, repaired and new parts.
