RECOMMENDED SERVICE BULLETIN

RSB 42-139

RSB 42NG-081

Replacement of rudder T-yoke axle with improved design.

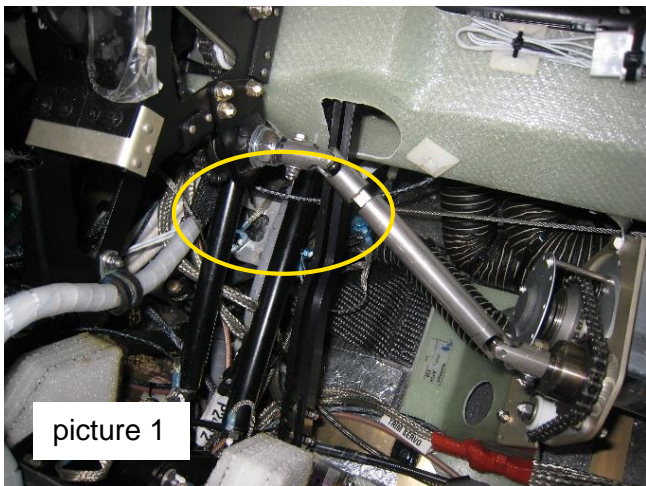
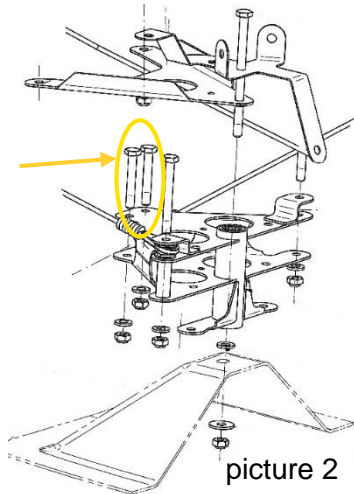
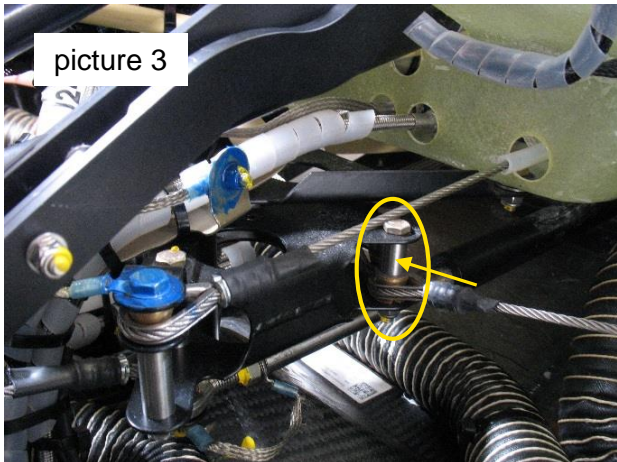
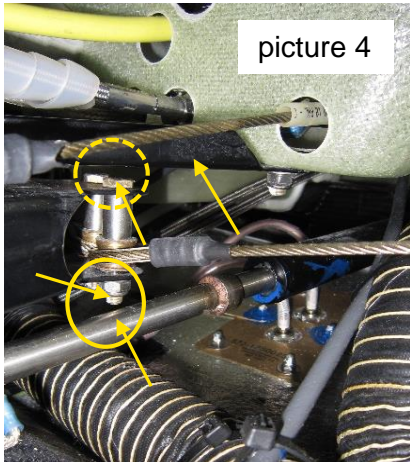
6.	<p>Check the clearances while moving the rudder in both directions</p> <ul style="list-style-type: none"> • between end of T-yoke bolts for copilot's right rudder cable & pilot's left rudder cable and nose landing gear (NLG) steering rod (continuous circle in picture 4) • and between head of T-yoke bolts for copilot's right rudder cable & pilot's left rudder cable and support plate (dashed circle in picture 4). <p>Record the measured clearances. Each clearance must be greater than 2 mm (0.08 in).</p> <p>Pictures 1 – 4 show the affected area.</p> <div style="display: flex; justify-content: space-around;"> <div data-bbox="285 1115 933 1599">

If any of the clearances is not greater than 2 mm (0.08 in), reposition the T-yoke in accordance with Work Instruction of MSB 42-087 / MSB 42NG-016, Section III.3, latest effective issue.

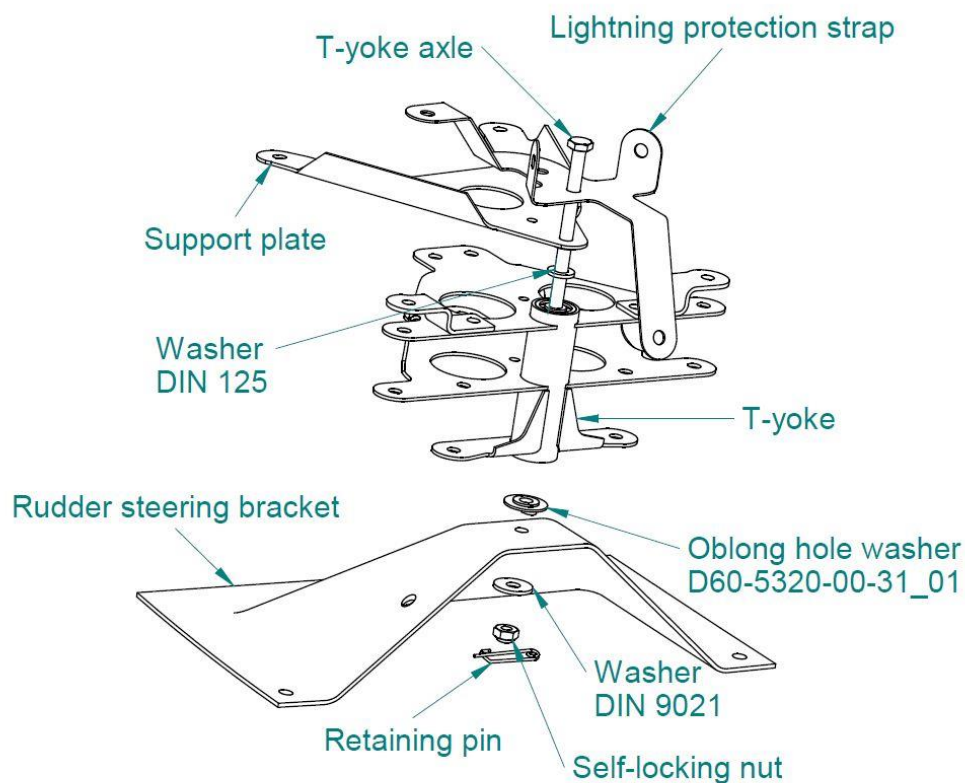
figure 4

Note: The retaining pin can damage the heating hose if not installed perpendicular to the flight direction.

- the new T-yoke bolt D60-5320-00-32,
- a DIN 125 washer between support plate and T-yoke,
- a DIN 9021 washer between the self-locking nut and the rudder steering bracket,
- a new self-locking nut and
- a retaining pin AN416-1 perpendicular to the flight direction

| 2. | Tighten the T-yoke bolt with a tightening torque of 10 Nm. |
