MANDATORY SERVICE BULLETIN

MSB 42-140/1

Type: DA 42, DA 42 M

Replacement of MLG axle.

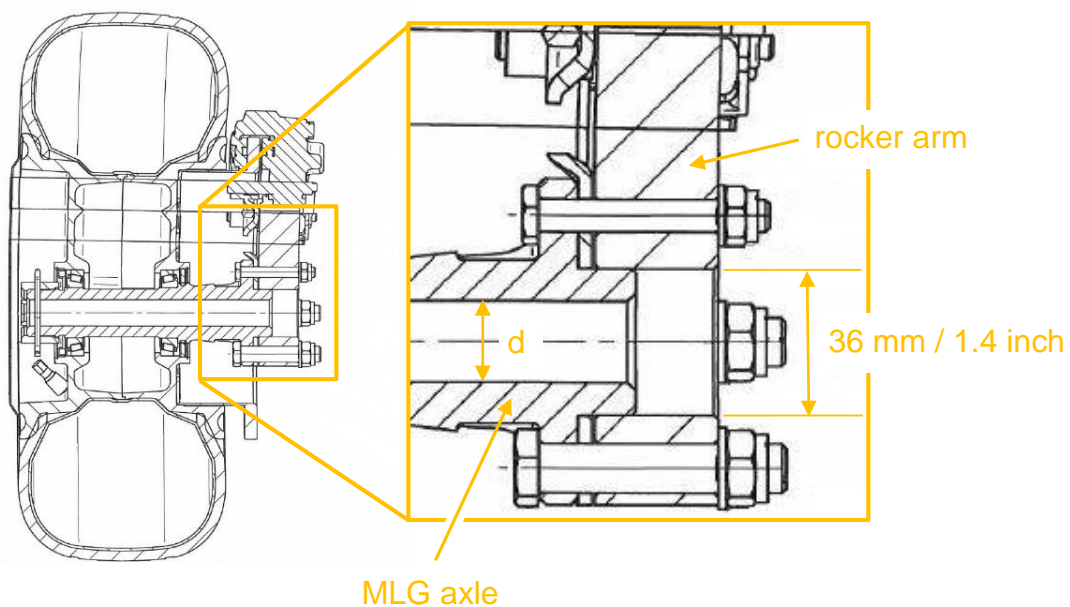
Diamond Aircraft Industries have received two reports of broken MLG axles on airplanes, which were equipped with the initial design of the MLG axle D60-3217-21-31, up to revision "f". A reinforced MLG axle was introduced with revision "g", which is not affected by this failure mode. This Service Bulletin prescribes to replace those initial MLG axles with the reinforced MLG axle to avoid, that cracks in the MLG axle remain undetected.

1. Measure the inner diameter **d** of the MLG axle of the left hand MLG and of the right hand MLG in accordance with the figure below.
2. If on both MLG axles the inner diameter **d** is 20 mm / 0.8 inch or 25 mm / 0.98 inch, no further measures are required. Make all necessary entries in the airplane logs.
3. If on one or on both MLG axles the inner diameter **d** is 14 mm / 0.55 inch, continue with step 4.

4. Replace all MLG axles, which have an inner diameter **d** of 14 mm / 0.55 inch with the latest MLG axle design in accordance with AMM, section 32-10.
5. Do a landing gear extension and retraction test in accordance with AMM, section 32-30.
6. Clean working areas, check for foreign objects.
7. Test all systems in working area for function.
8. Make all necessary entries in the airplane logs.
