# MANDATORY SERVICE BULLETIN

## MSB 42-143/1

## MSB 42NG-086/1

Inspection of hole position and condition in the rudder steering bracket.

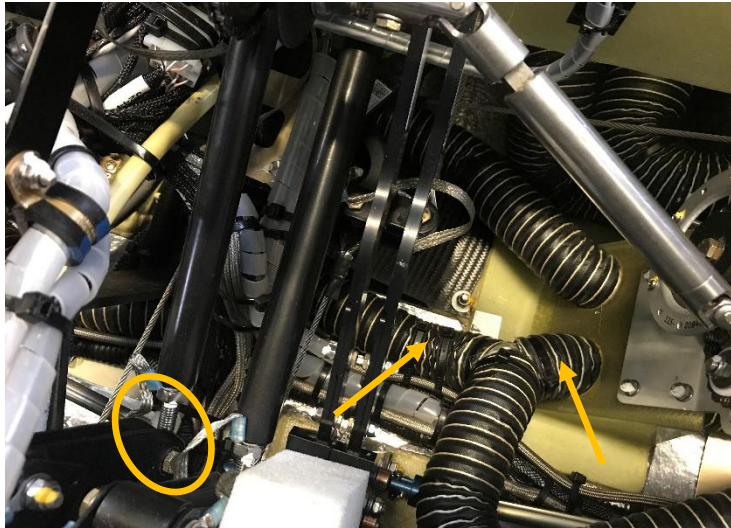
1.	Insert AMM-TR-MÄM-42-1213 into the AMM or use an AMM revision, in which AMM-TR-MÄM-42-1213 has been incorporated.
2.	Remove the pilot and co-pilot seat in accordance with AMM Section 25-10.
3.	Remove the middle tunnel front cover in accordance with AMM Section 25-10.
4.	<p>Remove components for better access to the rudder steering bracket:</p> <ul style="list-style-type: none"> <li>Remove the two heating hoses, that are indicated in the picture by the arrows, from the aluminum Y-connector,</li> <li>pull out the heating hose, that is routed along the rudder steering bracket,</li> <li>disconnect the short elevator push rod from the main spar lever as indicated by the circle.</li> </ul>

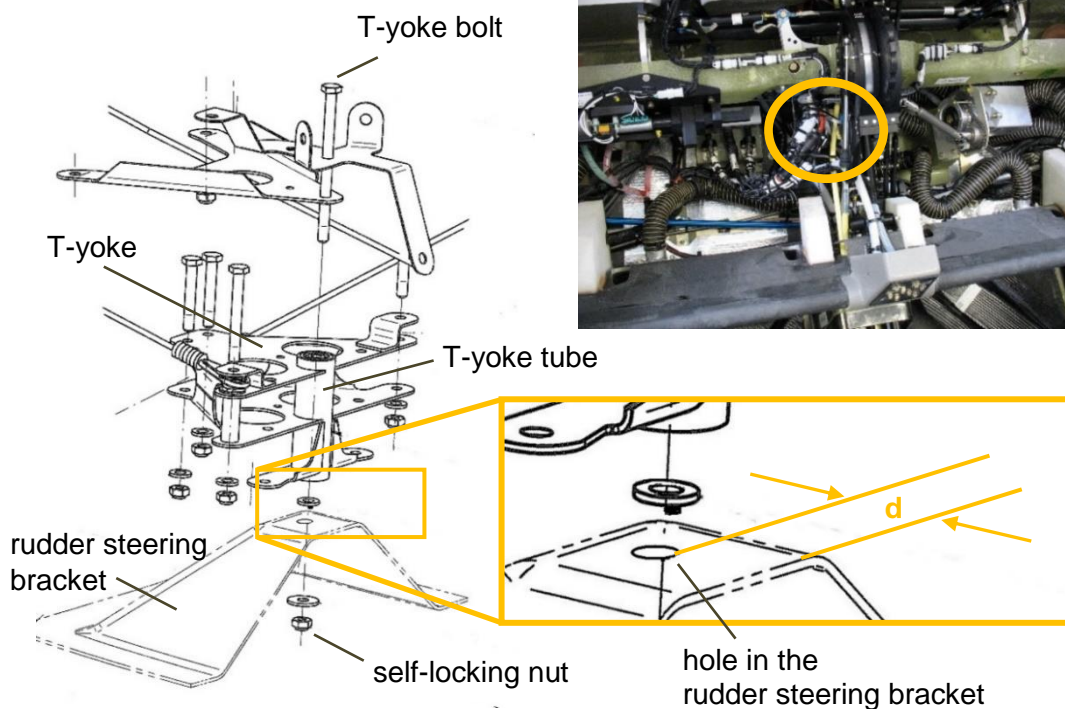
6. Find out, if distance **d** (the distance between the edge of the hole of the rudder steering bracket and rear edge of the rudder steering bracket) is at least 11 mm.

**d** < 11 mm → proceed with step 7

**d** ≥ 11 mm → proceed with step 8

7.	<p>If distance <b>d</b> is less than 11mm:</p> <ul style="list-style-type: none"> <li>• disconnect the NLG steering rod from the T-yoke,</li> <li>• remove the T-yoke bolt,</li> <li>• remove the T-yoke,</li> <li>• make sure that all washers are removed from the airplane,</li> <li>• confirm that the oblong hole washer is or is not installed,</li> <li>• confirm orientation of the oblong hole washer, if installed,</li> <li>• confirm dimension of distance <b>d</b> by measuring the distance between the edge of the hole and the edge of the bracket on rudder steering bracket,</li> <li>• send all information to <a href="mailto:support-austria@diamondaircraft.com">support-austria@diamondaircraft.com</a>, containing:           <ul style="list-style-type: none"> <li>- detailed photographs of the hole together with a measuring tape, positioned beside the hole,</li> <li>- the filled-in <a href="#">damage report</a>, which can be downloaded from DAI technical publications home page</li> </ul> </li> <li>• request repair instructions for the rudder steering bracket,</li> <li>• proceed with step 13 after repair.</li> </ul>

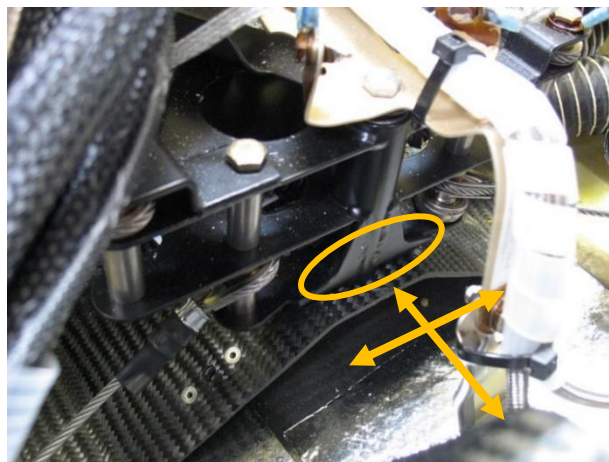
11. Examine the hole in the rudder steering bracket for wear and play. Look especially for possible lateral movement of the lower part of the T-yoke:

- Apply simultaneous rudder pedal force to the RH pilot rudder pedal and LH co-pilot rudder pedal.
- Apply rudder pedal force and move the rudder from full LH deflection to full RH deflection.
- Apply hand force to the T-yoke and tilt it back / forth and sideward.
- Use an inspection mirror to examine the hole in the bottom side of the rudder steering bracket.

12. If a worn or enlarged hole, or play of the T-yoke bolt in the hole of the rudder steering bracket has been found,

- disconnect the NLG steering rod from the T-yoke,
- disconnect all rudder control cables,
- remove the T-yoke bolt,
- remove the T-yoke,
- make sure that all washers are removed from the airplane,
- send all information to [support-austria@diamondaircraft.com](mailto:support-austria@diamondaircraft.com), containing:
  - dimensions of the worn / enlarged hole in the rudder steering bracket
  - detailed photographs of the worn / enlarged hole together with a measuring tape, positioned beside the hole,
  - filled-in [damage report](#), which can be downloaded from DAI technical publications home page
- request instructions for repair of the hole in the rudder steering bracket,
- proceed with step 13 after repair.

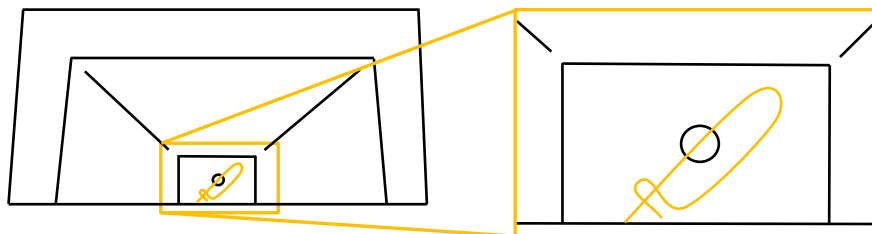
- Block the self-locking nut with an open-end wrench.
- Turn the T-yoke bolt, until the self-locking nut is positioned above the hole for the additional retaining pin. Do not yet tighten the T-yoke bolt.
- Remove the open-end wrench.
- Turn the T-yoke bolt to a position, so that the retaining pin can be installed to the T-yoke bolt.
- Install retaining pin.
- Turn the T-yoke bolt by 180°.
- Close the retaining pin.
- Block the self-locking nut with an open-end wrench.
- Torque the T-yoke bolt with 6 Nm.
- Remove the open-end wrench.
- Turn the T-yoke bolt to a position without blocking the self locking nut, so that the pointy end of the retaining pin is directly below the edge of the rudder steering bracket (refer to sketch).

- Block the self-locking nut with an open-end wrench.
- Torque the T-yoke bolt with 9 Nm.
- Make sure the pointy end of the retaining pin is hidden under the rudder steering bracket and does not damage the heating hose.

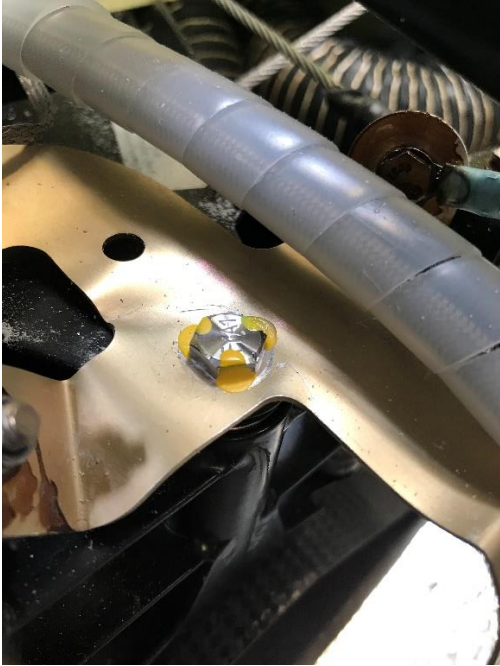
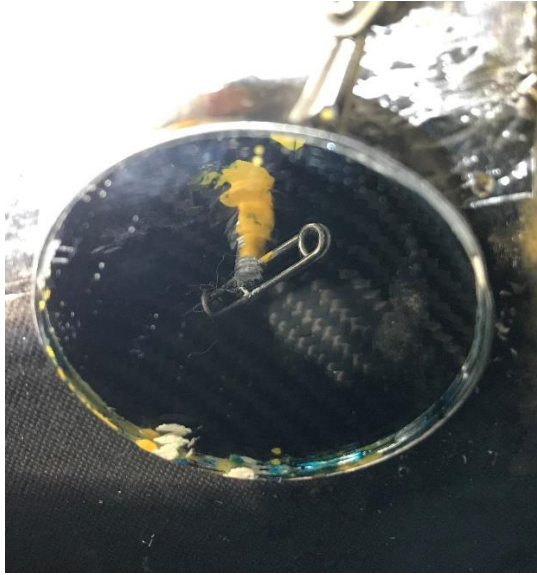
14.	Adjust left and right rudder cable turnbuckles to give the correct tension to the control cables in accordance with AMM, Section 27-20.
15.	<p>Mark the head of the T-yoke bolt and the self-locking nut with at least two torque seal marks.</p> <div style="display: flex; justify-content: space-around;">

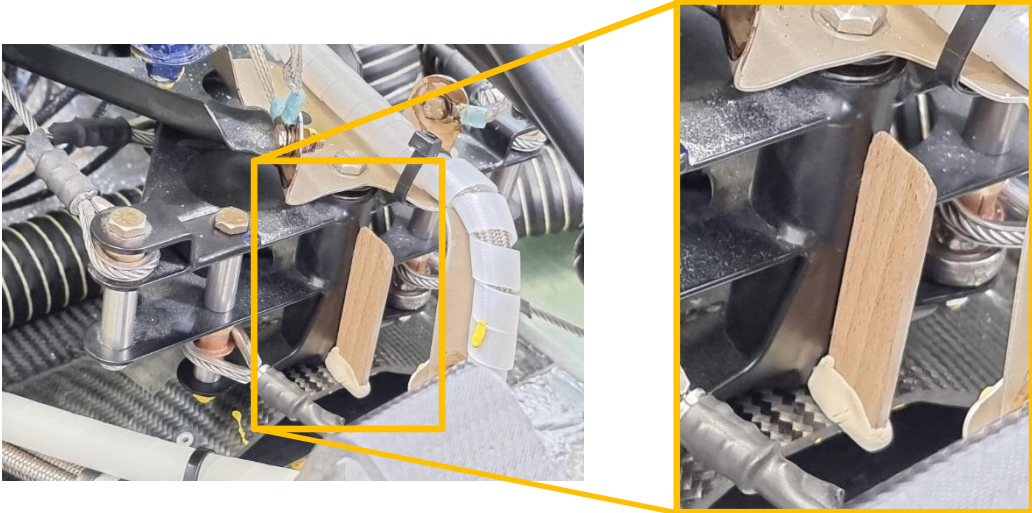
1.	<p>Use a wooden strip (cross-section e.g. 15 mm x 3 mm) and a piece of modeling clay to determine distance <b>d</b>.</p> <ul style="list-style-type: none"><li>• Put a small piece of modeling clay to the end of a wooden strip.</li><li>• Hold the wooden strip to the metal tube of the rudder bell crank.</li><li>• Move the wooden strip down, so that the modeling clay is pressed onto the rudder steering bracket.</li></ul> <p><b>Note:</b> Make sure there is no modeling clay between the wooden strip and the metal tube of the rudder bell crank.</p> <p><b>Note:</b> For illustration, this step is shown on an airplane with removed components in the area of the rudder steering bracket.</p> <div style="text-align: center;">

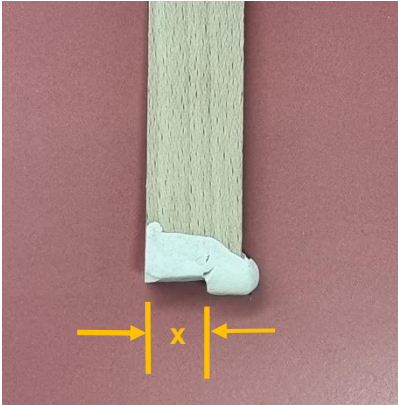
2.	<p>Measure distance <b>x</b>.</p>

3.	<p>If distance <b>x</b> is less than 3 mm (.12 in), distance <b>d</b> is less than 11 mm. Return to section III.</p> <p>If distance <b>x</b> is greater than or equal to 6 mm (.24 in), distance <b>d</b> is at least 11 mm. Return to section III.</p> <p>If distance <b>x</b> is between 3 mm (.12 in) and 6 mm (.24 in), proceed with the following steps.</p>
<p><b>Note:</b> As an alternative method an appropriate material (stick) with a defined thickness of 3 mm and 6 mm can be used, to check if distance <b>x</b> is less than 3 mm or if distance <b>x</b> is greater than or equal to 6 mm.</p>

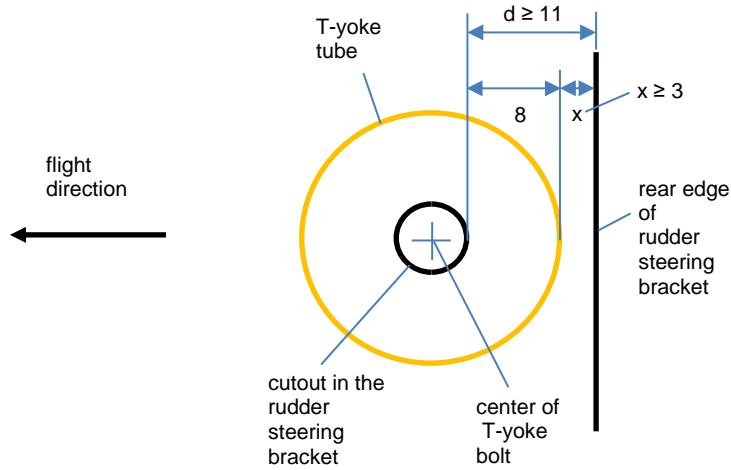
5. If no oblong hole washer installed, distance **d** is at least 11 mm. Return to section III.

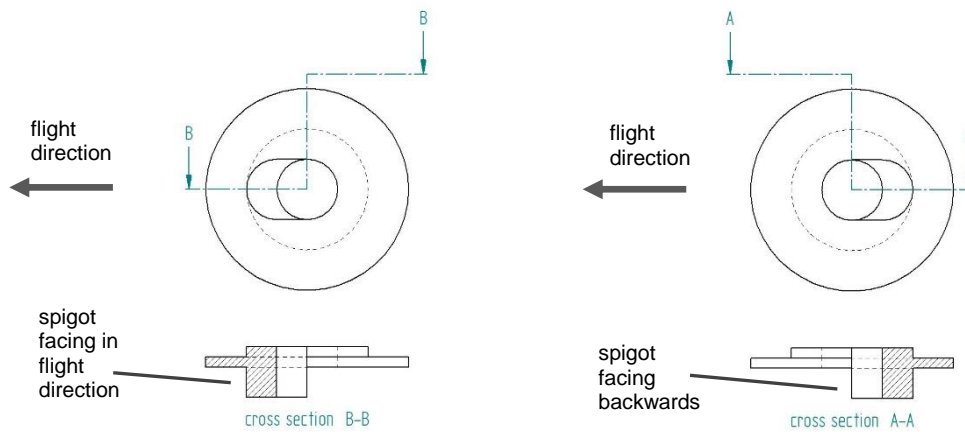
6. If an oblong hole washer is installed to the rudder steering bracket, determine the orientation of the oblong hole washer.

- Use an inspection mirror and inspect the bottom side of the rudder steering bracket.

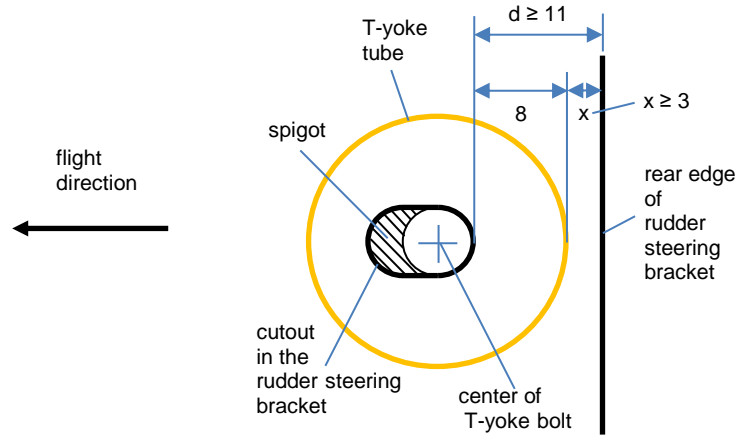
7. If an oblong hole washer is installed to the rudder steering bracket with the spigot facing in flight direction, distance **d** is at least 11 mm. Return to section III.

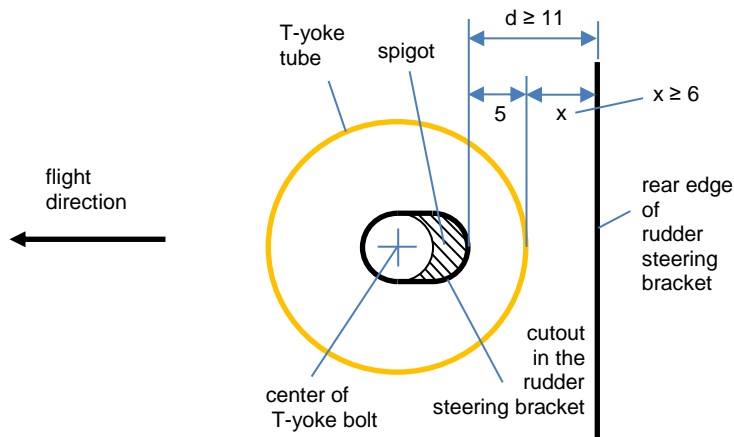
8. If an oblong hole washer is installed to the rudder steering bracket with the spigot facing backwards, distance **d** is less than 11 mm. Return to section III.
