MANDATORY SERVICE BULLETIN

MSB 42-148/1

MSB 42NG-094/1

Replacement of the main landing gear (MLG) and nose landing gear (NLG) retaining rings.

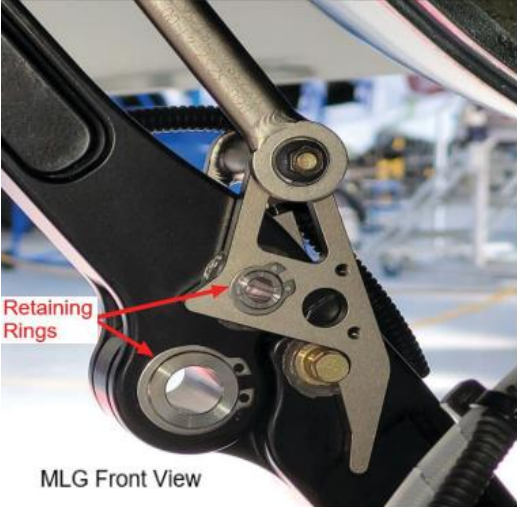
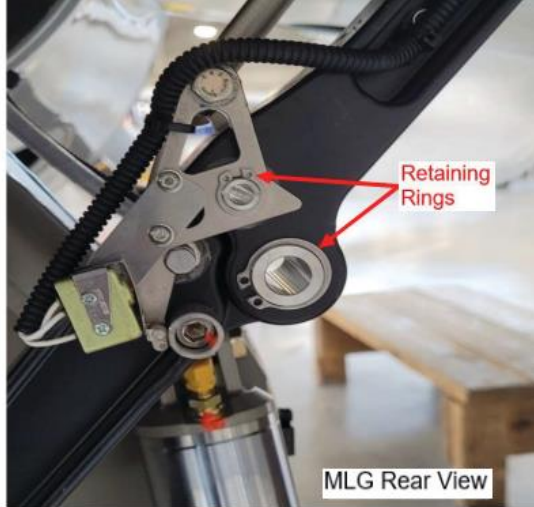
</div> <p style="text-align: center;">Figure 1: MLG Retaining Rings</p>

It was discovered that the main and nose landing gear braces of some aircraft had retaining rings with insufficient level of corrosion resistance being installed. This may cause the retaining rings to corrode, sustain damage, or fail (crack). If not corrected, this may lead to failure of the landing gear. This Service Bulletin describes the replacement of those retaining rings.

3	Replace one retaining ring at a time.
4	Remove the retaining rings from the MLG legs and NLG leg as per the figures. (Refer to Figures 1 and 2 for location)
5	<p>CAUTION: Do not remove or move shafts while replacing retaining rings:</p> <p>Clean the grooves of the bearing shafts. Inspect the folding stay and bearing shafts for general condition before installing the new retaining rings.</p> <p>NOTE: If for any reason the folding stay, and/or the bearing shaft needs to be removed for repair / replacement / further inspection, perform work in accordance with AMM section 32-00, then proceed to step 6.</p>
6	<p>NOTE: Do not overstretch the retaining rings during installation. Open the rings only enough to fit over the shaft when installing.</p> <p>Install the new retaining rings. Make sure the retaining rings properly engage into the grooves of the bearing shafts.</p>
7	Clean working areas, check for foreign objects.
