MANDATORY SERVICE BULLETIN

MSB 42-149

MSB 42NG-095

Actions to prevent Passenger Door Separation: Installation of Placards, AFM Procedure update and Inspection/Data Gathering.

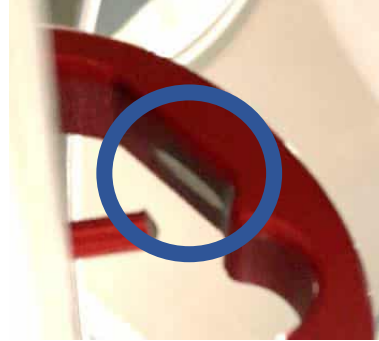
- 6 Examine the Safety Hook for signs of wear, corrosion and poor condition:
- Record the finding on the execution report in Appendix B.
 - There must be no deformation or cracks.
 - Pay particular attention to the contact area of the Actuation Pin.
 - Grooves in the Safety Hook must be less than 2 mm deep.

Replace Safety Hook, if

- any of the Safety Hook dimensions measured in this step are not within the given tolerances, or
- corrosion is found, or
- deformation, grooves, ridges or steps.

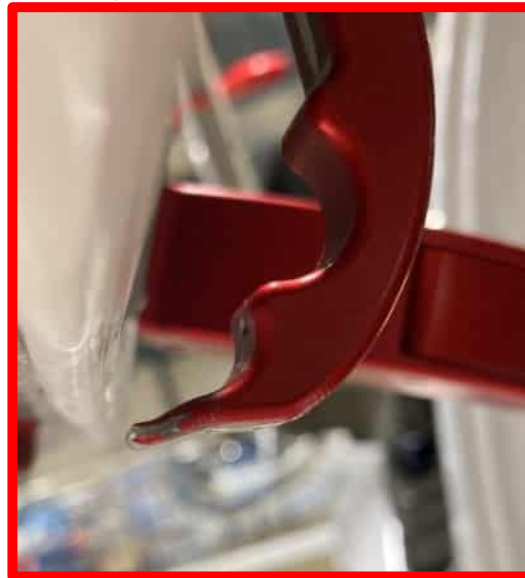
- Pay particular attention to the hook end of the Safety Hook.
 - The hook end must not be bent.
 - Not acceptable:

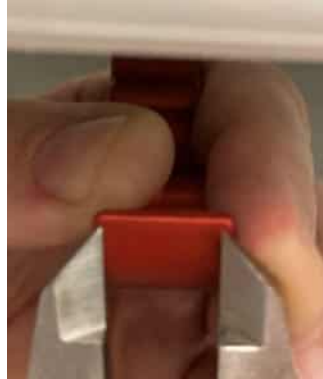
- Examine the tip of the Safety Hook for wear:
 - Wear of edges of Safety Hook:
 - The width of the tip of the Safety Hook must be greater than 10.5 mm.

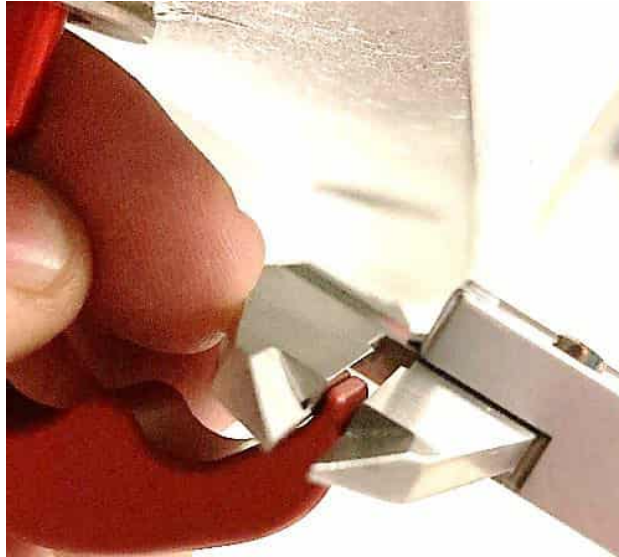
- Measure the maximum thickness of the Safety Hook at the location of the engaging surface, perpendicular to the engaging surface.
 - The thickness must be greater than 2.5 mm.
 - The maximum variation of measured thickness over the width of the Safety Hook must be less than 0.2 mm.

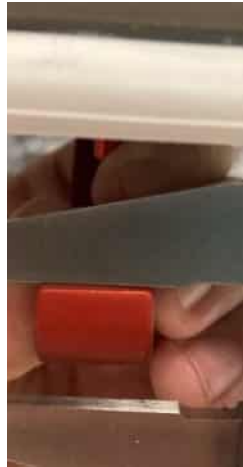
- The edge of the engaging section of the Safety Hook that is facing towards the Retaining Bracket must be free from ridges.

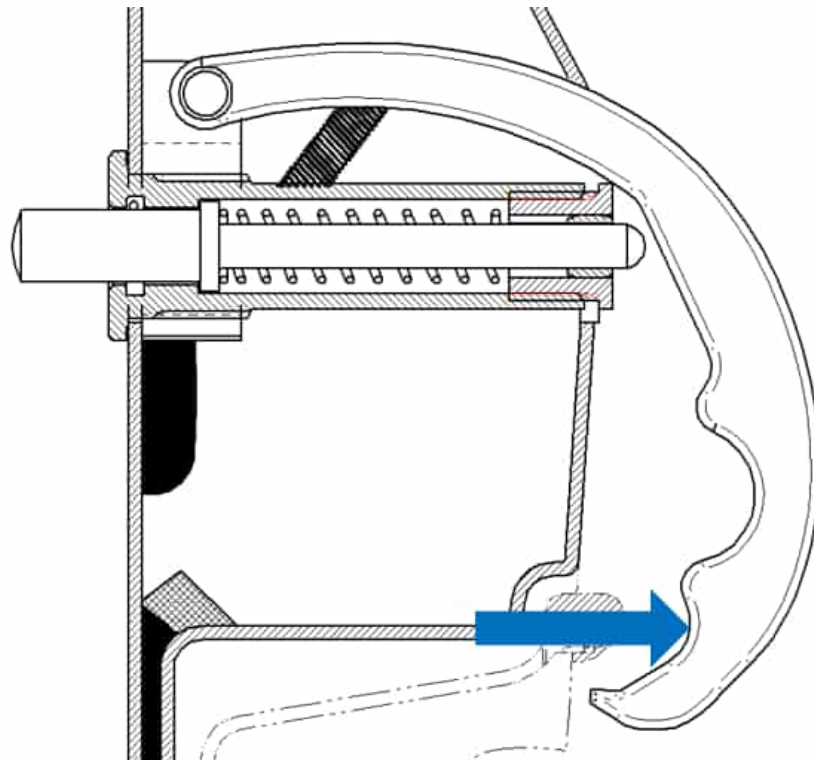
- 7 Measure the force to lift the Safety Hook from its resting position. Typically, the Safety Hook is resting on the cut-out in the Passenger Door.
- Open the Passenger Door.

- Attach a spring scale with a suitable measurement range to the lowest grip. Refer to the figure below.
 - Measure the force to lift the Safety Hook from its resting position.

- Verify that the Safety Hook does not lift from its resting position when a force of 0.1 kg / 1 N is applied.
 - If the Safety Hook lifts with a smaller force, check the spring for correct function. Replace if necessary and repeat the test.

- If the Safety Hook does not snap back:
 - Examine the spring of the Safety Hook.
 - Check the attachment of the Safety Hook for increased friction.
 - Check for interferences in the range of motion of the Safety Hook

- Record findings on the execution report in Appendix B.
 - Rectify any findings.
 - Repeat the test.
 - In case of doubt, contact Diamond Aircraft Industries GmbH

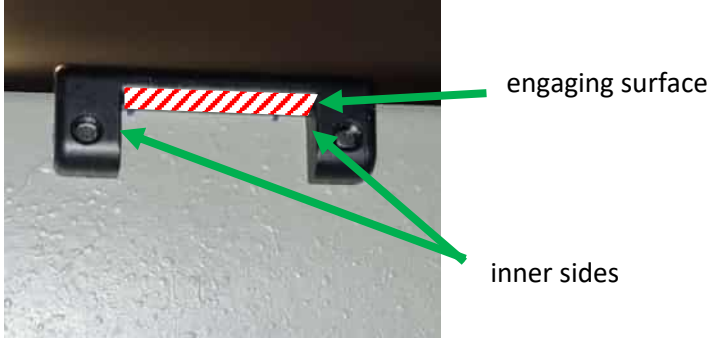
9	<p>If Retaining Bracket DA4-5200-00-69 is installed (refer to step 8.):</p> <ul style="list-style-type: none"> • Replace the Retaining Bracket according to MSB 42-083/MSB 42NG-014 (refer also to EASA AD 2010-0235). • Record replacement of the retaining bracket on the execution report in Appendix B.
10	<p>Examine the Retaining Bracket for signs of wear, corrosion and poor condition.</p> <ul style="list-style-type: none"> • There must be no corrosion on the Retaining Bracket. • Wear at the inner sides of the Retaining Bracket: maximum 0.5 mm per side. • The engaging surface of the Retaining Bracket and the edge of the engaging surface facing the Retaining Bracket must be free from steps and ridges. • Scratches or uniform wear of surface protection are permitted.

Replace the Retaining Bracket, if:

- any of the Retaining Bracket dimensions are not within the given tolerances, or
- if corrosion is found, or
- the wear limit is exceeded, or
- steps or ridges are found.

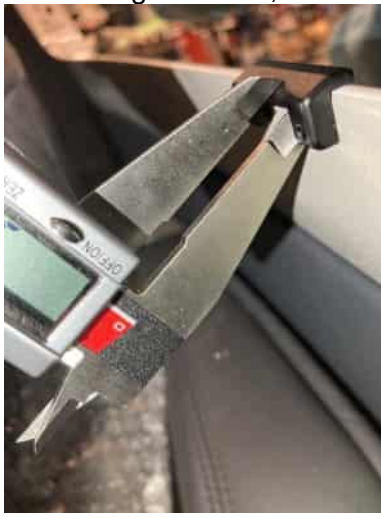
<ul style="list-style-type: none"> • The thickness of the Retaining Bracket measured perpendicular to the upper surface must be greater than <ul style="list-style-type: none"> ○ 4 mm (for Retaining Bracket DA4-5200-00-69_02 (extended with undercut), or ○ 6 mm (for all other Retaining Brackets, refer to Step 8).

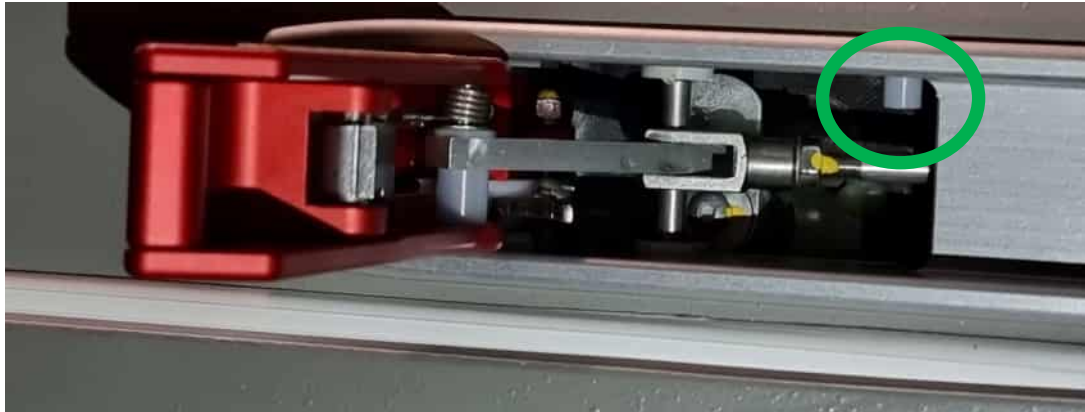
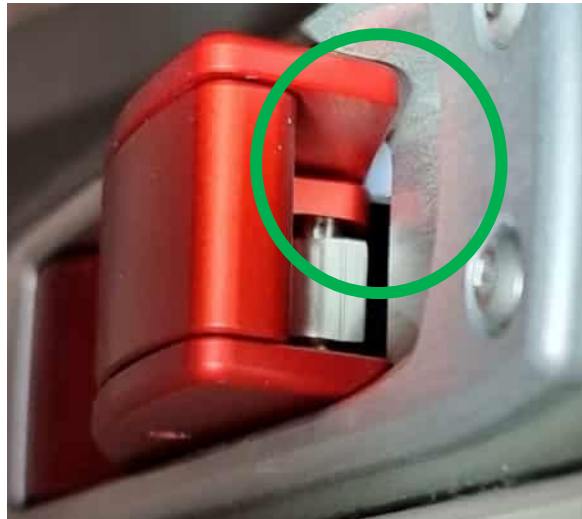
The gas spring inside the door handle must push the door handle into the latched position firmly against the stop:

- Open the Passenger Door.
- Move the Passenger Door Handle to the latched position.
- Examine, if the door handle is pushed into the mechanical stop inside the door handle mechanism (marked in the pictures below).
- If the Passenger Door Handle is not pushed against the mechanical stop by the gas spring, adjust the gas spring (refer to AMM section 52-10) and repeat this step.
- Record whether the gas spring was adjusted properly on the execution report in Appendix B.

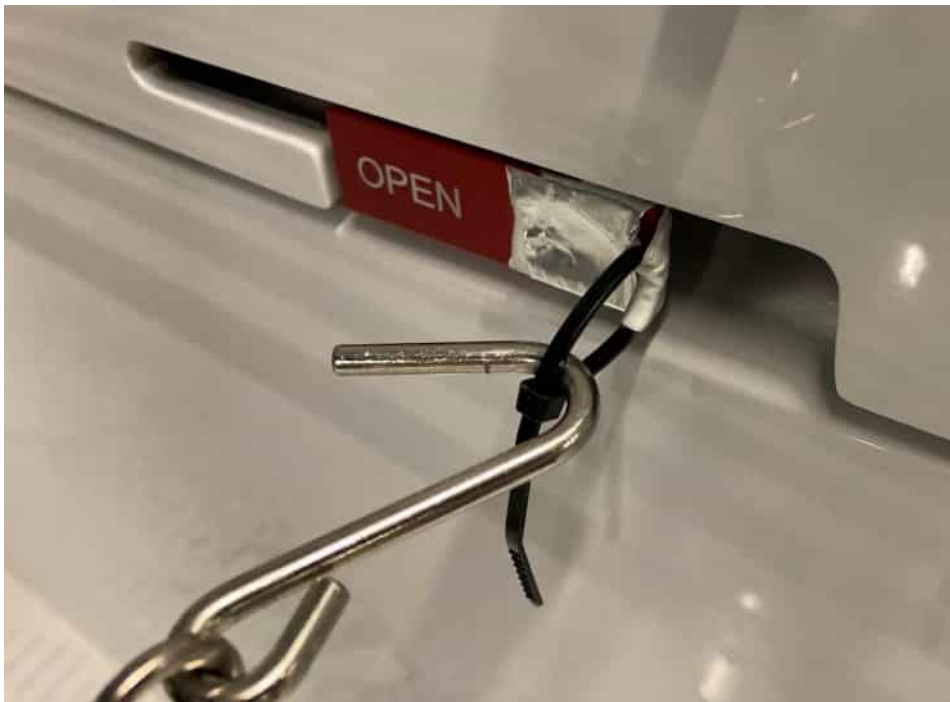
Example force measurement

- Measure the force necessary to move the Passenger Door handle to the unlatched position.
 - The force must exceed 1.8 kg / 18 N.
 - If the force does not exceed 1.8 kg / 18 N
 - Identify the reason for not reaching the minimum force limit and rectify any findings.
 - Repeat the test.
- Record the measured forces and any findings on the execution report in Appendix B.

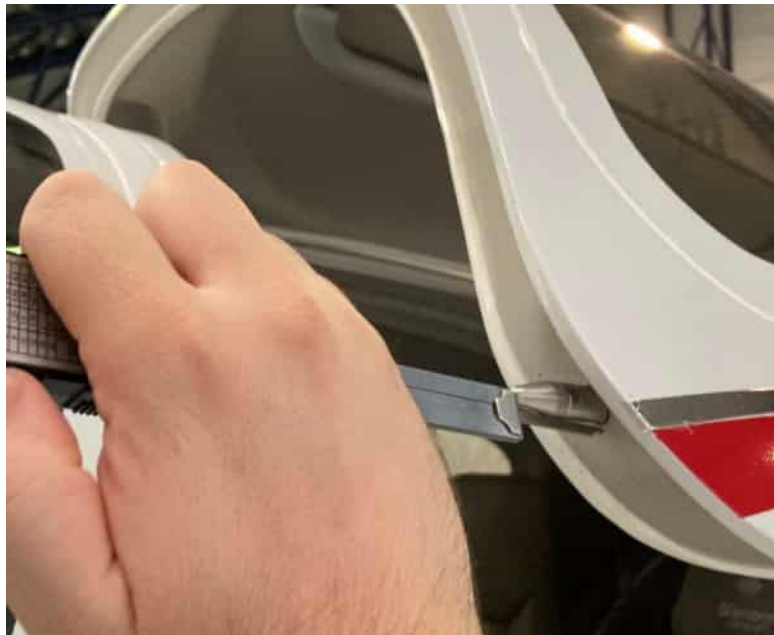
Front Latching Bolt

- Measure the extension length at the bottom of the front and rear latching bolts in mm. Refer to pictures below.
 - The front latching bolt extension length must be 40 ± 2 mm.

- If the extension length is out of tolerance, adjust the latching bolt if possible, or replace latching bolt if necessary.
 - After adjustment or replacement repeat this step.

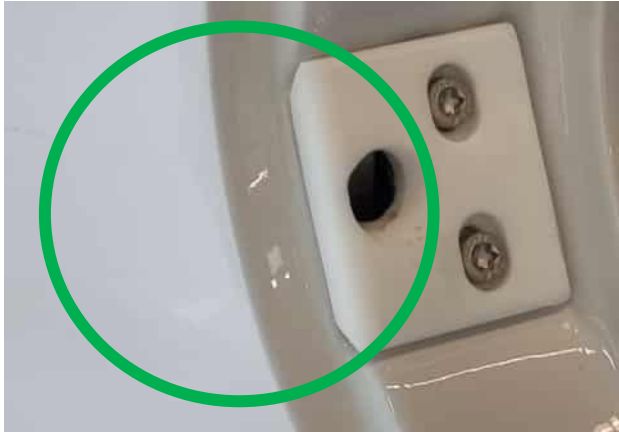
<p>Front</p>

24	<p>Data Collection: Inspect the door frame in the area around the front and rear latching bolts for damage.</p> <p>Record any damage on the execution report in Appendix B.</p> <div style="text-align: center;">
