SERVICE INFORMATION NO. SI 42-038

MSB 42-039 Retrofit Breather Line
ATA-Code: 72-00

NO. MSB-42-039

WI-MSB-42-039

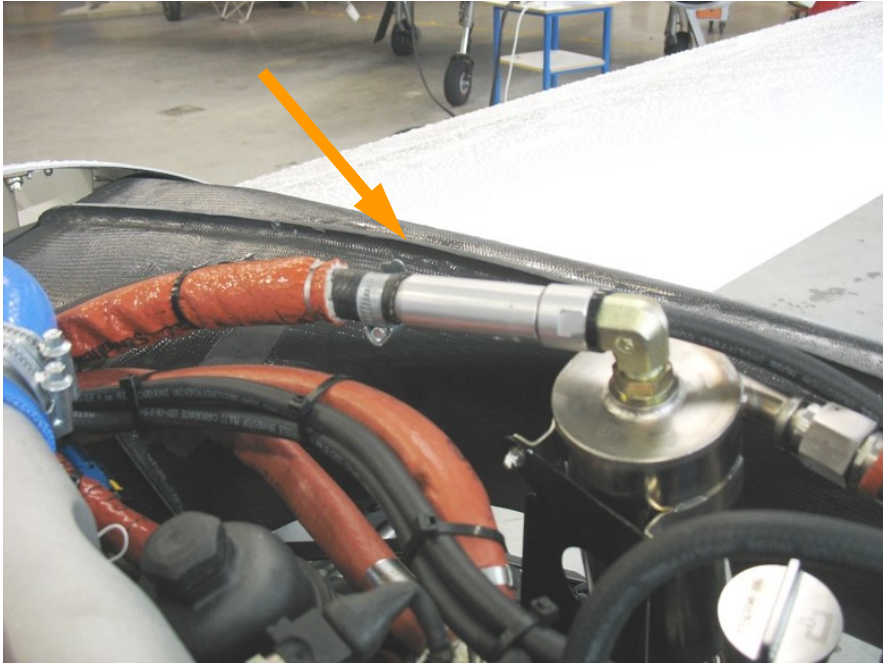
A design change in the turbo charging system from Thielert Aircraft Engines requires also the replacement of the oil separator and the breather line.

3	<p>Install new oil separator and new breather line according the following picture of this WI. Shorten breather line and fire sleeve as required and install breather line bypass (D60-7906-40-30 / D60-7906-40-31) acc. to picture.</p>
