SERVICE INFORMATION NO. SI 42-049

GARMIN - Service Bulletin No. 0736

NO.: 0736

G1000 System ID Tool

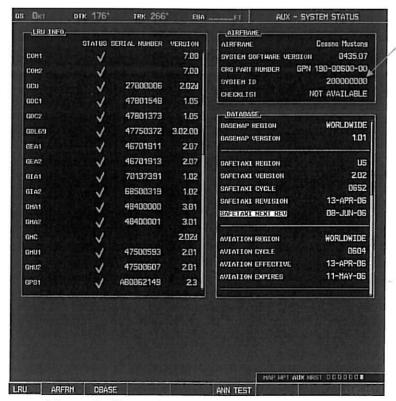
Figure 1. Example AUX - System Status Page

Garmin has identified an error associated with G1000 system software upgrades that sometimes results in an invalid System ID. An invalid System ID can be identified as either being "00000000" or "20000000". The G1000 System ID can be verified on the AUX-System Status Page (Figure 1).

All GDU 1XXXs with a System ID of "00000000" or "20000000". The G1000 System ID can be verified on the MFD AUX-System Status Page (Figure 1).

Use the G1000 System ID Tool (P/N 006-B0380-ZA) to change the G1000 System ID from "00000000" or "20000000" to a valid System ID by performing the following procedure:
