SERVICE INFORMATION NO. SI 42-051

Thielert TAE Service Bulletin TM TAE 125-1004 P1
ATA-Code: 72-00

Service Bulletin No. / TM TAE 125-1004 P1, Initial Issue / September 14, 2007
Date:

Betrifft: Entfernen des kleinen O-Rings des Ölfiltermoduls
Subject: *Removing the small O-Ring of the Oil Filter Module*

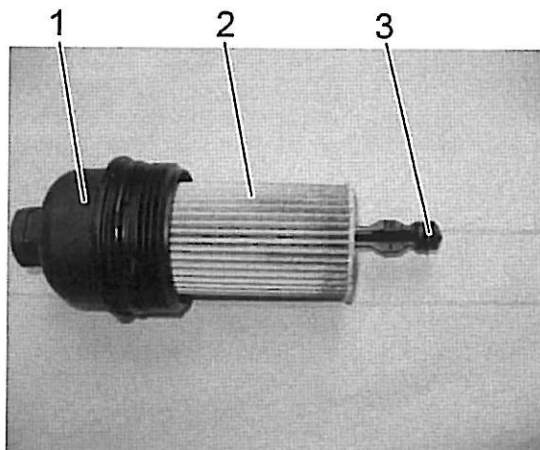
Bild 1 / Fig. 1

Grund: Aufgrund von möglichen Betriebsproblemen müssen die folgenden
Arbeiten durchgeführt werden.
Reason: *Because of possible incorrect operation, the following work sequences
must be accomplished.*

1. *Check the small o-ring for damages after remove of the oil filter. See Fig. 1.*
2. *If the small o-ring is damaged, make sure that no parts of the small o-ring are missing.*

■ **CAUTION:** *If any parts of the small o-ring are missing contact Thielert Aircraft Engines GmbH!*

3. *Remove the small o-ring without replacing it.*
4. *Finish the exchange of the oil and oil filter according to the current Operation & Maintenance Manual OM-02-02.*
