SERVICE INFORMATION NO. SI 42-063/1

EASA EAD No. 2008-0027-E and
Thielert Service Bulletin TM TAE 125-1005 P1 Bracket HP Line HPP-Fuel Rail, Rev. 1
ATA-Code: 73-00

Technische Mitteilung / Service Bulletin**PRIORITY 1 – Safety**

<u>Technische Mitteilung Nr. / Datum:</u>	TM TAE 125-1005 P1, Rev. 1 / 11.02.2008
<u>Service Bulletin No. / Date:</u>	TM TAE 125-1005 P1, Rev. 1 / February 11, 2008
<u>Betrifft:</u>	Installation Halter Kraftstoffhochdruckleitung
<u>Subject:</u>	Installation of Bracket High-Pressure Fuel Line
<u>Betroffenes Luftfahrtgerät:</u>	TAE 125-02-99 (CENTURION 2.0)
<u>Type affected:</u>	TAE 125-02-99 (CENTURION 2.0)
<u>Betroffene Geräte-Nr.:</u>	Motorseriennummern 02-02-1500 bis 02-02-2279
<u>Models affected:</u>	Engine Serial Number 02-02-1500 to 02-02-2279
<u>Einstufung:</u>	Kategorie P1 – Sicherheit
<u>Classification:</u>	Category P1 – Safety
<u>Ausführung bis:</u>	Gesamtmotorlaufzeit unter 20 Std.: Maßnahmen sind vor Erreichen einer Gesamtmotorlaufzeit von 30 Std. oder mit der nächsten Inspektion durchzuführen, maßgebend ist das ersteintreffende Ereignis. Gesamtmotorlaufzeit über 20 Std.: Maßnahmen sind innerhalb der nächsten 10 Flugstunden oder mit der nächste

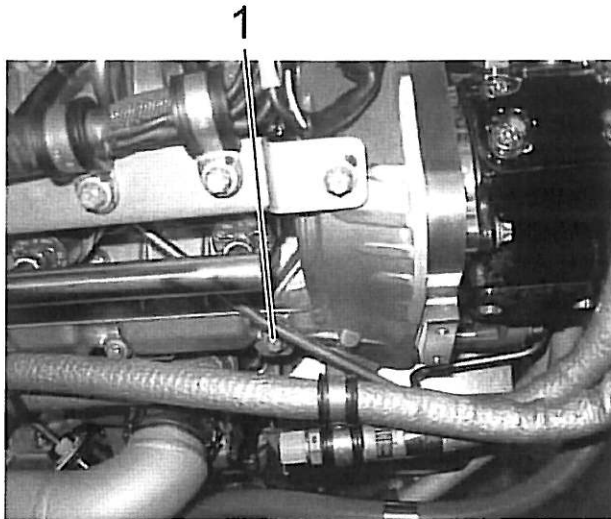
Bild 1 / Fig. 1

- 1 Schraube /
Screw

1. Detach the screw of the cylinder head cover. See Fig. 1.
2. Attach the spacer to the cylinder head cover. See Fig. 3.
Tightening torque:
12 Nm
3. Remove the high-pressure fuel line. See Fig. 2.

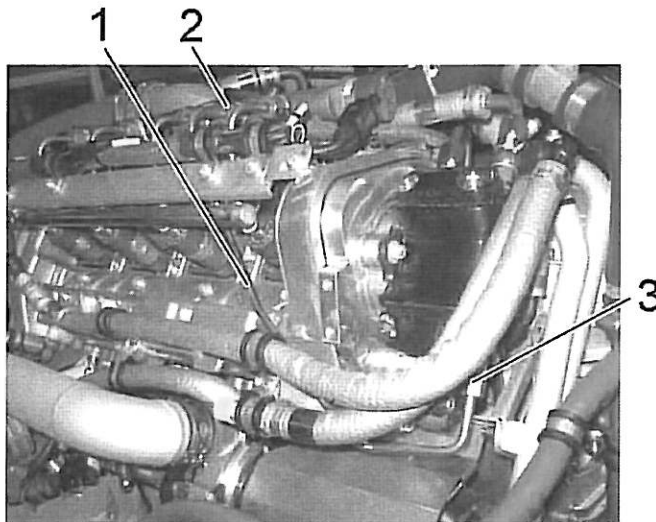
Bild 2 / Fig. 2

- Grund:** Aufgrund von möglichen Schwingungsbrüchen an der Kraftstoffhochdruckleitung müssen die folgenden Arbeiten durchgeführt werden.
- Reason:** *Because of possible fractures by vibration on the High-Pressure Fuel Line, the following work sequences must be accomplished.*

- 1 Kraftstoffhochdruckleitung /
High-Pressure Fuel Line
2 Überwurfmutter Fuel Rail (SW18) /
Union Nut Fuel Rail (wrench size 18mm)
3 Überwurfmutter Hochdruckpumpe (SW14) /
Union Nut High-Pressure Pump (wrench size 14mm)

8. Tighten the screw of the fastener. See Fig. 3.
Tightening torque:
7 Nm
9. Tighten the union nuts of the high-pressure fuel line. See Fig. 2.
Tightening torque:
Union nut high-pressure pump (wrench size 14mm): 22 Nm
Union nut fuel rail (wrench size 18mm): 27 Nm
10. Carry out a ground run with data recording in accordance with the current Operation & Maintenance Manual OM-02-02.
11. Carry out a visual inspection and check for leaks.

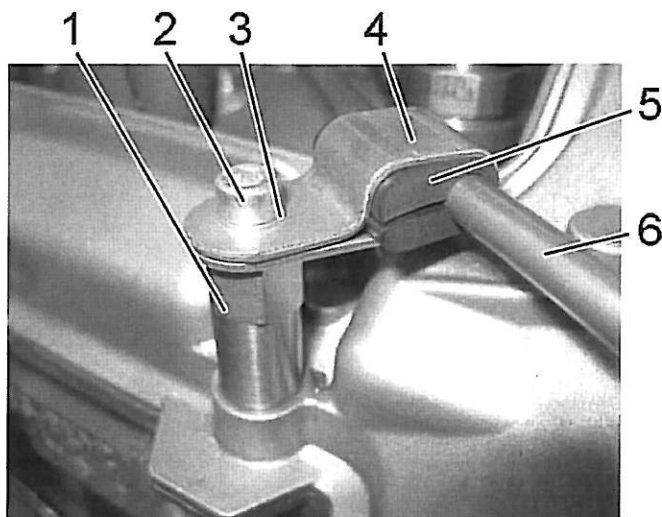
Bild 3 / Fig. 3

- 1 Abstandshalter /
Spacer
- 2 Schraube /
Screw
- 3 Scheibe /
Washer
- 4 Halter /
Fastener
- 5 Beilage /
Insert
- 6 Kraftstoffdruckleitung /
High-Pressure Fuel Line

5. Attach the fastener and the insert to the high-pressure fuel line. See Fig 3.
6. Attach the fastener to the spacer using one bolt and one washer. See Fig. 3.
