SERVICE INFORMATION NO. SI 42-068

Garmin G1000 System: Transponder Flight Identification Operation
ATA-Code: 34-00

SERVICE ADVISORY

TO: All Garmin G1000 Customers
DATE: 14 March 2008
SUBJECT: G1000 Transponder Flight Identification Operation

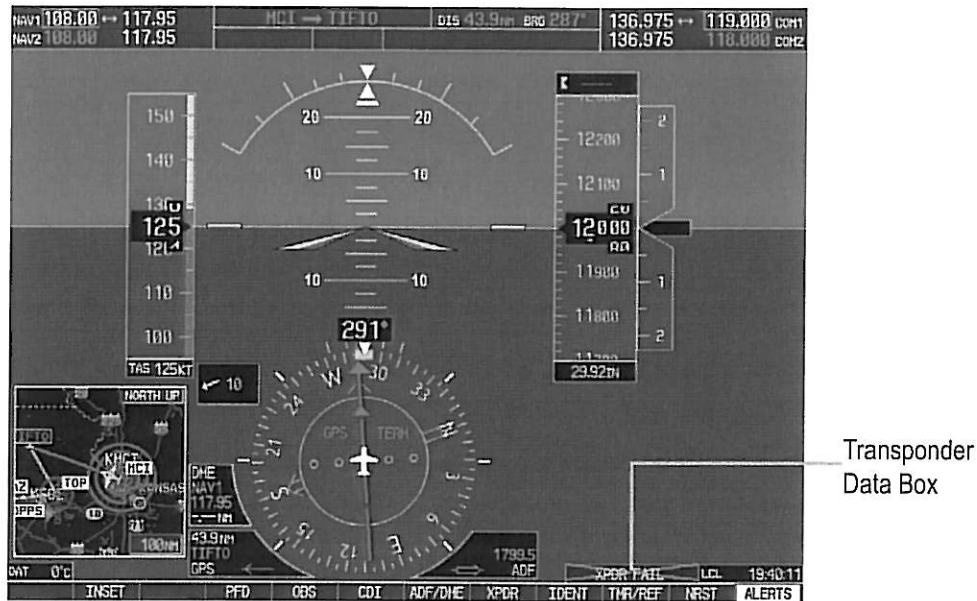
Figure 2 – Transponder Data Box

Garmin has identified an issue that is infrequently encountered when entering or changing a G1000 Transponder Flight Identification (ID) number using the Primary Flight Display (PFD) entry method. This issue may cause the following to appear on the PFD:

- A red "X" (failure indication) on the Transponder Data Box
- A "XPDR Config Service" message in the Message Box

If the Transponder Data Box (Figure 2) is marked with a red “X” after entering or changing a Flight ID number, perform the following:

1. Pull the associated transponder circuit breaker to prevent transmitting an incorrect Flight ID number and/or transponder code
2. Select the opposite transponder using the PFD softkeys.
3. Contact your maintenance organization to service the transponder.

- If airborne, advise Air Traffic Control of a possible transponder failure and follow ATC instructions for continued operation of the transponder.
- If on the ground, contact your maintenance organization to service the transponder.

Software upgrades containing GDU v9.00 and later software will resolve this issue.
