SERVICE INFORMATION NO. SI 42-070

Garmin G1000 System: Transponder Flight Identification Operation
ATA-Code: 34-00

NO.: 0806 Revision B

TO: All Garmin G1000 Customers
DATE: 18 March 2008
SUBJECT: G1000 Transponder Flight Identification Operation
REVISION B: Removed GDU software version number

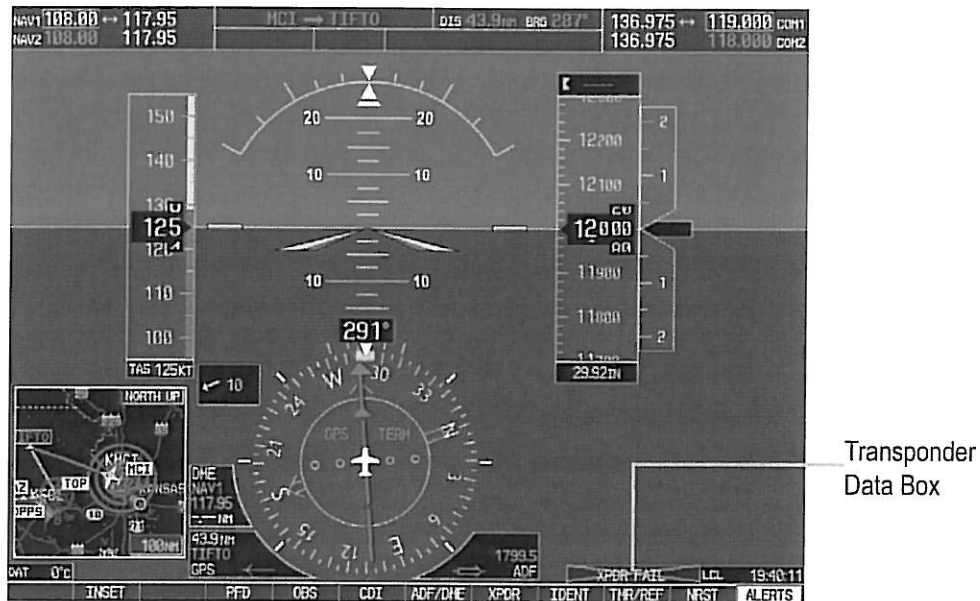
Figure 2 – Transponder Data Box

Garmin has identified an issue that is infrequently encountered when entering or changing a G1000 Transponder Flight Identification (ID) number using the Primary Flight Display (PFD) entry method. This issue may cause the following to appear on the PFD:

- A red "X" (failure indication) on the Transponder Data Box
- A "XPDR Config Service" message in the Message Box

If the Transponder Data Box (Figure 2) is marked with a red “X” after entering or changing a Flight ID number, perform the following:

For dual transponder installations:

1. Pull the associated transponder circuit breaker to prevent transmitting an incorrect Flight ID number and/or transponder code
2. Select the opposite transponder using the PFD softkeys.
3. Contact your maintenance organization to service the transponder.

For single transponder installations:

- If airborne, advise Air Traffic Control of a possible transponder failure and follow ATC instructions for continued operation of the transponder.
- If on the ground, contact your maintenance organization to service the transponder.

Maintenance personal should refer to the airframe's G1000 System or Line Maintenance Manual for instructions on how to reconfigure the transponder.
