SERVICE INFORMATION NO. SI 42-073

GARMIN Service Bulletin No. 0713 Rev. D
FAA Airworthiness Directive 2008-02-06, dated 26-Feb-2008
ATA-Code: 22-10

NO.: 0713 Revision D

SUBJECT: GSM 85 Inspection Procedure

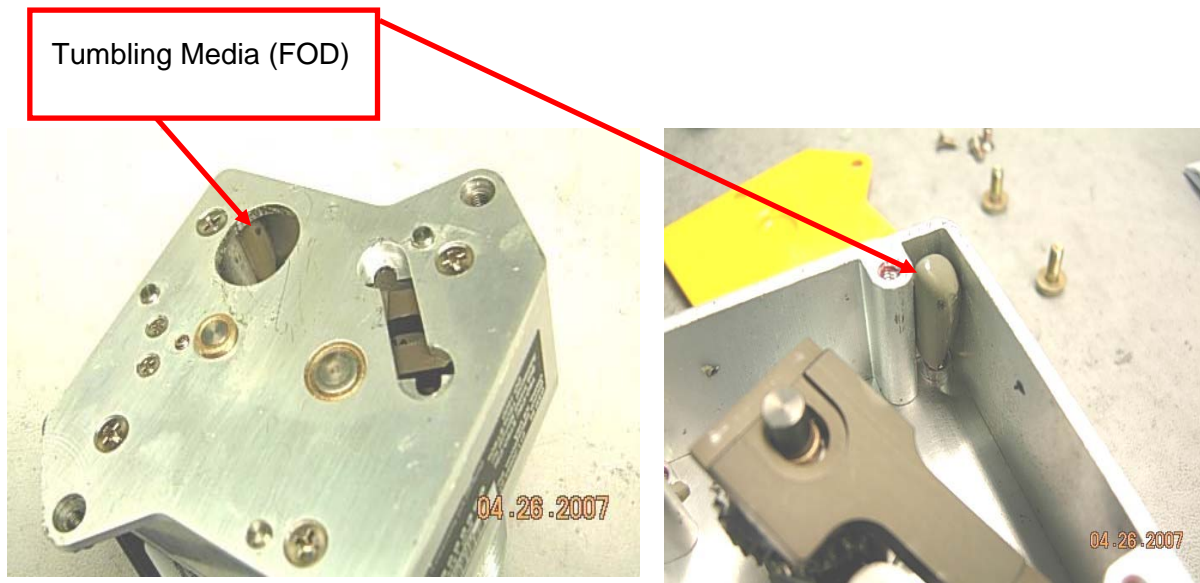
Figure 4-1

- 4.1 Remove the GSA 8X servo from the GSM 85 per the OEM Aircraft Maintenance Manual.
- 4.2 Insert the borescope into the hole on the bottom side of the GSM 85 where the actuator gear of the GSA 8X servo inserts.
- 4.3 Maneuver the borescope to view all potential areas where foreign objects (FOD) may be present, particularly in the corners of the extrusion (Figure 4-1). Also look closely at the gears for the presence of FOD, rotate the gears to view all potential areas for FOD. FOD may be present anywhere inside of the extrusion, not only where shown in Figure 4-1.

- 4.4 If FOD is present, remove the GSM 85 per the OEM Aircraft Maintenance Manual and return the GSM 85 servo gearbox to Garmin for exchange. After receiving the replacement GSM 85 from Garmin, proceed to Section 6 Reinstallation.
