## SERVICE INFORMATION NO. SI 42-087

GARMIN – Service Bulletin No. 0823 Rev. B  
ATA-Code: 34-00

**NO.: 0823 Rev B**

**SUBJECT:** GDU 104X CRS/BARO Knob Interference

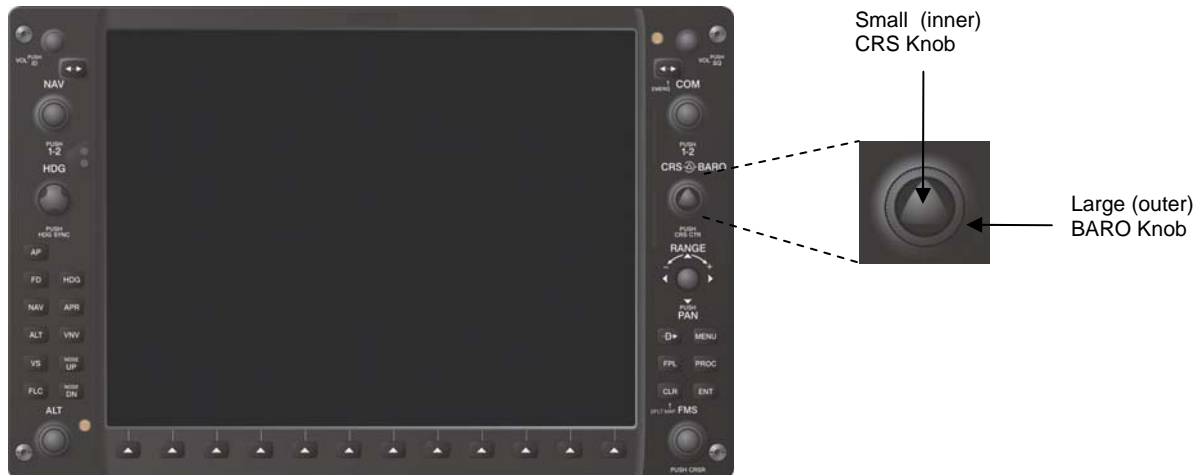
**Figure 1**

Garmin has identified an issue, whereby the large (outer) BARO knob and the small (inner) CRS knob may interfere with each other.

This service bulletin contains instructions on how to test for knob interference and remove/replace the CRS/BARO knobs, as required.
