## SERVICE INFORMATION NO. SI 42-088

GARMIN – Service Alert No. 0824 Rev. B  
ATA-Code: 34-00

NO.: 0824 Rev B

**TO:** All G1000/G900X/G950 Owners and Operators  
**DATE:** 4 August 2008  
**SUBJECT:** GDU 104X CRS/BARO Knob Interference  
**REVISION B:** Removed the GDU 1045 (011-00819-04) and added a list of affected serial numbers

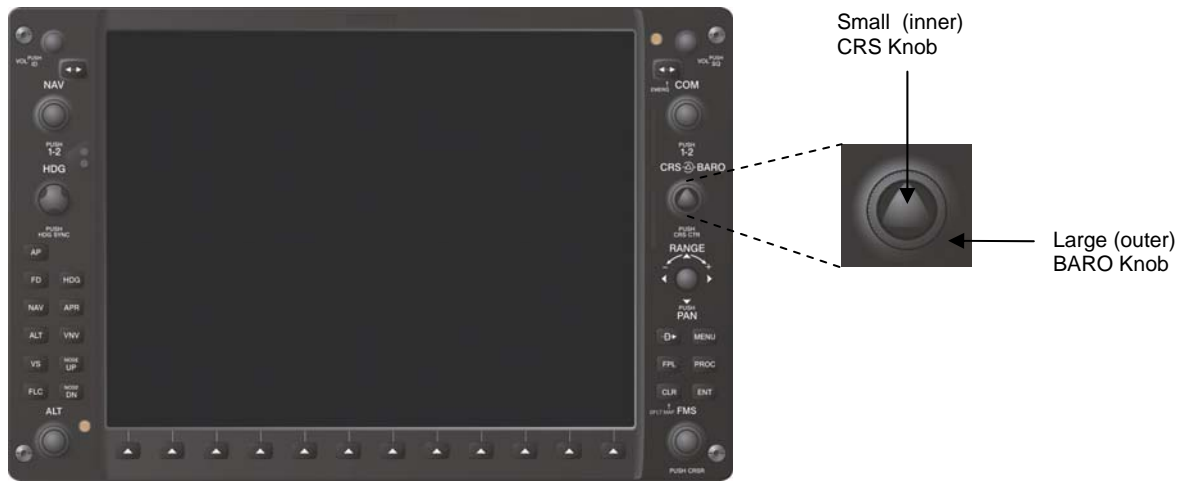
**Figure 2**

Garmin has identified an issue, whereby the large (outer) BARO knob and the small (inner) CRS knob may interfere with each other.

1. Apply power to the G1000/G900X/G950.
2. Press the CDI softkey on the Primary Flight Display(s) (PFD) to enter VOR mode on the HSI.
3. Rotate the large (outer) BARO knob (refer to Figure 2) a minimum of three complete revolutions in each direction while monitoring the Horizontal Situation Indicator/Digital Course Indicator (refer to Figure 3) on the PFD. If a change in the Horizontal Situation Indicator/Digital Course Indicator is produced while turning the BARO knob contact your local Garmin Service Center or OEM Dealer to replace the knobs.

4. Rotate the small (inner) CRS knob (refer to Figure 2) a minimum of three complete revolutions in each direction while monitoring the Barometric Altimeter Setting (refer to Figure 3) on the PFD. If a change in the Barometric Altimeter Setting is produced while turning the CRS knob contact your local Garmin Service Center or OEM Dealer to replace the knobs.
5. Repeat Steps 3 and 4 for each affected GDU.
