SERVICE INFORMATION NO. SI 42-095

Garmin G1000 System: Transponder Flight Identification Operation
ATA-Code: 34-00

NO.: 0806 Revision C

TO: All Garmin G1000 Customers
DATE: 23 October 2008
SUBJECT: G1000 Transponder Flight Identification Operation
REVISION C: Added GDU software version number

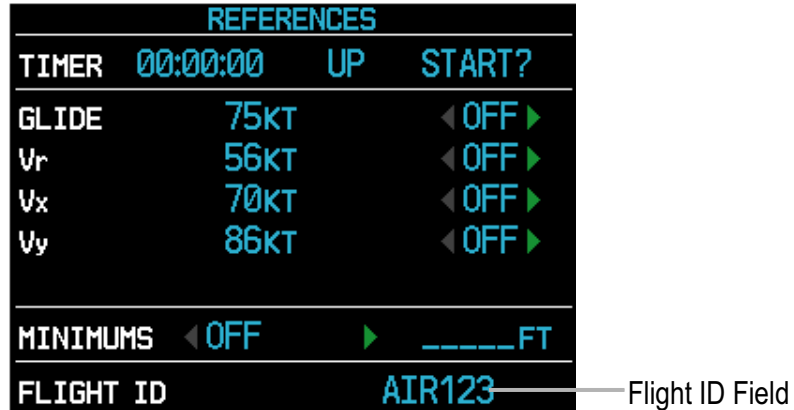
Figure 1 – PFD Timer Reference Window

The PFD Entry configuration setting is primarily used outside the continental United States for commercial and/or training operations. Systems with PFD Entry enabled may be readily identified by the presence of a FLIGHT ID field (Figure 1) located at the bottom of the Timer/References Window on the PFD. The Flight ID differs from the 4 digit “squawk” code.

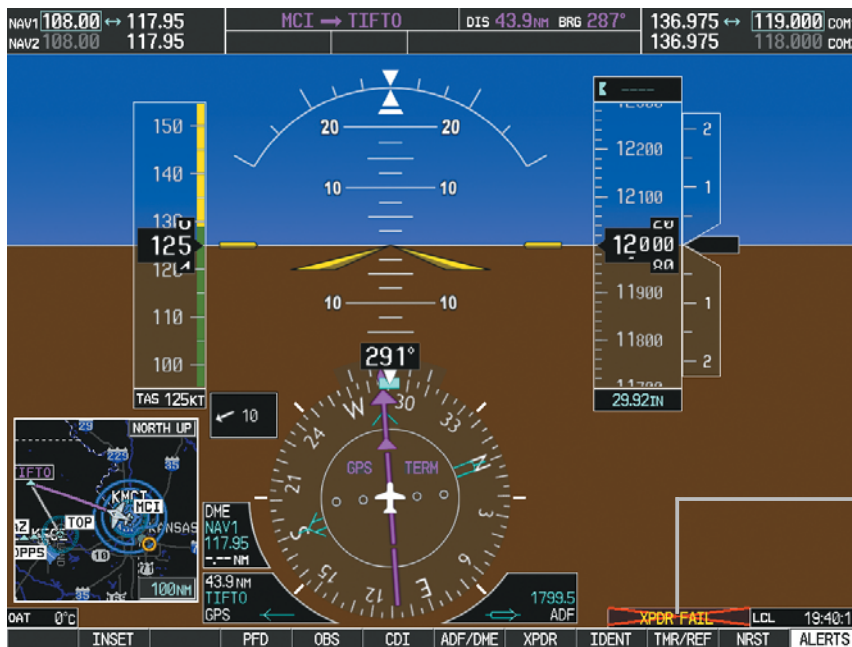
Figure 2 – Transponder Data Box

Garmin has identified an issue that is infrequently encountered when entering or changing a G1000 Transponder Flight Identification (ID) number using the Primary Flight Display (PFD) entry method. This issue may cause the following to appear on the PFD:

- A red "X" (failure indication) on the Transponder Data Box
- A "XPDR Config Service" message in the Message Box

If the Transponder Data Box (Figure 2) is marked with a red “X” after entering or changing a Flight ID number, perform the following:

1. Pull the associated transponder circuit breaker to prevent transmitting an incorrect Flight ID number and/or transponder code
2. Select the opposite transponder using the PFD softkeys.
3. Contact your maintenance organization to service the transponder.

- If airborne, advise Air Traffic Control of a possible transponder failure and follow ATC instructions for continued operation of the transponder.
- If on the ground, contact your maintenance organization to service the transponder.

System software upgrades containing GDU software version 9.02 and later will resolve this issue. Contact your airframe manufacturer for details.
