SERVICE INFORMATION NO. SI-42-110

EASA Airworthiness Directive No. 2009-0151
Thielert Aircraft Engines Service Bulletin TM TAE 125-1009 P1
ATA-Code: 61-20

<u>Technische Mitteilung Nr. / Datum:</u>	TM TAE 125-1009 P1, Erstausgabe / 07.07.2009
<u>Service Bulletin No. / Date:</u>	TM TAE 125-1009 P1, Initial Issue / July 07, 2009
<u>Betrifft:</u>	Constant Speed Unit – Schwingungsdämpfer
<u>Subject:</u>	Constant Speed Unit – Vibration Isolator
<u>Betroffenes Luftfahrtgerät:</u>	TAE 125-02-99 (CENTURION 2.0)
<u>Type affected:</u>	TAE 125-02-99 (CENTURION 2.0)
<u>Betroffene Geräte-Nr.:</u>	Alle DA42 Installationen
<u>Models affected:</u>	All DA42 installations
<u>Einstufung:</u>	Kategorie P1 – Sicherheit
<u>Classification:</u>	Category P1 – Safety
<u>Ausführung bis:</u>	Maßnahmen sind innerhalb der nächsten 100 Flugstunden oder mit der nächsten Inspektion durchzuführen, maßgebend ist das ersteintreffende Ereignis.
<u>Time of Compliance:</u>	Measures have to be accomplished within the next 100 flight hours or with the next inspection, whichever occurs first.
<u>Grund:</u>	Mögliche Motorausfälle, welche durch ein Versagen des Proportional-druckreduzierventils aufgrund von Vibrationen veru

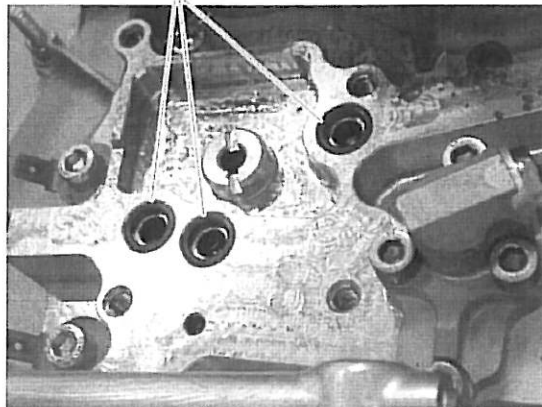
Figure 4

■ **CAUTION:** The surface of the ground plate **MUST NOT** be damaged / get scratches when removing the O-rings. Check the surface of the ground plate for scratches. If any scratches on the surface of the ground plate have been found, Thielert Aircraft Engines GmbH **MUST** be contacted.

4. Remove the three O-rings at the ground plate very carefully and discard them. See Figure 4.
