SERVICE INFORMATION NO. SI-42-122

GARMIN Service Bulletin No. 0823 Revision C
ATA-Code: 34-00

**** MANDATORY ****
SERVICE BULLETIN
NO.: 0823 Rev C

SUBJECT: GDU 104X CRS/BARO Knob Interference

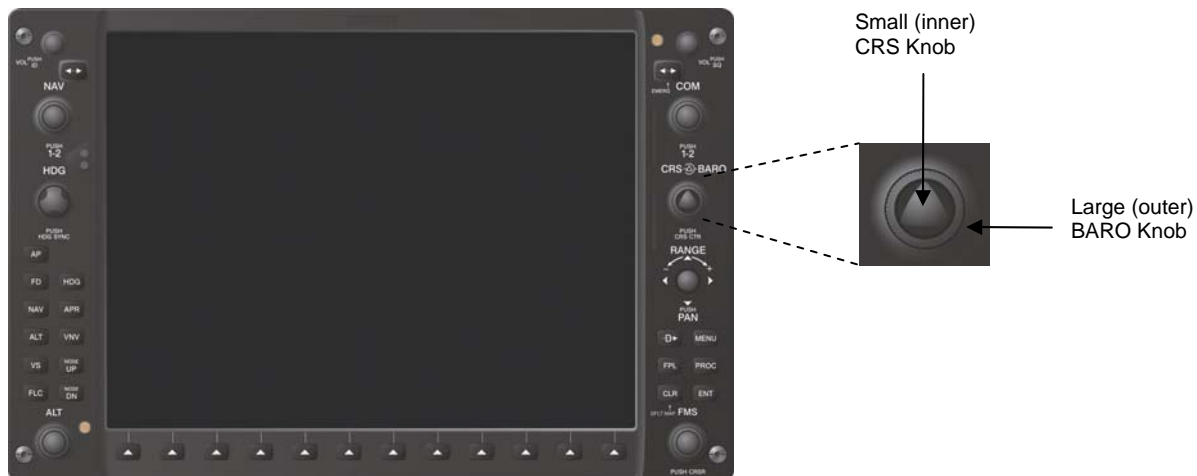
Figure 1

GARMIN has identified an issue, whereby the large (outer) BARO knob and the small (inner) CRS knob may interfere with each other. The Service Bulletin No. 0823 Rev. C contains instructions on how to test for knob interference and replace the CRS/BARO knobs, if required.

Garmin has identified an issue, whereby the large (outer) BARO knob and the small (inner) CRS knob may interfere with each other.

If CRS/BARO Knob interference is confirmed, perform the steps below to replace the CRS/BARO Knob. New knobs can be obtained through a Garmin Service Center or Aircraft OEM under Garmin part number K00-00446-00.

1. Grasp the small (inner) CRS knob and firmly pull the knob off the shaft.
2. Discard knob.
3. Grasp the large (outer) BARO knob and firmly pull the knob off the shaft.
4. Discard knob.
