SERVICE INFORMATION NO. SI 42-160

EASA Emergency Airworthiness Directive No. 2011-0152-E
TM TAE 125-0021, Rev 1 - Replacement Clutch
TM TAE 125-1011 P1, Rev 1 - Replacement Clutch
ATA-Code: 72-10

Technische Mitteilung Nr. / Datum: TM TAE 125-0021, Rev. 1 / 17.08.2011
Service Bulletin No. / Date TM TAE 125-0021, Rev. 1 / August 17, 2011

Service Bulletin No. / TM TAE 125-1011 P1, Rev. 1 / August 17, 2011
Date:

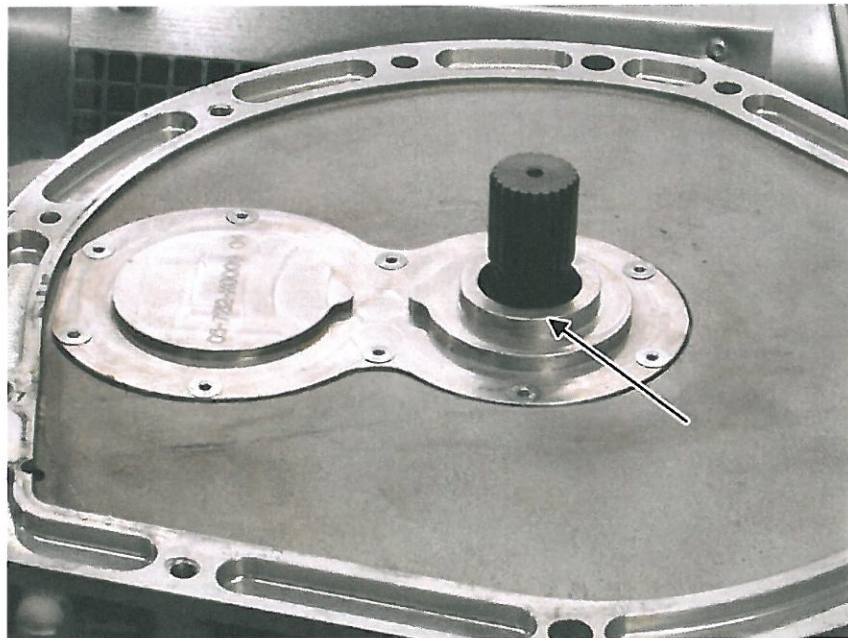
Bild 1 Absatz am Getriebedeckel

Wenn der hintere Getriebedeckel die Teilenummer 05-7212-K000904 und den im Bild 1 sichtbaren Absatz aufweist muss der hintere Getriebedeckel nach den folgenden Schritten bearbeitet werden. Ansonsten mit Arbeitsschritt 19 fortfahren:

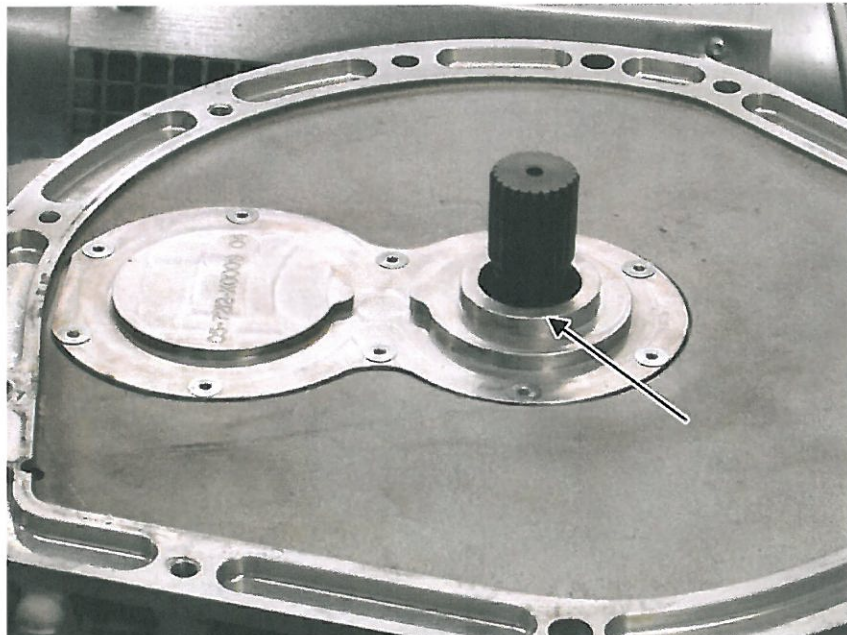
Fig. 1 Shoulder on the rear gearbox cover

If the rear gearbox cover has the part number 05-7212-K000904 and the shoulder shown in Fig. 1, you must rework the rear gearbox cover in accordance to work steps which follow. Otherwise, proceed to step 19.
