## **SERVICE INFORMATION**

### **No. SI 42-188/1**

GARMIN Terrain Data Alert No. 1351 Revision B

## Terrain Data Alert 1351

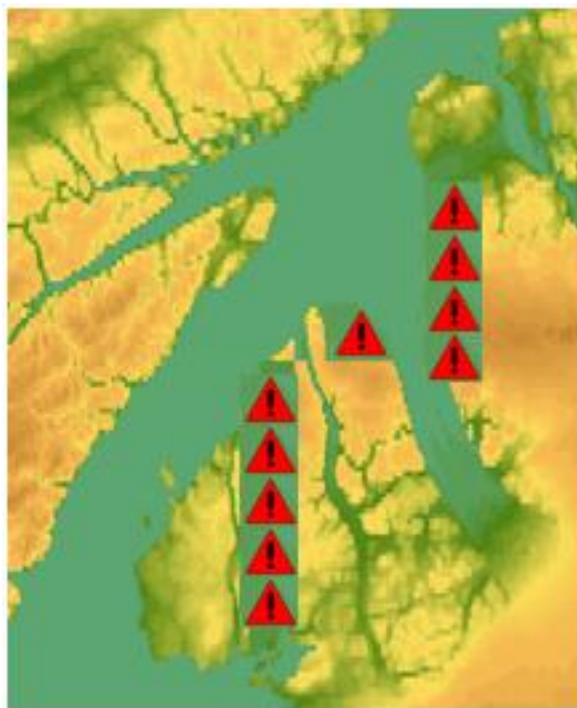
Refer to the figure below. The affected area is within a 55nm radius centered around N80° 50', W62° 30' located in the northwest region of Greenland.

= Affected Area

Anomalies may prevent TAWS/Terrain alerts and display an invalid terrain representation when using Synthetic Vision Technology (SVT) in the affected area.

Pilots should utilize extra caution and maintain awareness of the surrounding terrain when flying in northwest Greenland.

This issue will be corrected in a future cycle release. Refer to the [Areas of Degraded Terrain Database Performance](#) on the Garmin website for a list of resolved Terrain Database issues.
