## SERVICE INFORMATION NO. SI 42-198

EASA Airworthiness Directive No. 2014-0232  
TM TAE 125-0021, Revision 2 - Replacement Clutch  
ATA-Code: 72-10

Technische Mitteilung Nr. / Datum: TM TAE 125-0021, Rev. 2 / 13.10.2014  
Service Bulletin No. / Date TM TAE 125-0021, Rev. 2 / October 13, 2014

**Technische Mitteilung** TM TAE 125-1011 P1, Rev. 2 / 31.08.2011  
**Nr. / Datum:**

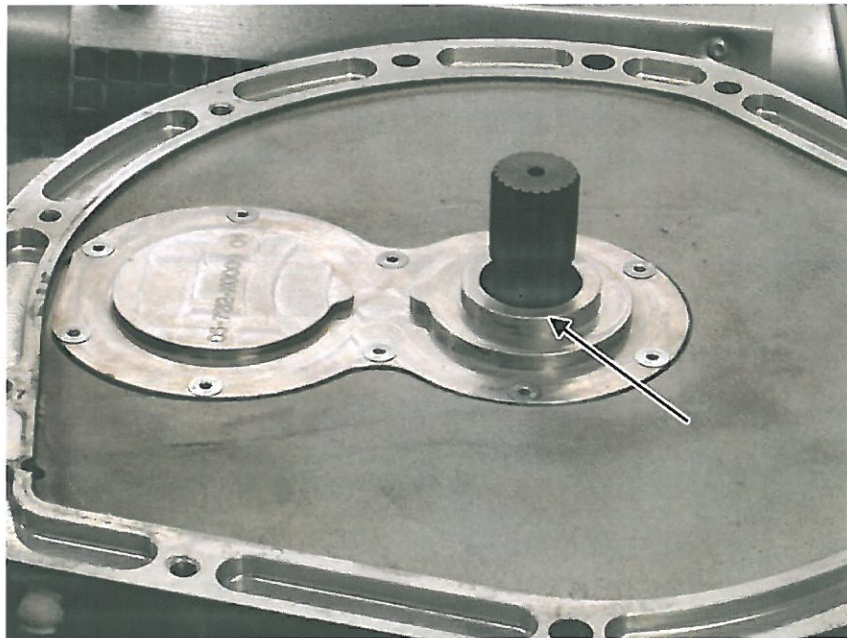
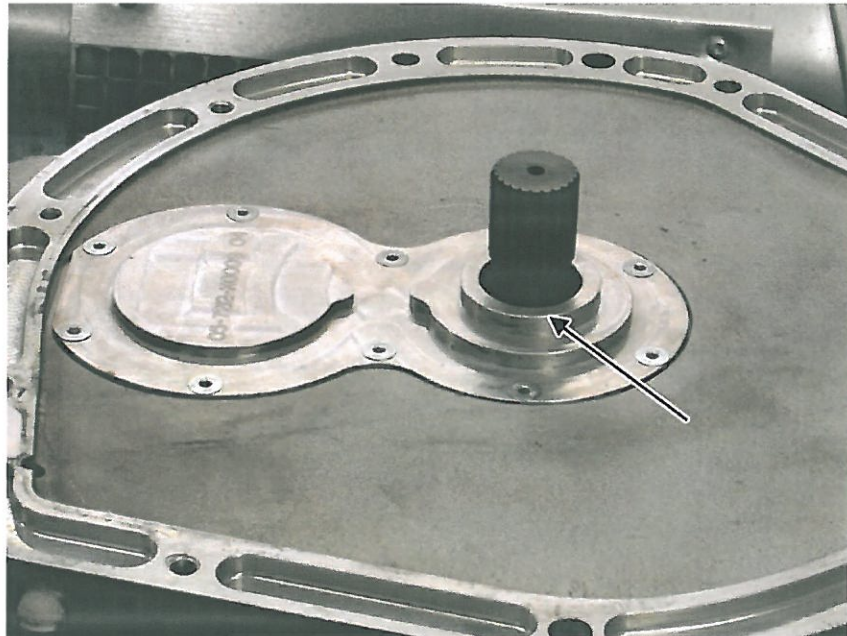
**If the rear gearbox cover has the part number 05-7212-K000904 and the shoulder shown in Fig. 1, you must rework the rear gearbox cover in accordance to work steps which follow. Otherwise, proceed to step 19.**

Fig. 1 Shoulder on the rear gearbox cover

**Wenn der hintere Getriebedeckel die Teilenummer 05-7212-K000904 und den im Bild 1 sichtbaren Absatz aufweist muss der hintere Getriebedeckel nach den folgenden Schritten bearbeitet werden. Ansonsten mit Arbeitsschritt 19 fortfahren:**

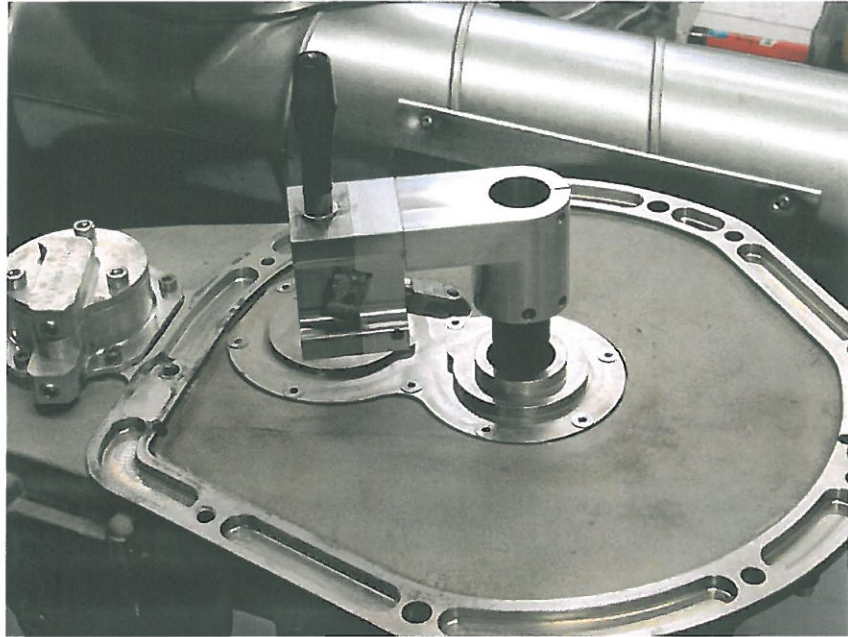
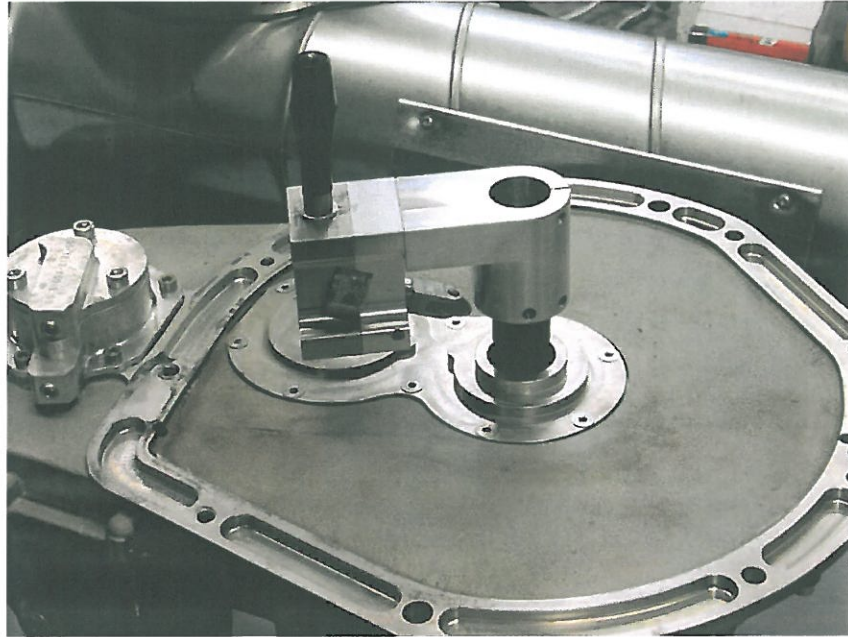
Fig. 2 Install special tool

5. Das Spezialwerkzeug VR00388 über die Getriebeeingangswelle führen. Siehe Bild 2.

5. Put the special tool VR00388 to the input shaft of the gearbox. See Fig. 2.

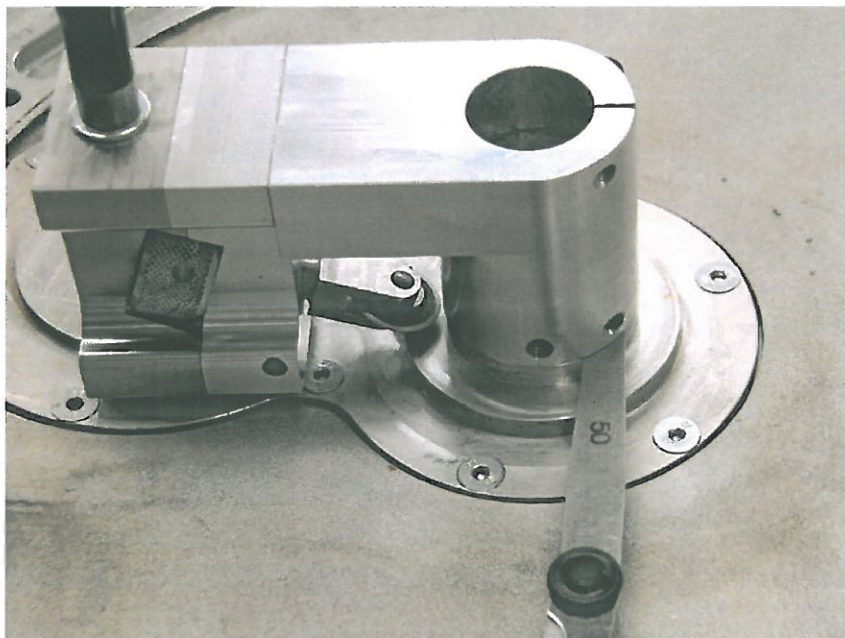
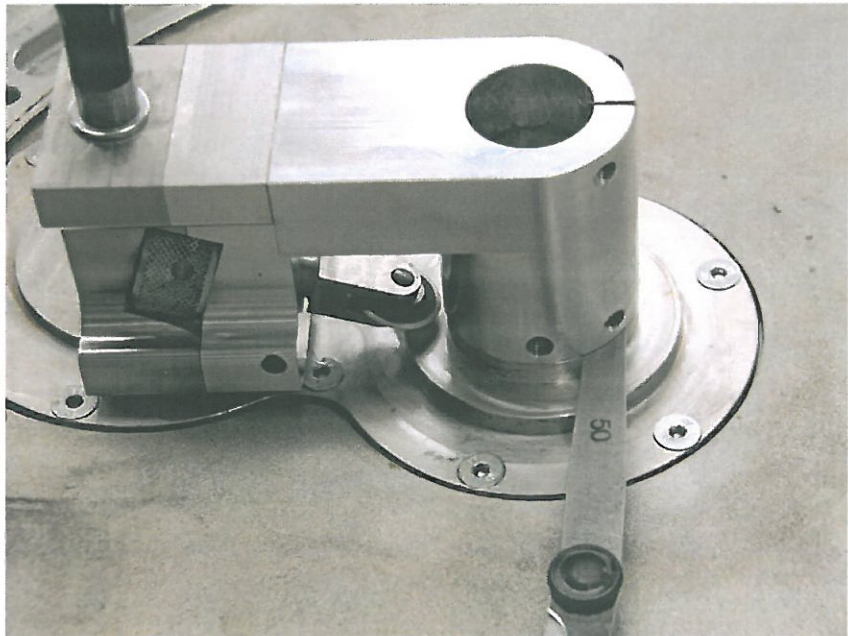
Fig. 3 Adjust clearance with feeler gauge

6. Das Spezialwerkzeug aufschieben und mit einer Fühlerlehre einen Abstand von 0.5mm zwischen Spezialwerkzeug und dem hinteren Getriebedeckel einrichten. Siehe Bild 3.

6. Move the special tool downwards to the rear gearbox cover until there is a clearance of 0.5mm between the special tool and the rear gearbox cover. Use a feeler gauge to ensure the clearance of 0.5mm. See Fig. 3.

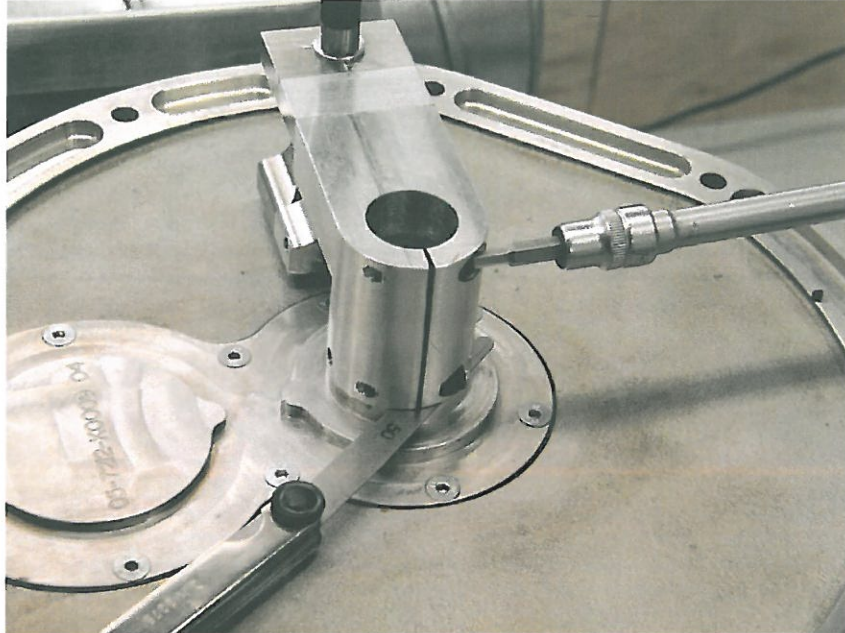
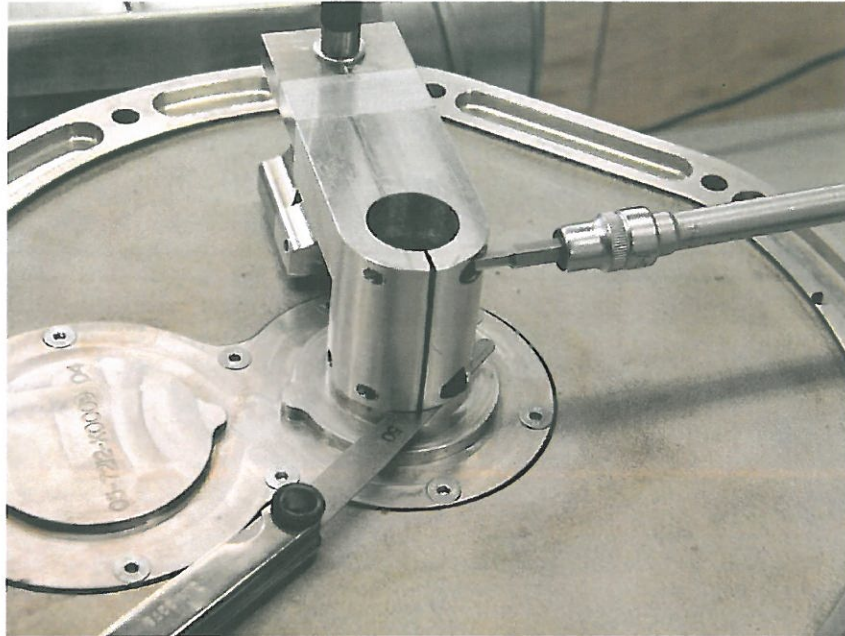
Fig. 4 Screws for the attachment of the special tool

7. Die zwei Innensechskantschrauben am Spezialwerkzeug mit dem vorgeschriebenen Drehmoment anziehen. Siehe Bild 4.

7. Tighten the two cylinder head screws to the specified tightening torque. See Fig. 4.

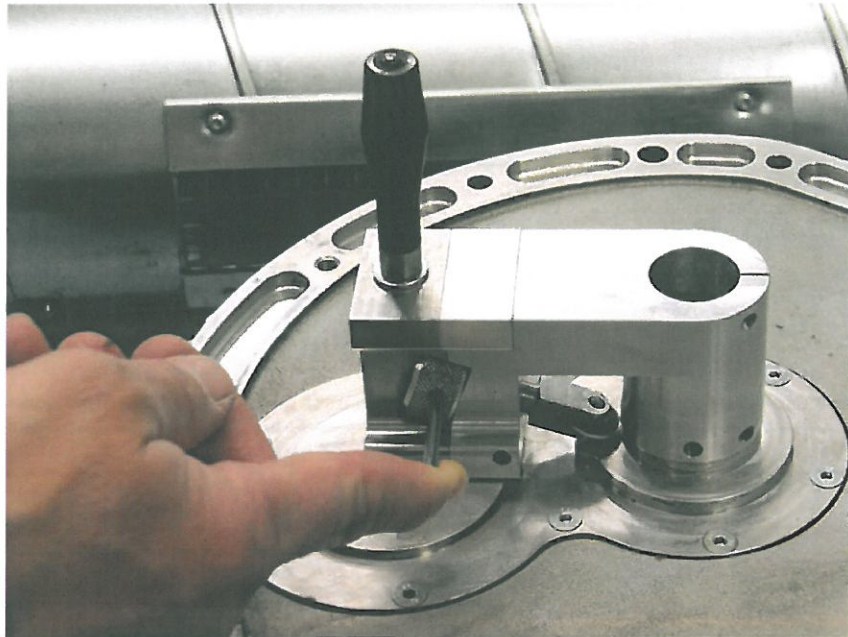
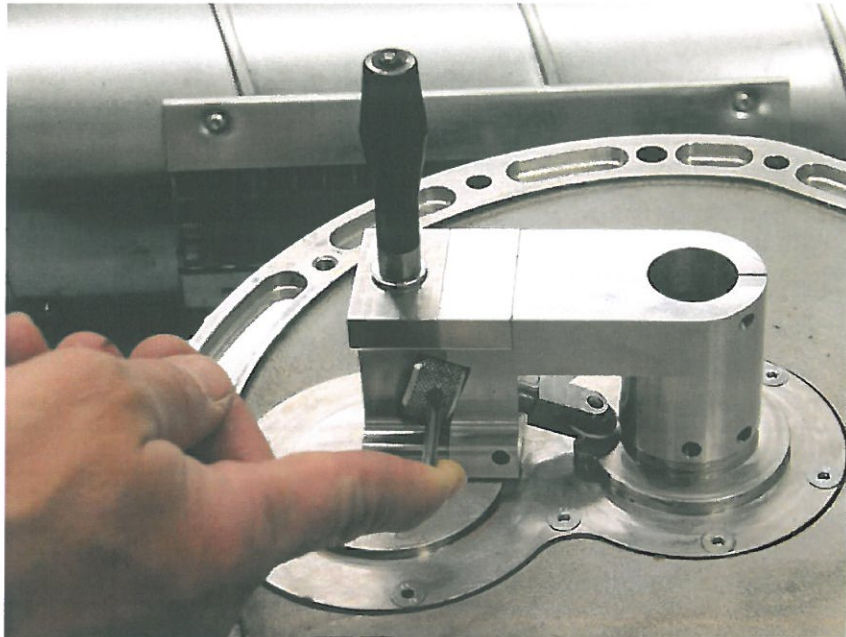
Fig. 5 Turn the adjustment wheel to feed the cutting tool

8. Remove the feeler gauge.  
9. Turn the adjustment wheel until the cutting tool touches the shoulder of the rear gearbox cover.  
10. Put the cylinder pin in the drill hole of the adjustment wheel. See Fig. 5.  
11. Turn the adjustment wheel until the cylinder pin touches the housing of the tool. See Fig. 5.

- **CAUTION:** Do not turn the adjustment wheel more than 45°. It can cause damage to the cutting tool!
- ◆ **Note:** Use the cylinder pin to turn the adjustment wheel. See Fig. 5.

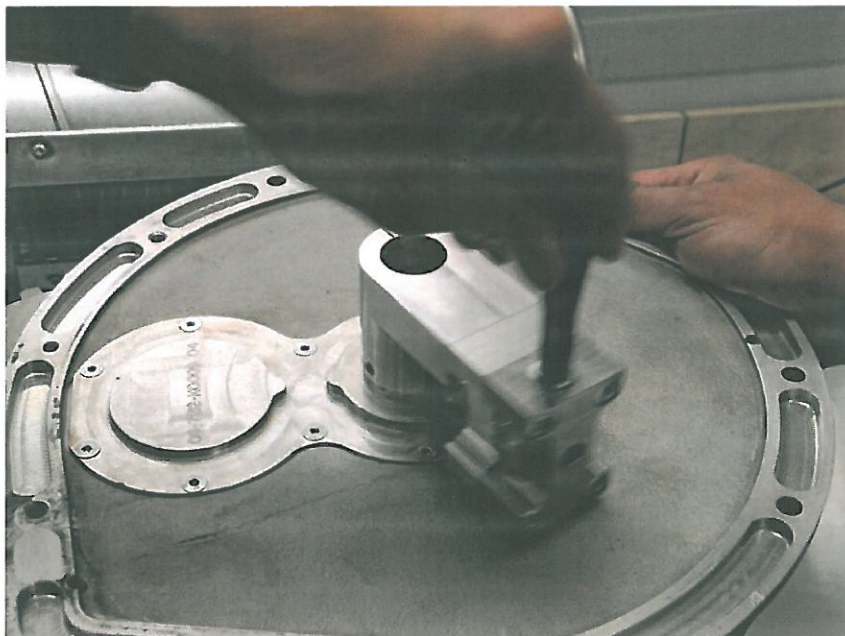
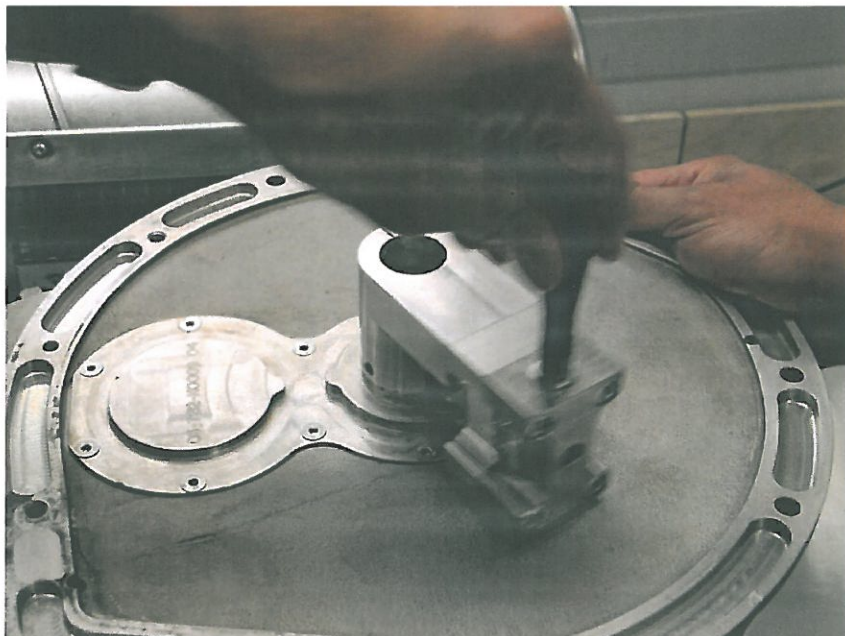
Fig. 6 Turn the special tool

12. Das Werkzeug am Griff mehrere Umdrehungen mit der Getriebeeingangswelle drehen. Siehe Bild 6.

12. Turn the special tool together with the gearbox input shaft a few revolutions. Use the handle bar. See Fig. 6.

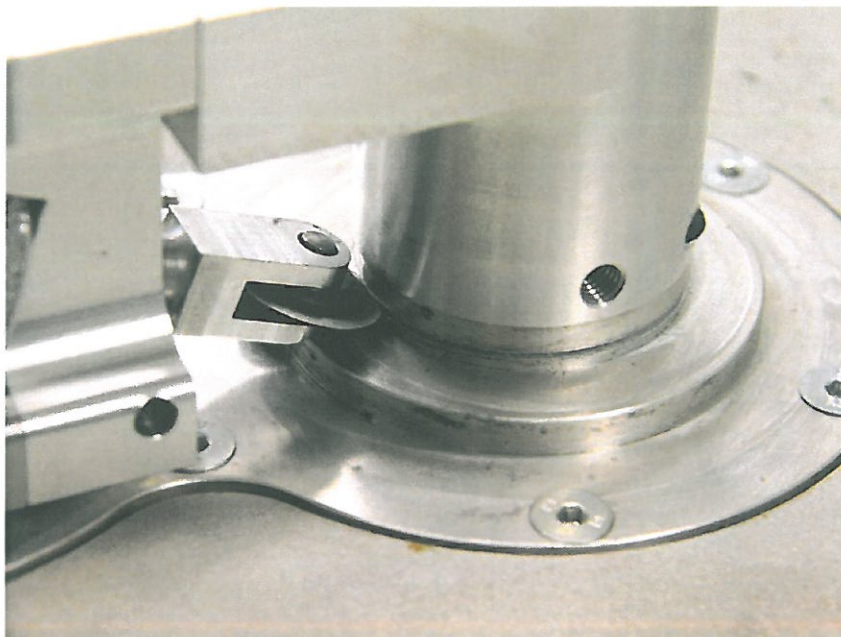
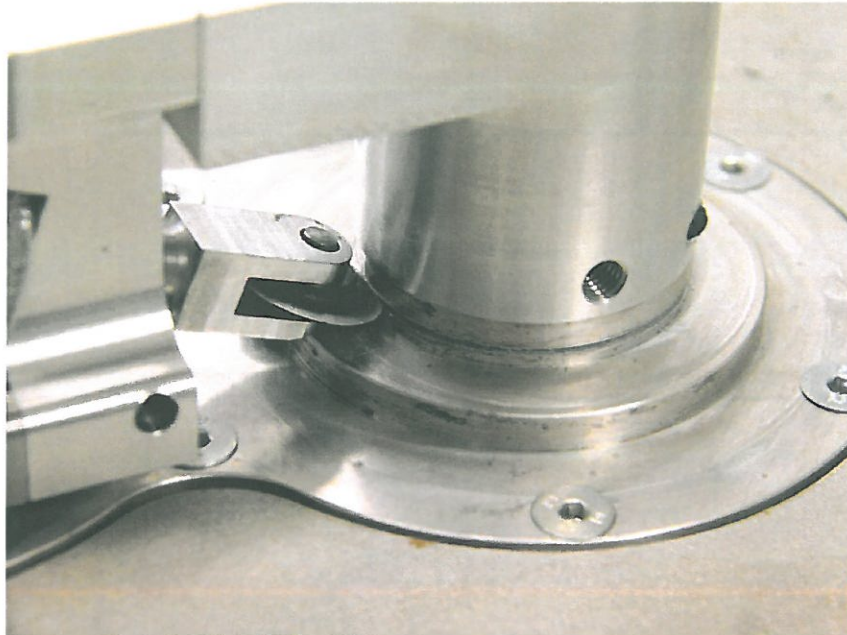
Fig. 7 Shoulder is cut through

13. Anschließend analog zu Arbeitsschritt 12 das Schneidwerkzeug weiter zustellen und das Spezialwerkzeug am Griff drehen. Die Arbeitsschritte 12 und 13 solange wiederholen, bis sich der Bund vom Getriebedeckel löst. Siehe Bild 7.

13. Feed the cutting tool. Refer to work step 12. Then turn the special tool. Refer to work step 13. Repeat work step 12 and 13 until the shoulder of the rear gearbox cover gets loose. See Fig. 7.

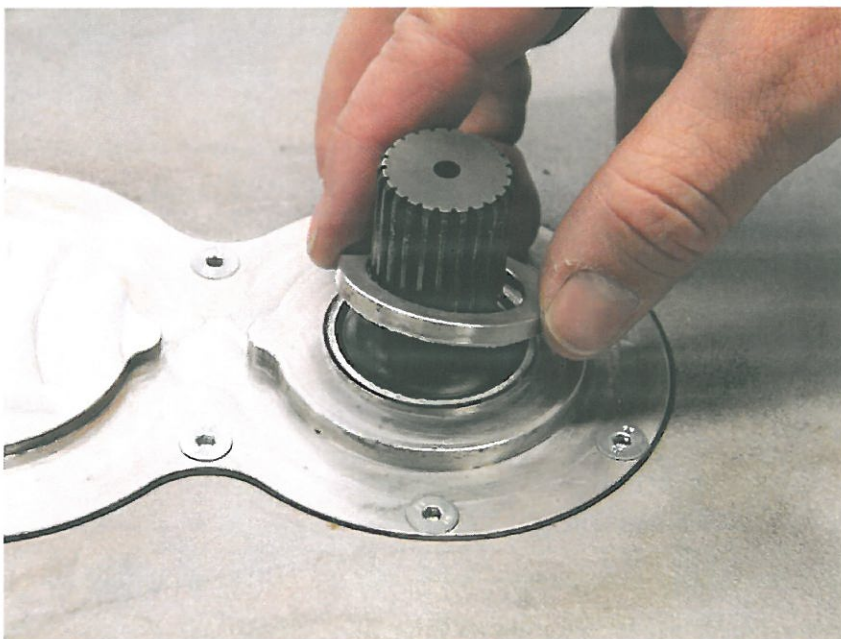
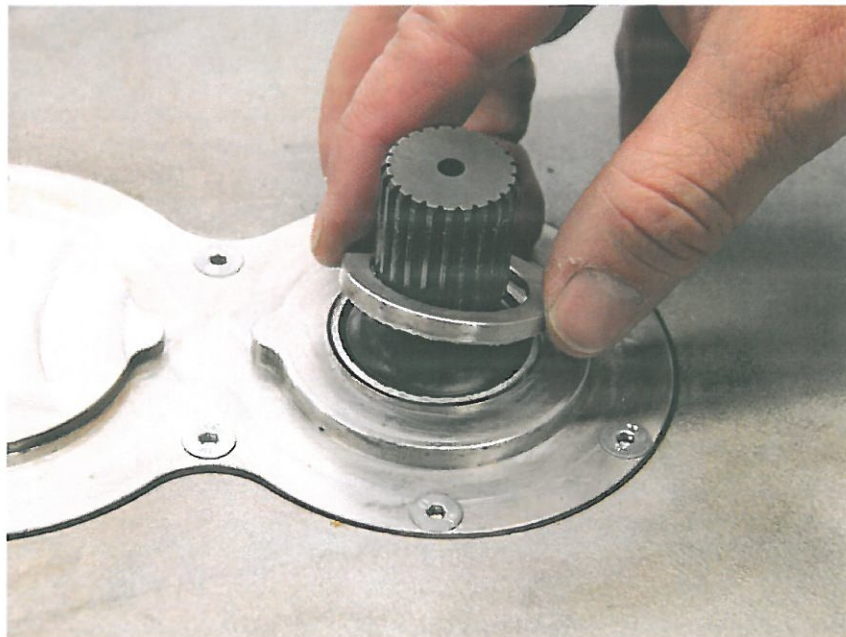
Fig. 8 Remove the shoulder

14. Das Einstellrad zurück drehen bis das Schneidwerkzeug ausreichend Freigang zur Entnahme des Spezialwerkzeuges hat.
15. Die zwei Zylinderschrauben vom Spezialwerkzeug lösen.
16. Das Spezialwerkzeug abnehmen.
17. Den Bund vom Getriebedeckel abnehmen. Siehe Bild 8.

14. Turn the adjustment wheel backwards until the cutting tool has enough clearance to the shoulder to remove the special tool.
15. Loosen the cylinder head screws of the special tool.
16. Remove the special tool.
17. Remove the shoulder of the rear gearbox cover. See Fig. 8.
