## SERVICE INFORMATION NO. SI 42-205

Technify Motors Service Bulletin TMG 125-1020 P1  
ATA-Code: 72-00

**Service Bulletin No. / Date:** SB TMG 125-1020 P1, Initial Issue / January 27, 2016

**Subject:** Gearbox Oil Leak Inspection

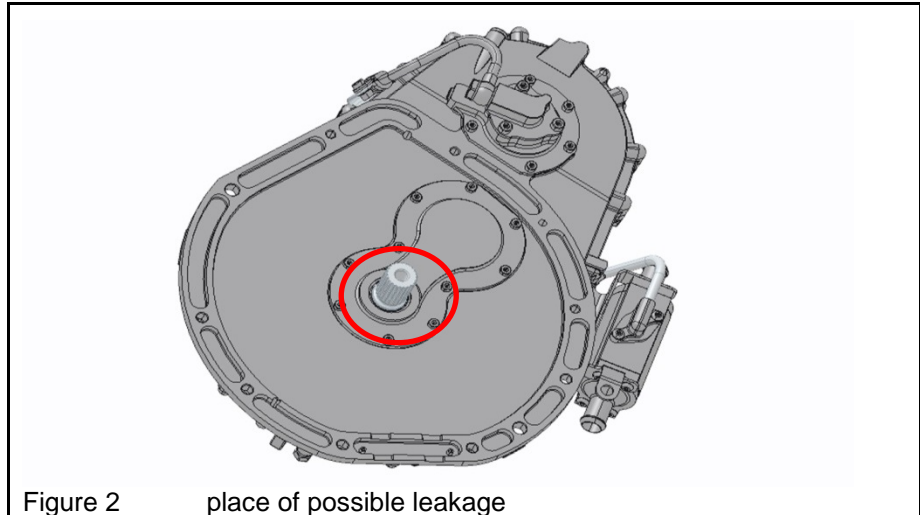
**Reason:** Radial shaft sealing ring may not seal properly due to an improper lapped gearbox drive shaft. This can lead to an oil leak and a slipping clutch and finally to a loss of power.

- Remove the gearbox and replace the clutch by dual mass flywheel in accordance with RM-02-02, Chapter 72-10.18, Issue 3, Revision - or later approved revisions.
- Inspect the gearbox, check the rear radial shaft sealing ring on the gear shaft for oil leakage and moisture, see Figure 2 and Figure 3.
