SERVICE INFORMATION

No. SI 42-208

GARMIN Service Advisory No. 1372 Rev. B

SUBJECT: Unavailable RNAV (GPS) approaches due to lack of VDA

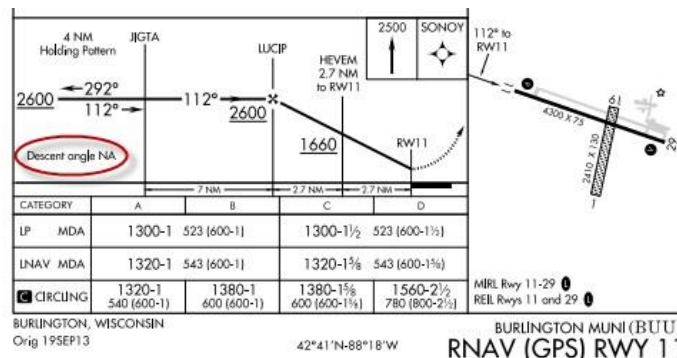
A limited number of RNAV (GPS) approaches, including all service levels, are unavailable for selection when the approach includes LP minima and also has no published vertical descent angle (VDA). See the example in Figure 1.

Figure 1: No Published Vertical Descent Angle (VDA) Example

- G1000, Cirrus Perspective, Embraer Prodigy, G950, and G900X GDU software versions 15.00 and later
- G2000, G3000, and G5000 GDU software versions 5.00 and later
- GNS 400W/500W Series main software versions 5.10 and later
- GTN 6xx/7xx Series main software versions 5.13 and later
