SERVICE INFORMATION NO. SI 42-239

Continental Aerospace Technologies GmbH SB CG 125-1028 P1

SERVICE BULLETIN

Subject: Inspection / sealing of the cylinder head side cover

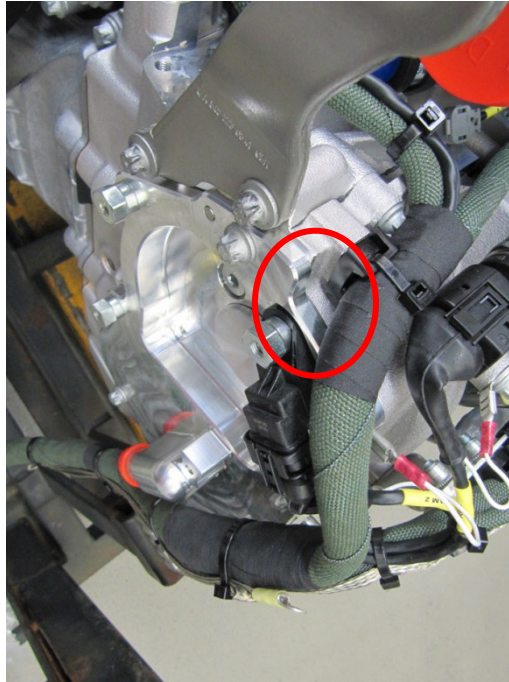
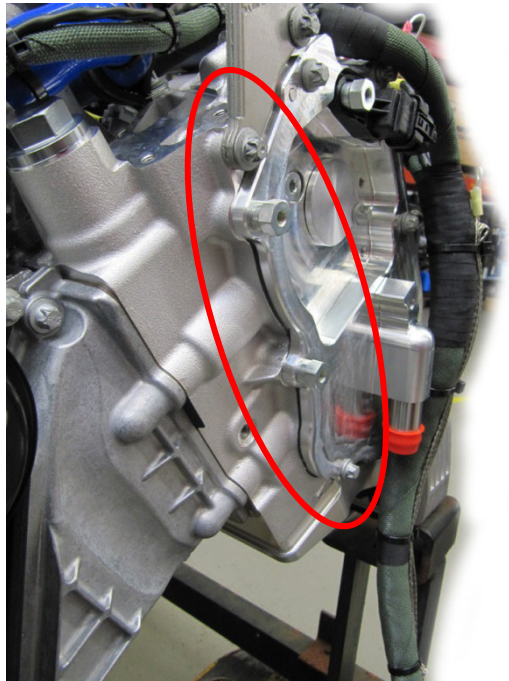
Reason: Possible oil leakage due to an improper sealing of the cylinder head side cover. The oil leak, if not corrected, can result in a damaged v-ribbed belt and possibly an engine shut down.

1. Check the side cover for oil leaks at the marked points. See Figure 1 and Figure 2.
