## NO. SI 42-247

## NO. SI 42NG-133

Garmin Service Bulletin No. 22117 Rev. B

NO.: 22117 Rev B

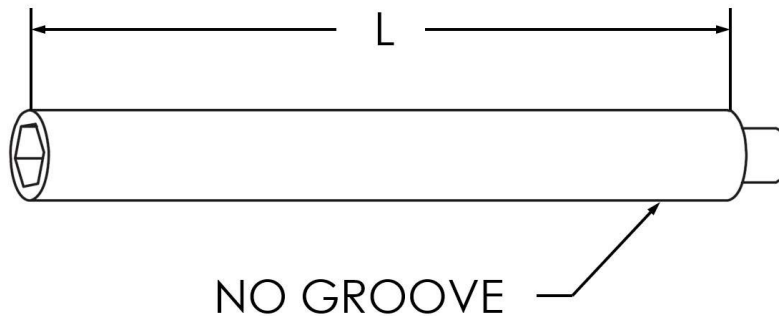
**Figure 1 - 233-00075-01 and 233-00075-02 Cable Retention Pins**

Both the -01 and -02 Cable Retention Pins have no grooves (See Figure 1). The -01 Cable Retention Pin is 1.48" long and the -02 is 1.60" long (See Figure 1).

In the event of the loss of the clutch retaining bolt, the output shaft drive pin may become partially disengaged causing the capstan to bind.

This Service Bulletin contains instructions to replace the cable retention pins with new longer cable retention pins to ensure the GSM servo gearbox capstan is free to rotate in the event that the clutch retaining bolt is not retained.
