SERVICE INFORMATION

NO. SI 42-249

GARMIN Service Bulletin No. 0736 Rev. C
ATA-Code: 34-00

SUBJECT: G1000 System ID Tool

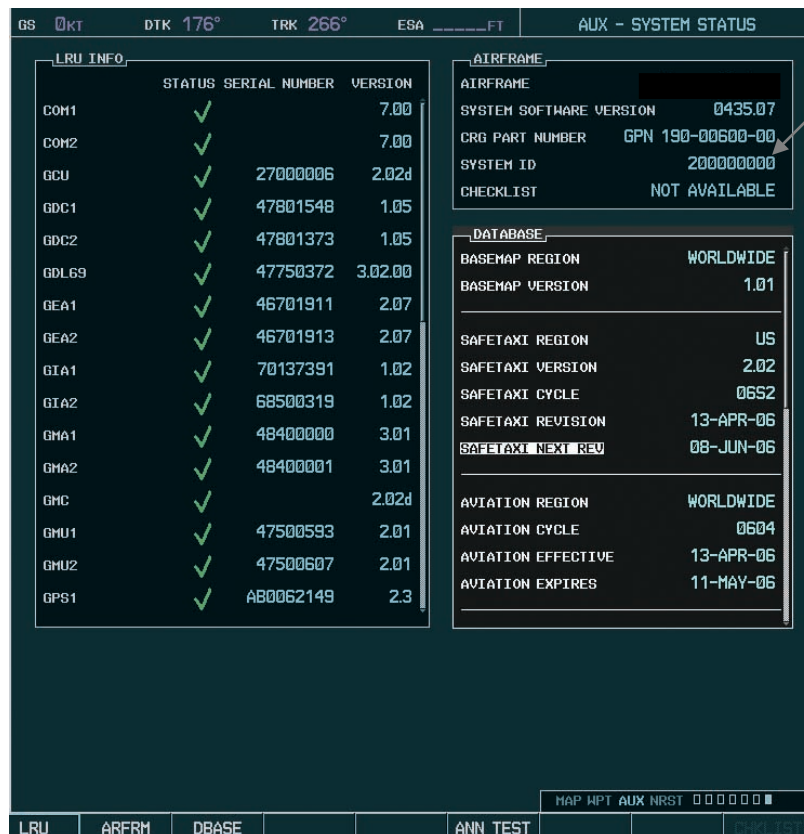
Figure 1. Example AUX – System Status Page

Garmin has identified an error associated with G1000 system software upgrades that sometimes results in an invalid System ID. An invalid System ID can be identified as either being “00000000” or “20000000”. The G1000 System ID can be verified on the AUX-System Status Page (Figure 1).

All GDU 1XXXs with a GDU software version of 7.00 or greater **and** a System ID of “00000000” or “20000000”. The G1000 System ID can be verified on the MFD AUX-System Status Page (Figure 1).

Use the G1000 System ID Tool (P/N 006-B0380-ZA) to change the G1000 System ID from “00000000” or “20000000” to a valid System ID by performing the following procedure:
