RECOMMENDED SERVICE BULLETIN

RSB 50-007

Lubrication of flap actuator trigger rod.
ATA Code: 27-50

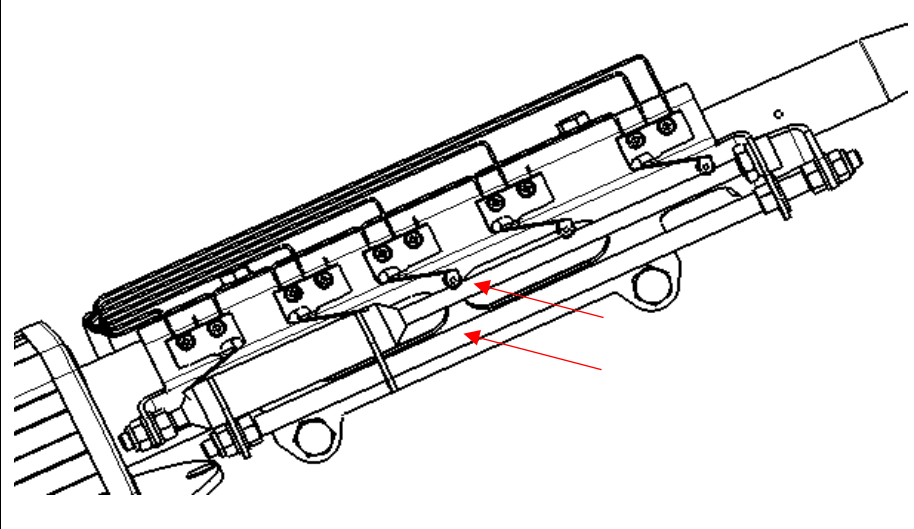
1	Set the flaps to the UP position.
2	Pull the flap circuit breaker.
3	Remove the seat cushion from the passenger seat row.
4	Remove the maintenance cap from the LH passenger seat row.
5	<p>Clean the marked rods of the flap actuator.</p>

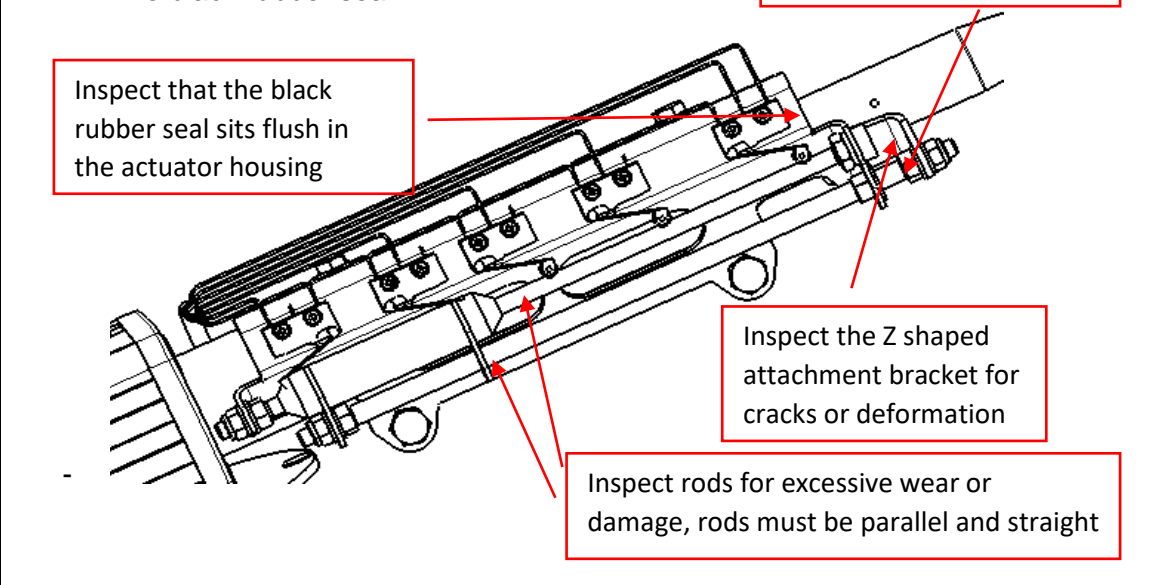
6	<p>Inspect for excessive wear or damage:</p> <ul style="list-style-type: none"> - The marked rods - The z - shaped attachment bracket of the rods - The black rubber seal

<div style="border: 1px solid red; padding: 5px; width: fit-content; margin: 5px;">Inspect the threaded end for cracks or deformation</div> <div style="border: 1px solid red; padding: 5px; width: fit-content; margin: 5px;">Inspect that the black rubber seal sits flush in the actuator housing</div> <div style="border: 1px solid red; padding: 5px; width: fit-content; margin: 5px;">Inspect the Z shaped attachment bracket for cracks or deformation</div> <div style="border: 1px solid red; padding: 5px; width: fit-content; margin: 5px;">Inspect rods for excessive wear or damage, rods must be parallel and straight</div>
