MANDATORY SERVICE BULLETIN

MSB 50-013

Type: DA 50 C

Replacement of the propeller de-ice brushes bracket bolts.

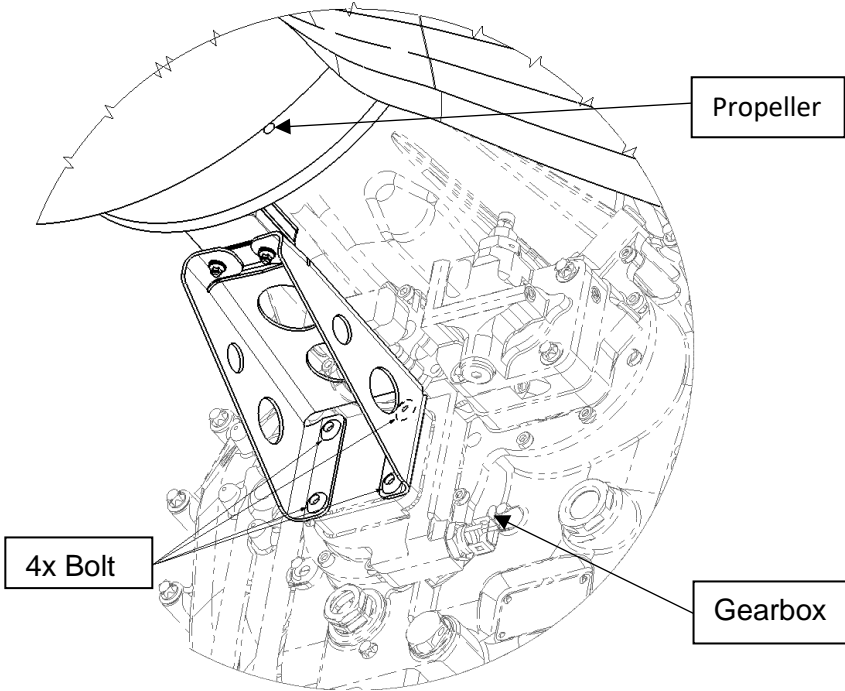
The effective thread length of the bolts that attach the propeller de-ice brushes bracket to the engine gearbox are shorter than specified by the engine manufacturer. This can cause tear out of the aluminum thread in gearbox housing and imperfect seal of the accessory drive cover and may subsequently lead to leakage of gearbox oil. This Service Bulletin describes replacement of these bolts with the right length as specified by the engine manufacturer as a precautionary action.

| 2 | <p>Replace each of the 4 bolts that attach the propeller de-ice brushes bracket to the gearbox, one by one, with the ISO7380-M8x16-10.9-BZP bolts.</p> <ul style="list-style-type: none"> • Replace on bolt at a time • Apply Loctite 243 (or equivalent) to the bolts. |
| 3 | Torque the bolts to 20 Nm \pm 2 Nm. |
