SERVICE INFORMATION

NO. SI 50-002

Garmin Service Bulletin No. 22117 Rev. B

SERVICE BULLETIN

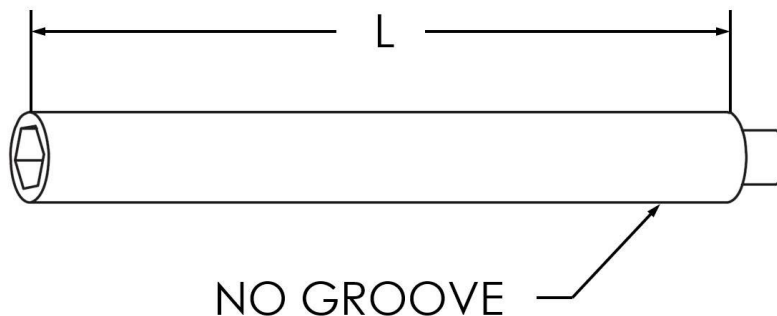
Figure 1 - 233-00075-01 and 233-00075-02 Cable Retention Pins

Both the -01 and -02 Cable Retention Pins have no grooves (See Figure 1). The -01 Cable Retention Pin is 1.48" long and the -02 is 1.60" long (See Figure 1).

In the event of the loss of the clutch retaining bolt, the output shaft drive pin may become partially disengaged causing the capstan to bind.

This Service Bulletin contains instructions to replace the cable retention pins with new longer cable retention pins to ensure the GSM servo gearbox capstan is free to rotate in the event that the clutch retaining bolt is not retained.
