# **SERVICE INFORMATION**

## **NO. SI 50-006**

Safe Flight Service Bulletin for Lift Transducer C-99707-2

Moisture ingress on certain lift  
transducer main connections

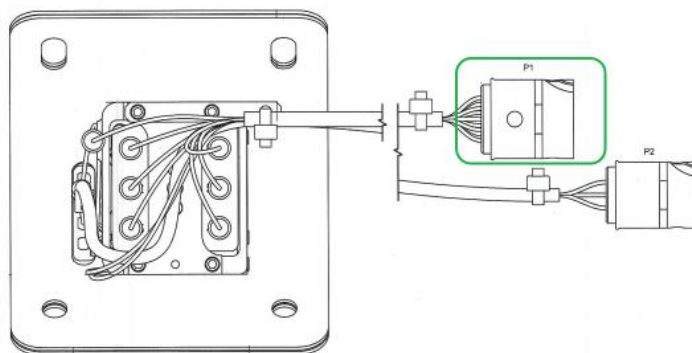
**Figure 1**

The Manufacturer of the aircraft interface connector, Amphenol PCD, has made Safe Flight aware of a non-compliance of the connectors ability to prevent moisture ingress.

- 1.) The moisture ingress prone component, P1 interface connector, is located at the end of the pigtail of Lift Transducer, P/N C- C-99707-2 (See Figure 1) .

Once P1 is identified, the course of action to mitigate the potential moisture ingress will be either Method 1 for severe exposure areas that are classified as Severe Wind And Moisture Problem (SWAMP), or Method 2 for areas that incorporate aircraft design features that environmentally protect the P1 connection location. Both methods are in accordance with Amphenol's instructions and have been deemed acceptable by Amphenol's applications engineers.
