OPTIONAL SERVICE BULLETIN

OSB 62-012/1

Installation of power plant cooling improvement.

WI-OSB 62-012

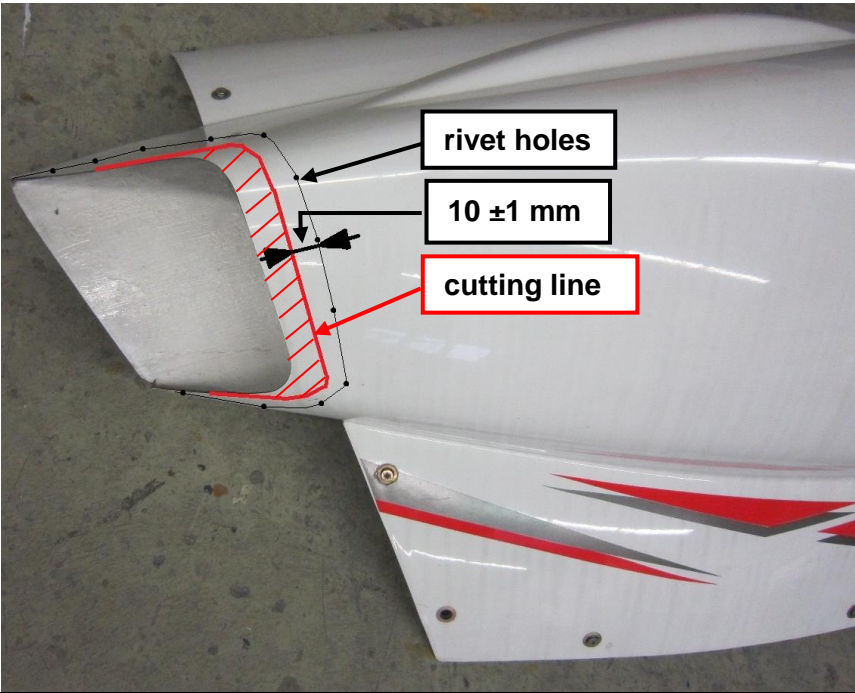
Diamond has developed a cowling that improves the power plant cooling in hot weather conditions.
This Service Bulletin describes the modification of the cowling for aircraft already in service.

1	Perform this work instruction on LH and RH engine. Remove the top RH cowlings i.a.w. AMM Section 71-10.
2	Pre fit the enlarged air outlet on the top RH cowlings.
3	Drill the holes for blind rivets on the top RH cowlings through the holes in the pre fitted enlarged air outlet, refer to step above.
4	<p>Mark a cutting line on the cowling air outlet 10 ±1 mm away from rivet holes i.a.w. picture below. Trim along the cutting line and break sharp edges.</p>

5	Mount the enlarged air outlets with blind rivets on the top RH cowlings.
6	Seal the gaps around the enlarged air outlets with Rotabond2000_weiss.
7	Cure time of the seal about 24 hours.
8	Install the top RH cowlings i.a.w. AMM Section 71-10.
9	Clean working area, check for foreign objects
10	Check all altered, replaced, repaired parts for proper function.
11	Test all systems in working area for function.
12	Make all necessary entries in the airplane logs.
